The Buncefield Investigation

Second progress report

Part 1 Progress with the primary investigation

1.1 Loss of containment of fuel and contaminants

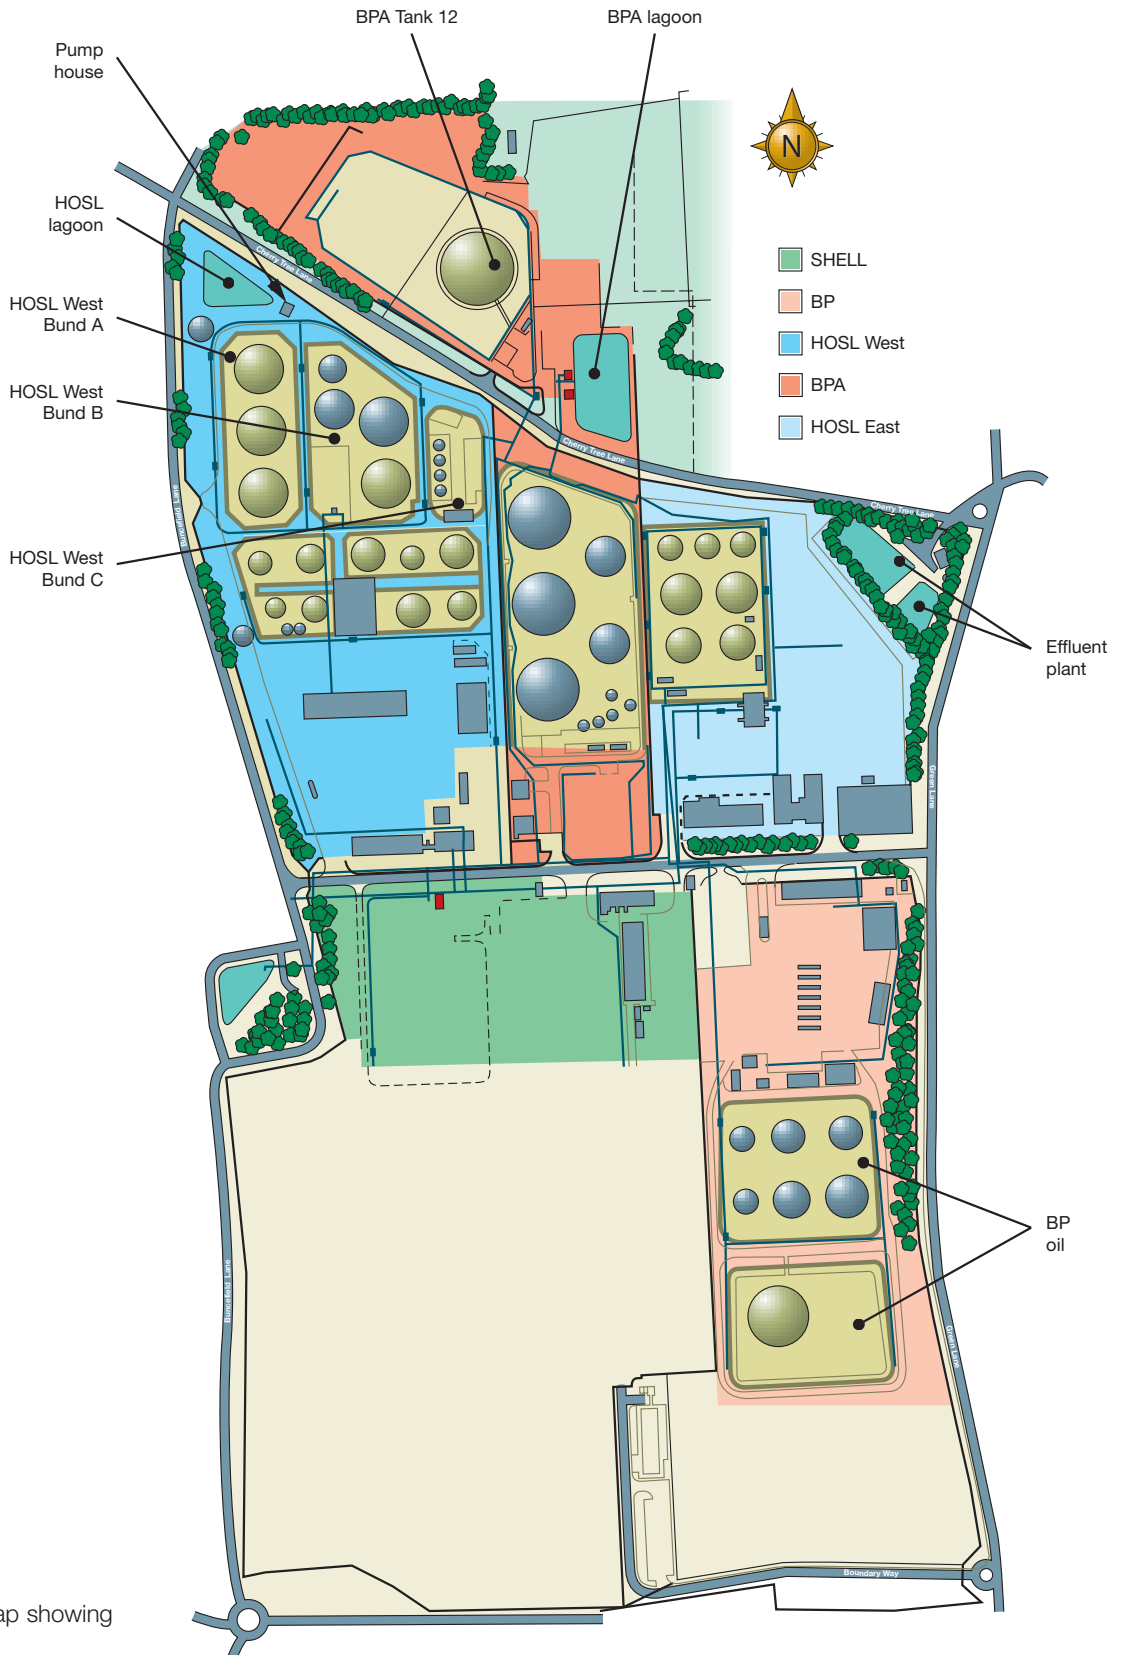
Figure 1 Site map showing bunds

a flammable mixture with the air. Little was known about how primary containment was lost or how the escaping fuel formed into a flammable mixture. (Figure 1 shows a schematic of the bunds.)

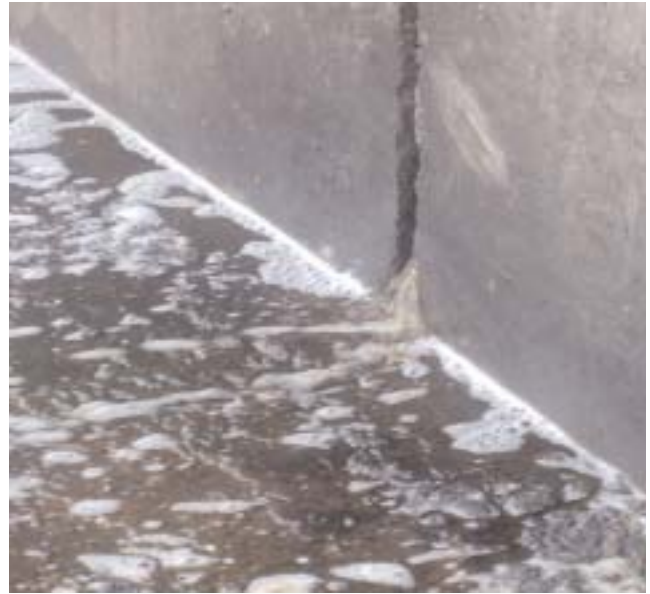
17 Many of the bunds around the site have suffered varying degrees of sealant damage. Figure 6 shows fire water and product leaking from such a joint in the later stages of the incident.

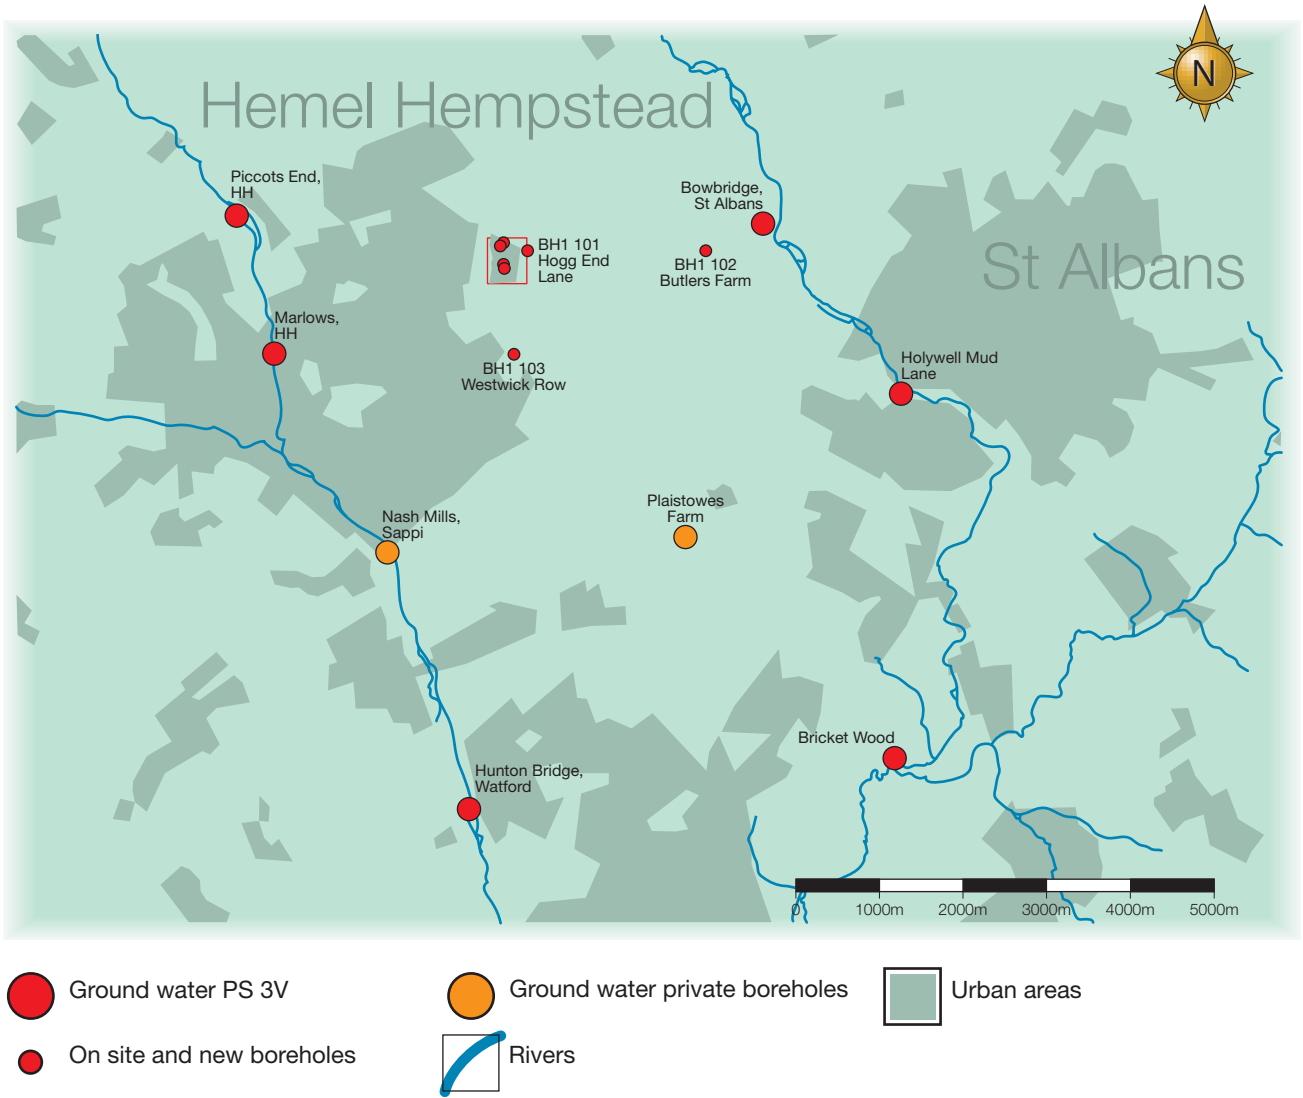
45 Three new observation boreholes have been drilled closer to the Buncefield site to provide early detection of any ground water pollution: Butlers Farm (between Buncefield and Bow Bridge Pumping Station); Breakspear House (south of Buncefield); and Hogg Lane (on the east boundary of Buncefield – see Figure 16). This is part of an ongoing monitoring regime that will provide further boreholes surrounding the site. They have each been sampled once, along with drinking water boreholes, and analysed for pollutants.

Figure 16 Map of ground water boreholes
