Buncefield: Why did it happen?

The underlying causes of the explosion and fire at the Buncefield oil storage depot, Hemel Hempstead, Hertfordshire on 11 December 2005

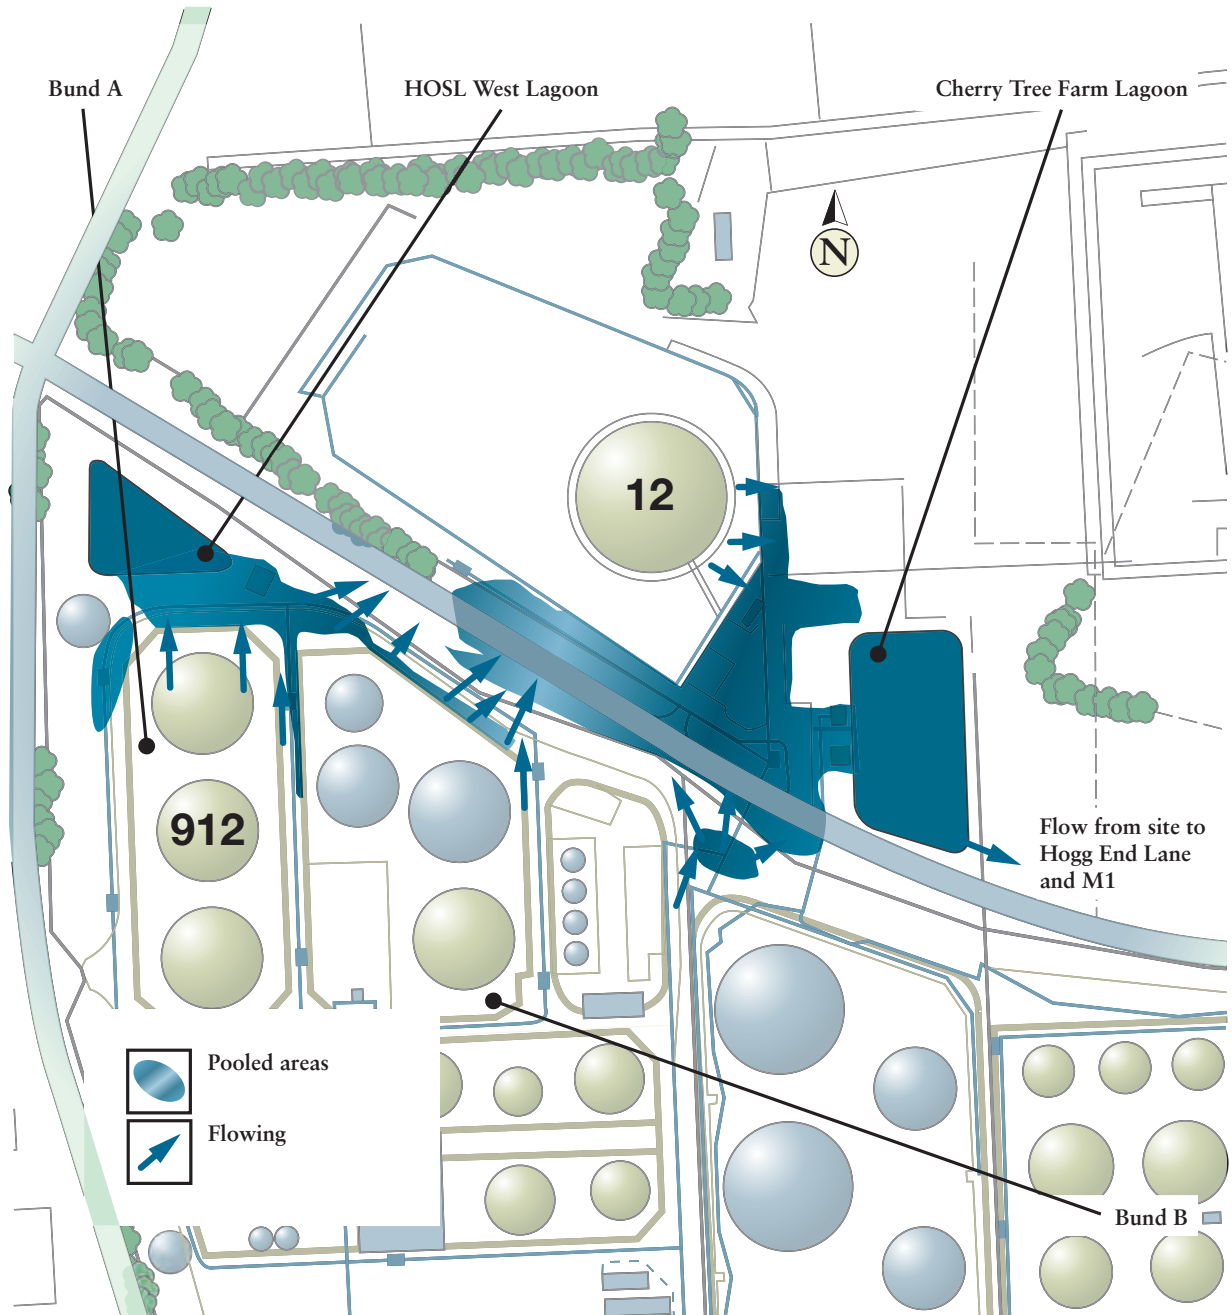
Figure 3 Layout of the Buncefield site showing flow of liquids

16 The fire lasted five days and large quantities of water and firefighting foam were used to bring the blaze under control. Fuel, water and foam spilled from leaking bunds formed a large pool of liquid to the east of BPA Tank 12. Liquids subsequently flowed down Cherry Tree Lane, past the roundabout into Hogg End Lane and as far the M1 motorway bridge, several hundred metres away.

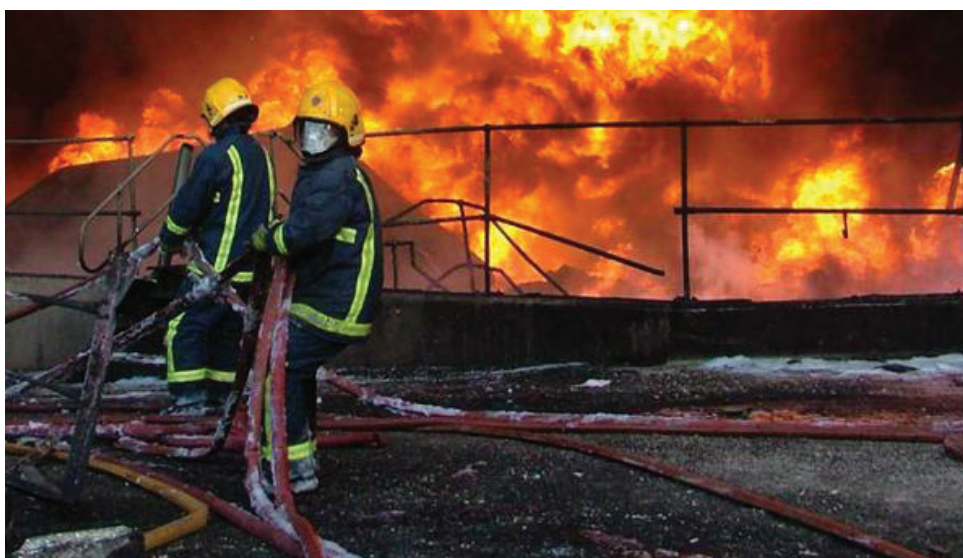
Figure 4 Firefighters tackle a blazing tank at Buncefield © Hertfordshire County Council

15 The severity of the explosion was far greater than could reasonably have been anticipated based on knowledge at the time and the conditions at the site. The devastation was enormous. Fortunately there were no fatalities but over 40 people were injured. The ensuing fire, the largest seen in peacetime UK, engulfed over 20 fuel tanks on the HOSL and adjacent sites and burnt for several days. Fire crews attended from many parts of the country. Fuel and firefighting chemicals flowed from leaking bunds down drains and 'soakaways', both on and off site. The environmental, social and economic toll was considerable. The human toll should not be underestimated; while no one lost their life some have yet to fully recover from the effect that the explosion had on their lives. The human effects may have been even greater had the event not occurred early on a Sunday morning when the adjacent industrial area was relatively quiet.

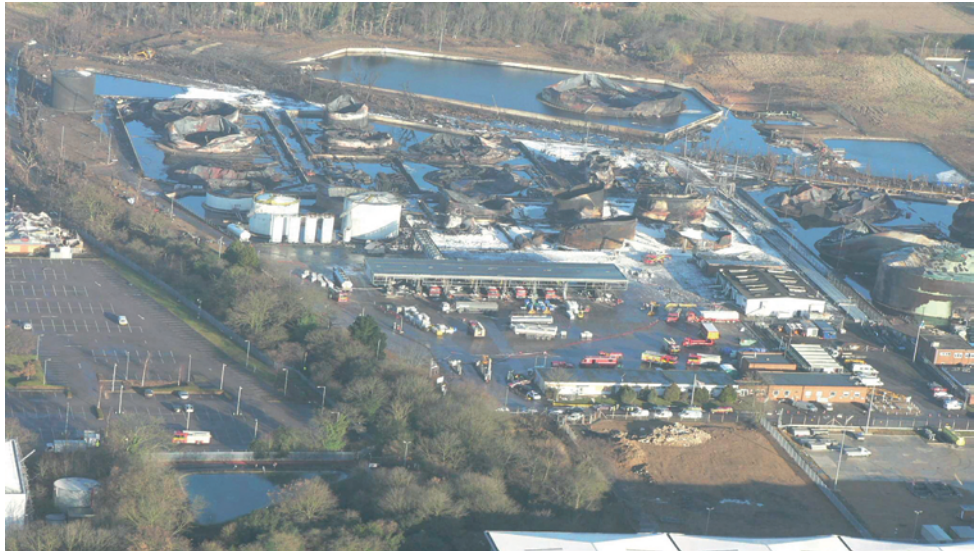
Figure 5 Part of the Buncefield depot after the incident © Chiltern Air Support
