**IMPERIAL CHEMICAL INDUSTRIES LIMITED**  
**PETROCHEMICALS DIVISION**

**SAFETY NEWSLETTER No. 57**

**57/1 WATER HAMMER AGAIN**

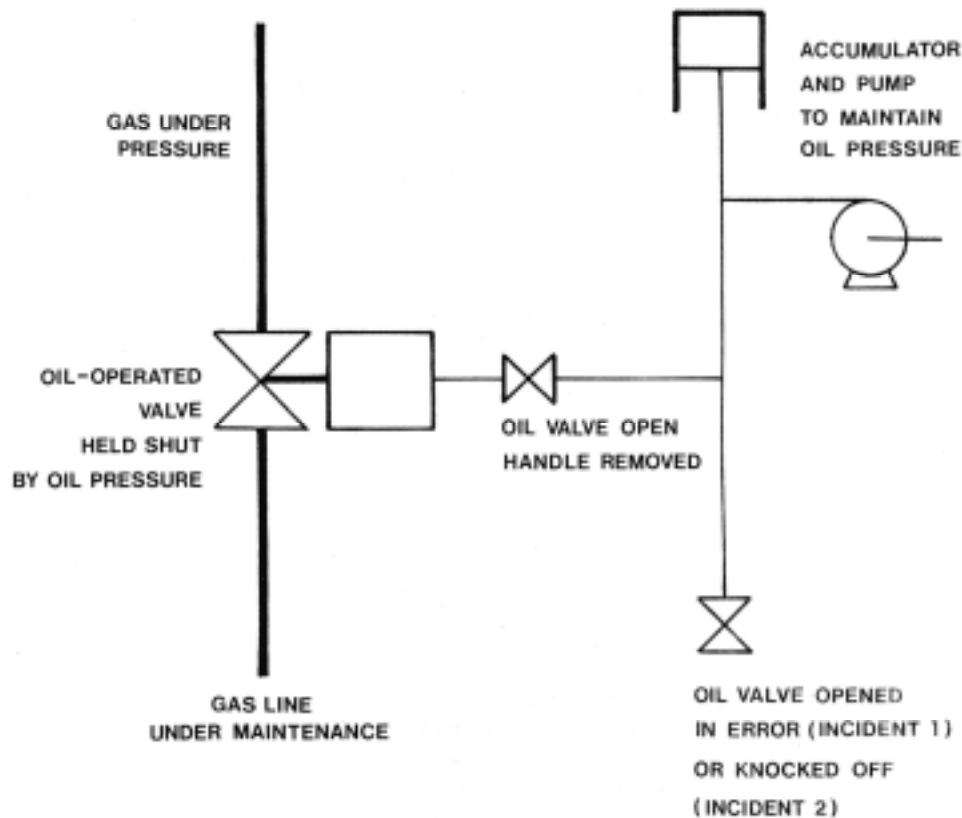
On 9 September 1928 a pipeline was isolated by closing oil-operated valves and the line was then opened up for repair. The valves were held closed by oil pressure and the handles were removed from the oil valves to prevent anyone isolating the oil.

Unfortunately an error in operation elsewhere led to a loss of oil pressure. The oil-operated valves opened and allowed flammable gas to escape into the building. There was a mild explosion which broke most of the windows but this was followed by a fire which spread to a neighbouring structure; two men who came down the stairs into the fire were fatally burned. Another two men retreated to the far end of the structure and escaped without injury.

The source of ignition was probably a lighting fitting which was broken by the escaping gas. The recommendations made in the report are as true to day as when they were written.

*The oil pressure should be turned on to each valve periodically*

*This will ensure that the breaking of an oil-pipeline will not cause all oil operated valves to open.*

Today, we would insist that the valves are secured by a mechanical lock and, in addition, unless the job to be done is a quick one, the process lines should be slip-plated.
