No. 125

PREPARATION FOR MAINTENANCE AND ENTRY

IMPERIAL CHEMICAL INDUSTRIES LIMITED
PETROCHEMICALS DIVISION

July 1979

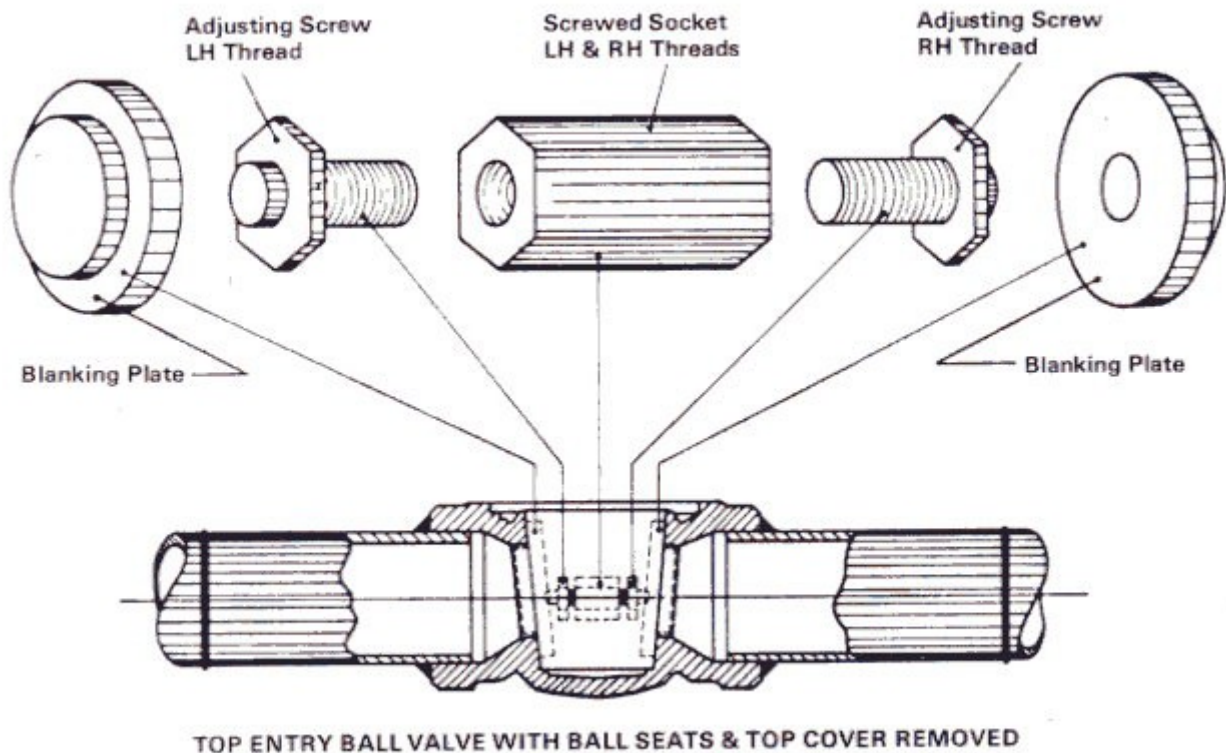
Sometimes on all-welded plants, there is no way of slip-plating or disconnecting vessels which have to be entered.

The diagram below shows a method that can be used to isolate a line with a welded-in ball valve. The topwork is removed and replaced by two blanking plates, forced apart by the two adjusting screws and the screwed socket.
