Loss Prevention Bulletin

Process Safety Essentials

Issue 272, April 2020

The Feyzin Disaster

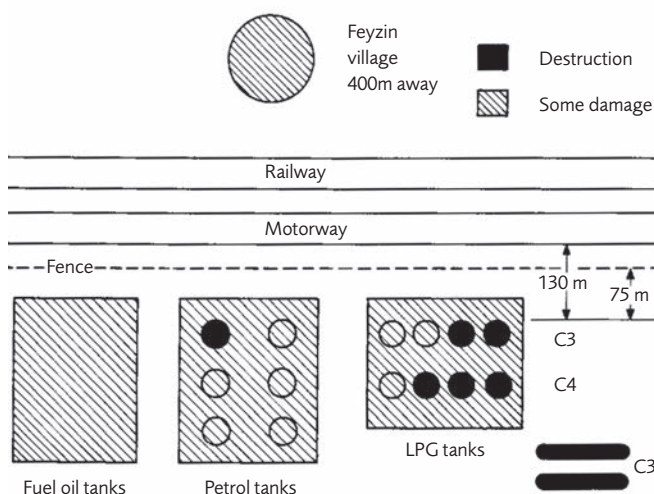
Figure 1: General site layout

The main storage areas were situated to the south of this road in a 145 m wide strip adjacent to a boundary fence with a motorway. The key area in the tank farm relates to the following units, (see Figure 1).

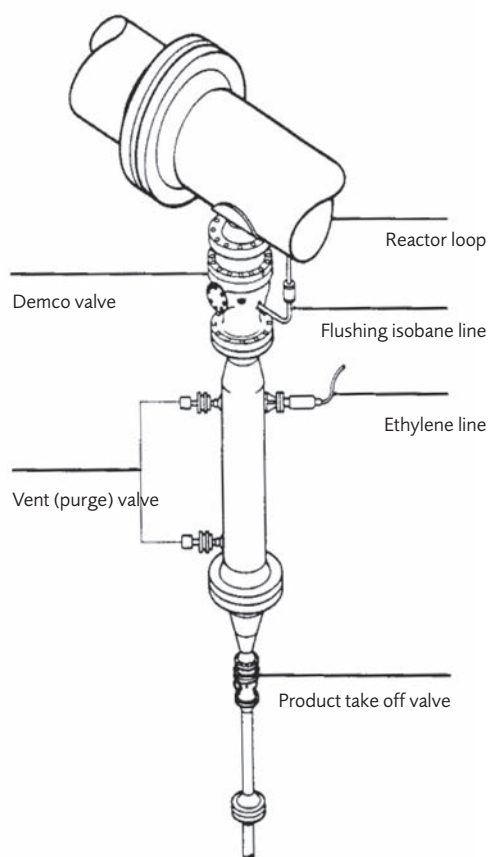
Figure 1: Typical piping settling leg arrangement

At the top of each leg is a ball valve (Demco brand) where it joins the reactor pipe loop. This ball valve is kept open

during normal operation. Clogging of the settling legs occurs periodically and on these occasions the top Demco ball valve is closed and the leg removed to clear the blockage. The reaction is continued during this operation as the product is able to settle out in adjacent settling legs.
