Health and Safety Executive

## *The Brightside Lane Warehouse Fire*

A report of the investigation by the  
Health and Safety Executive into the  
effects of the fire at the National Freight  
Consortium warehouse building, Brightside Lane,  
Sheffield, on 14 December 1984.

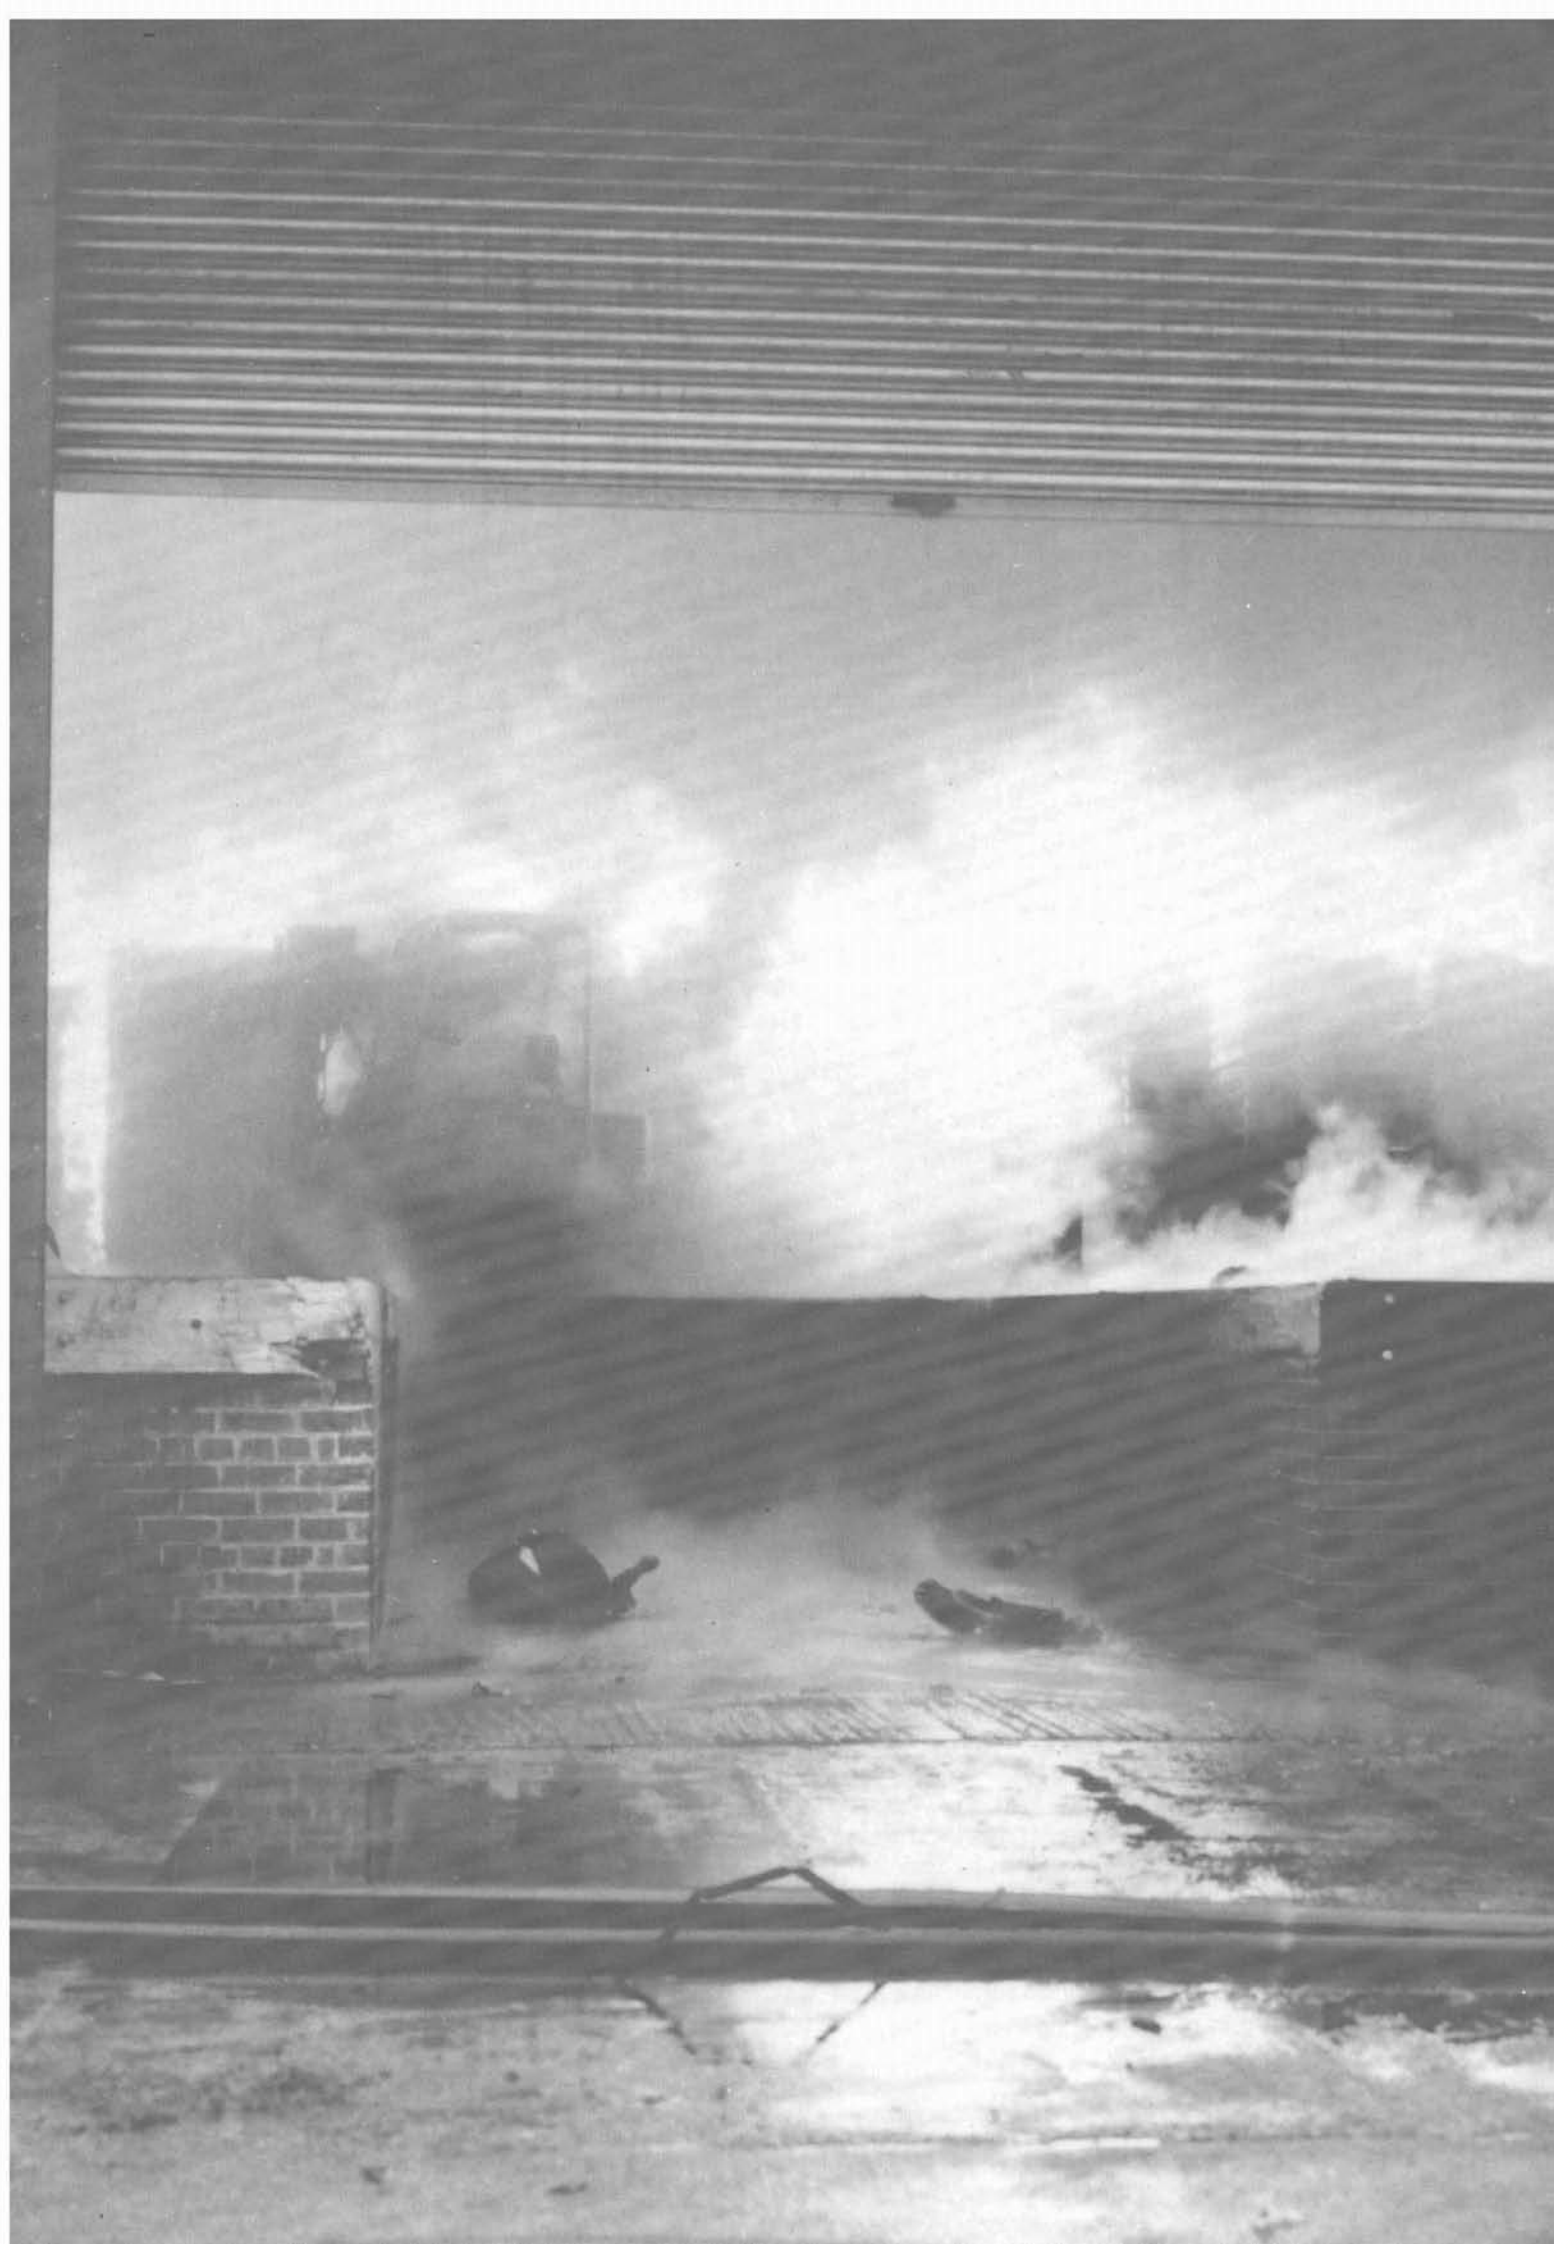
Fig 5 Fire at 1335 hrs on 14 December 1984

58 The fire was advancing along Unit 2 at walking pace and crews sought to extend hoselines to get ahead of the flames and make a ‘stop’ — a point at which the fire could be checked. It was difficult to keep pace with the fire, particularly since flames were spreading at roof level into Unit 5 above the fire crews. Unit 1 was totally engulfed: the front roller shutter door had collapsed, fire had broken through some of the external wall sheets and the gable wall which was bulging outwards collapsed shortly afterwards. Figure 5 shows the position at 1335 hrs.

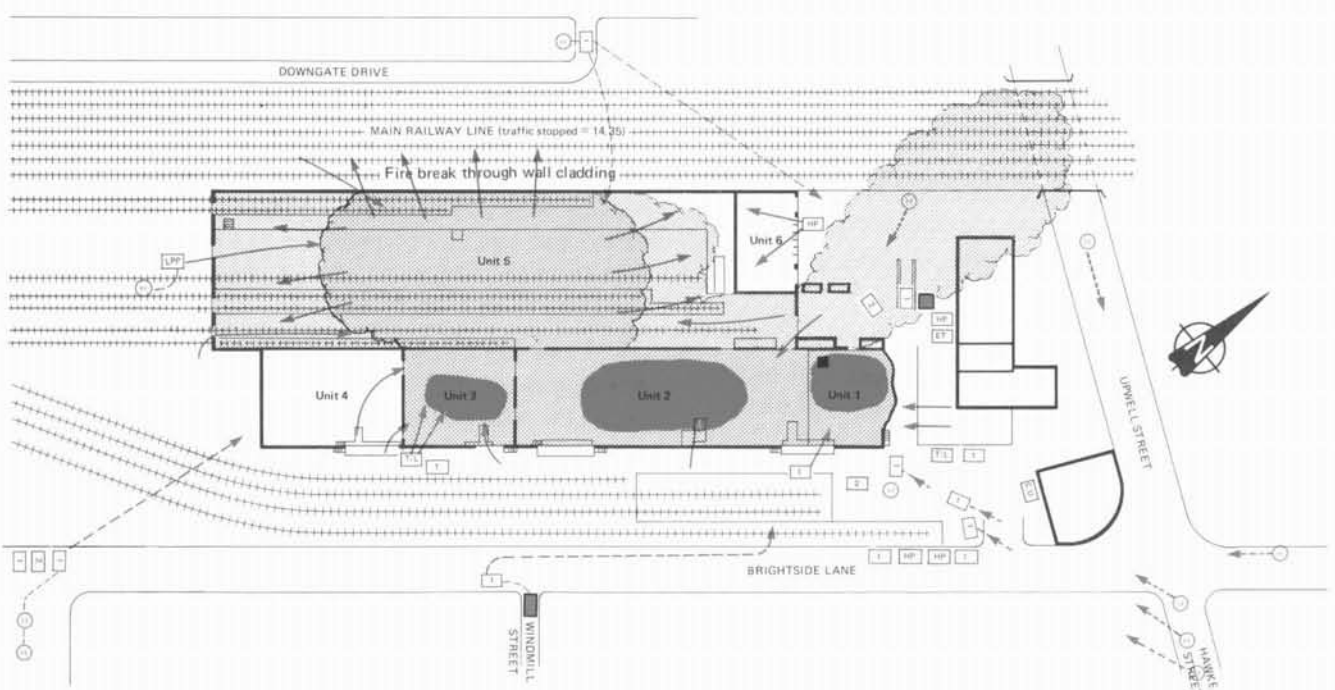
Fig 7 Fire at 1500 hrs on 14 December 1984

66 At 1438 hrs a "make pumps 17" priority message was sent and the responding crew arrived at 1446 hrs. By now the fire was so intense that crews and appliances were redeployed simply to minimise further spread. It was impossible to enter many parts of the building and crews fought the fire from the outside or from loading bay entrances which gave limited, but safe, access inside the building for a time. Figure 7 shows the position at 1500 hrs.

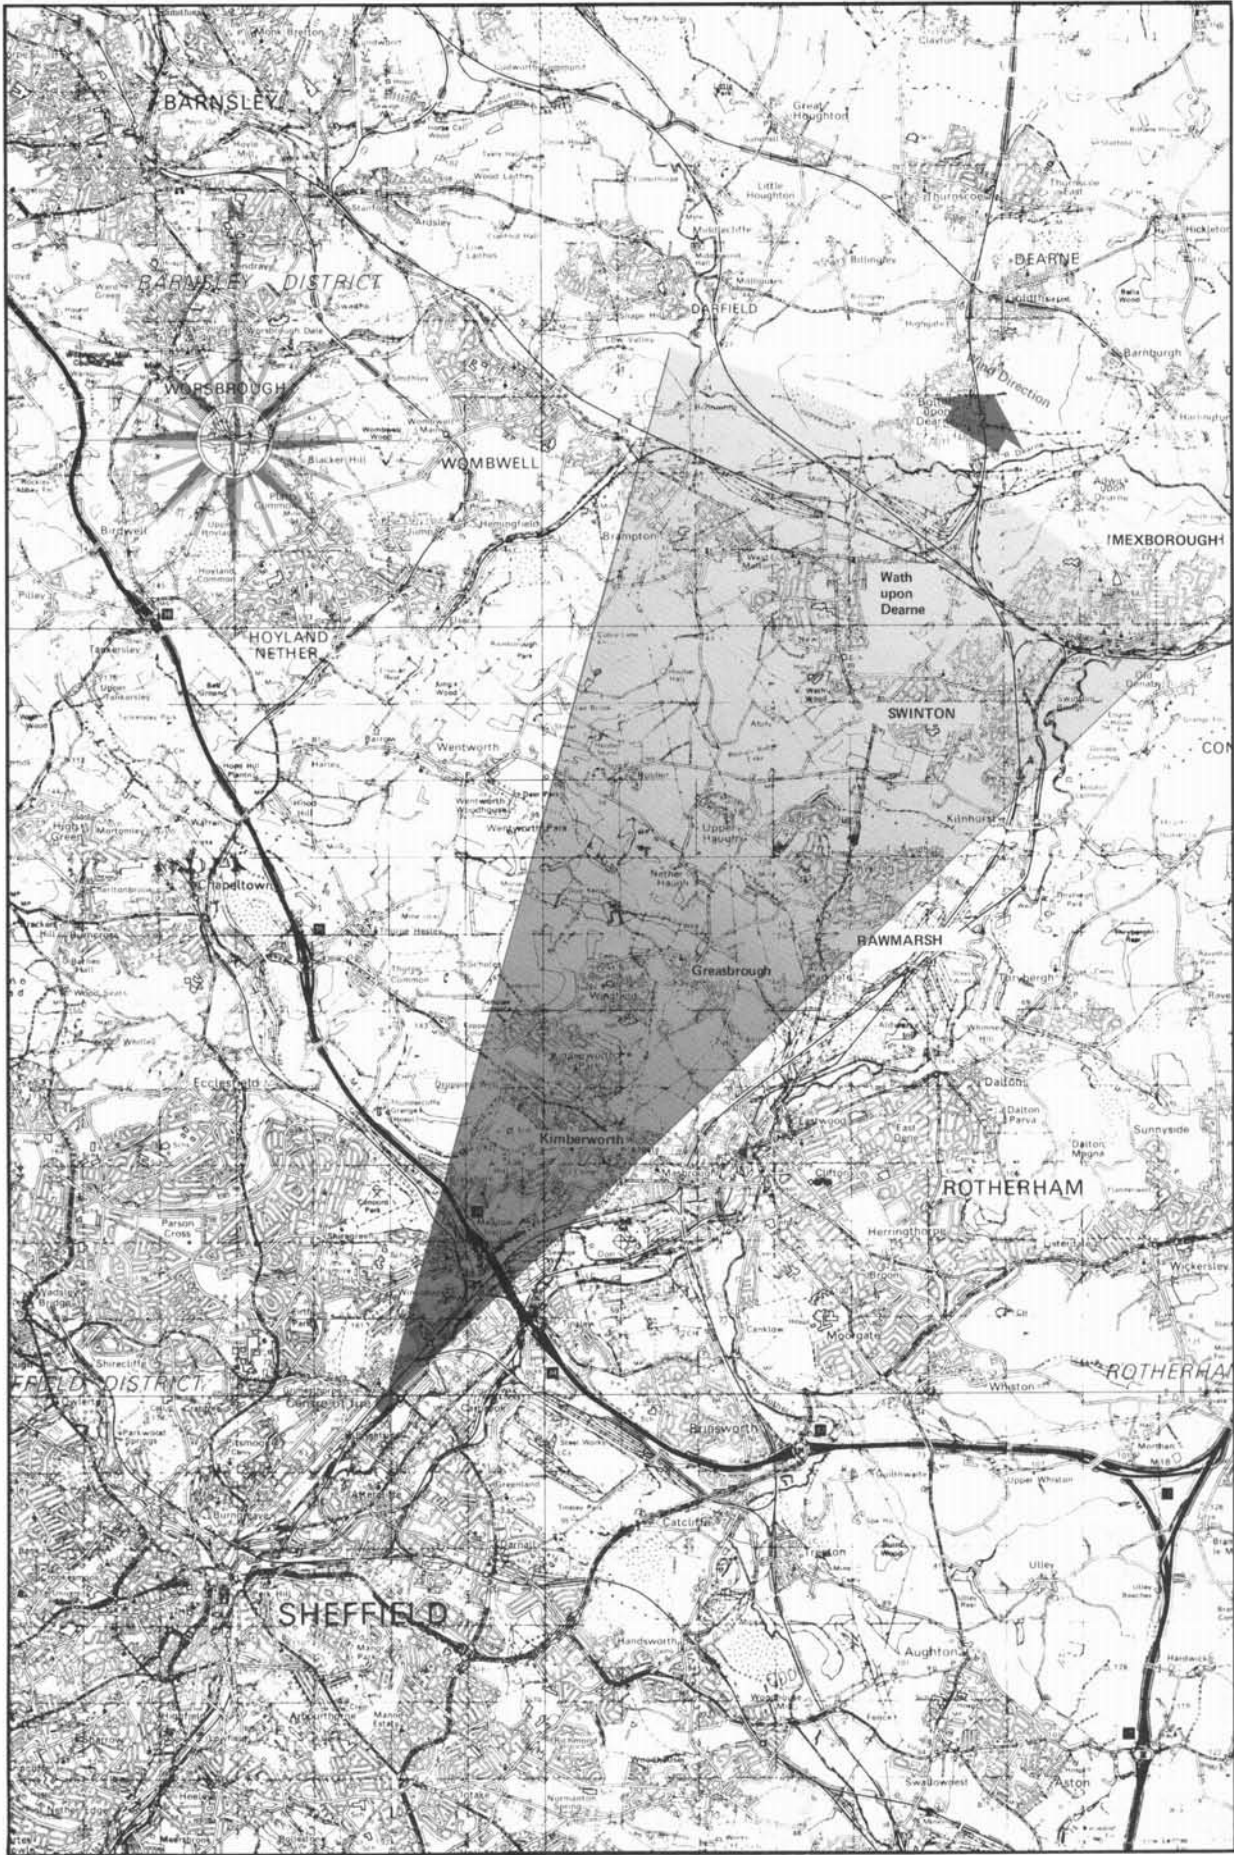
Fig 9 Area affected by fallout material

188 The Rotherham EHOs contacted two local radio stations to inform the public of the problem and to invite telephoned information from 0900 on the Saturday. As a result it was established that fallout had occurred over a mile wide corridor the length of the Borough of Rotherham, including the Kimberworth, Greasbrough, Rawmarsh, Swinton and Wath areas (see Figure 9).
