The fires and explosion at BP Oil (Grangemouth) Refinery Ltd

A report of the investigations by the
Health and Safety Executive into the fires and
explosion at Grangemouth and Dalmeny,
Scotland, 13 March, 22 March and 11 June
1987

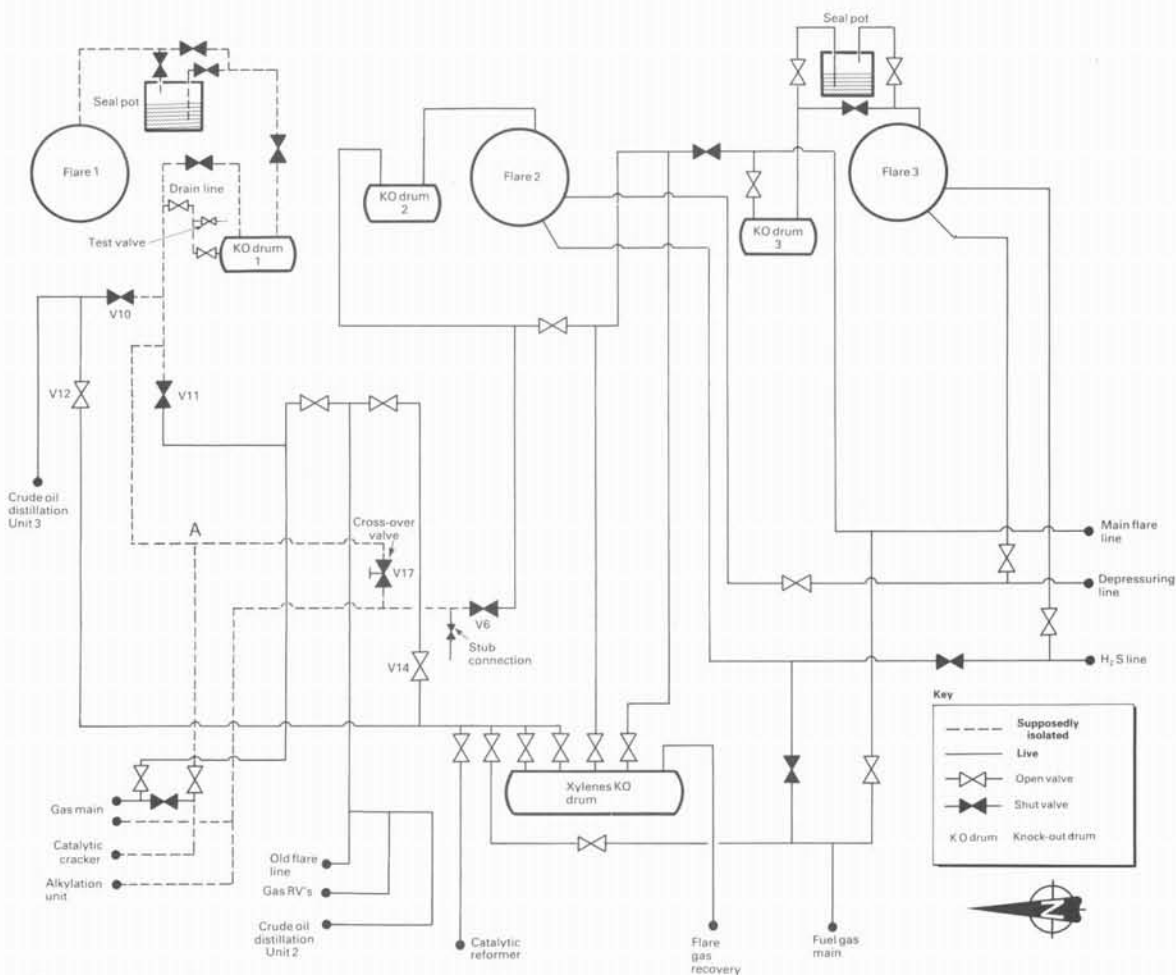
Fig 1 Refinery flare system

through the refinery is shown in Fig 1. The dotted lines represent pipework which should have been isolated to enable the cross-over valve V17 (with which this incident is concerned) to be removed safely. Vented hydrocarbon gases from production units can be flared in three 91 m high flare stacks or recovered for fuel gas. Much of the flare system pipework is suspended on gantries about 4.6 m above ground. Sections can be isolated for maintenance by operating cross-over valves allowing vented gases from operating units to be re-routed. As gases pass through the extensive pipework system entrained liquids condense out on the unlagged cold surfaces.

11 Pipelines slope down to knock-out drums which collect the condensate for transfer to the refinery slops system for reclamation. At certain locations pipelines slope down in both directions, one such being at point A on Fig 1 which is 25 m to the north of V17. The 760 mm diameter lines slope down towards No 1 knock-out drum and down towards No 2 knock-out drum, via V17 and V6. The directions of slope are not marked and at gradients of 1 in 400 are not obvious. At V17 the direction of liquid flow could only be established by knowledge of the flare system or by survey.

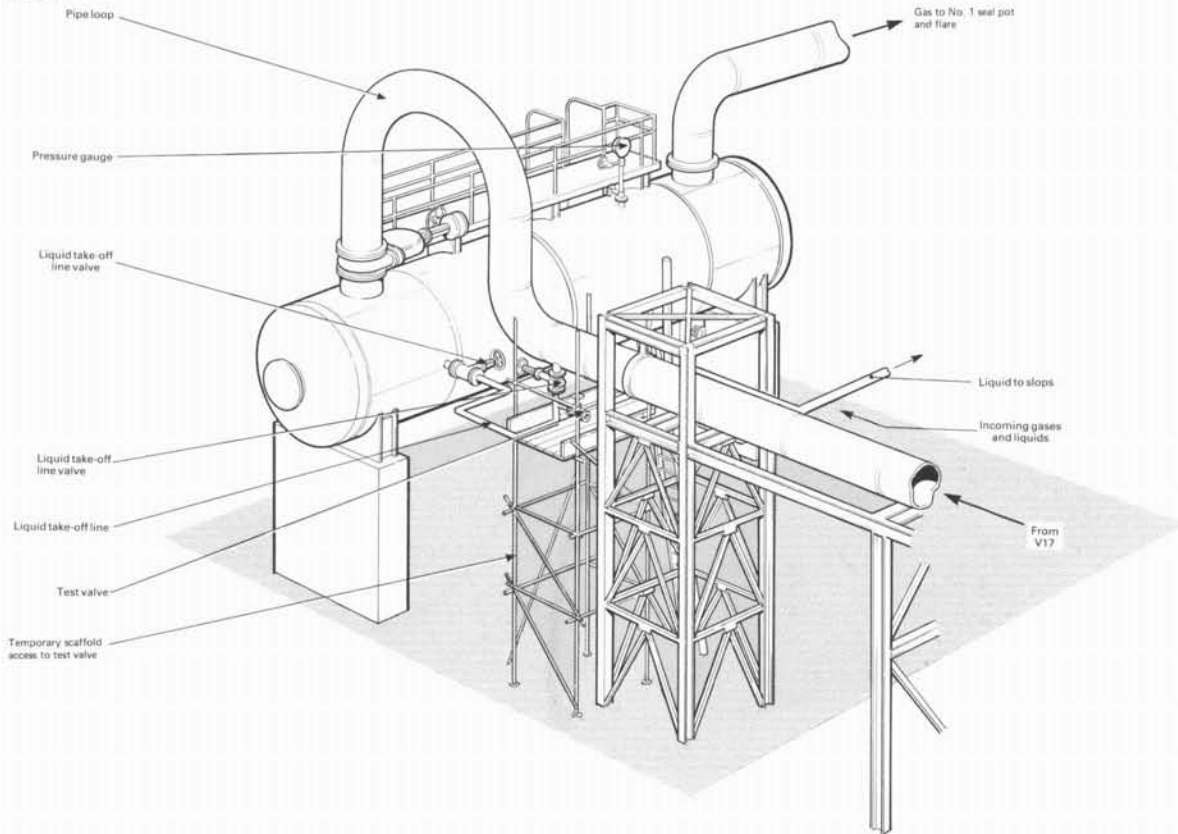
Fig 2a Flare knock-out drum

12 Fig 2a shows a knock-out drum. As incoming gases and entrained liquids pass over the vertical loop into the upper part of the drum, the consequent loss of velocity causes liquids to separate out. Liquids already in the line by-pass the loop by means of a liquid take off. Gas is taken from the top of the drum to flare possibly via further knock-out drums, and the liquid which collects is pumped to the slops system.

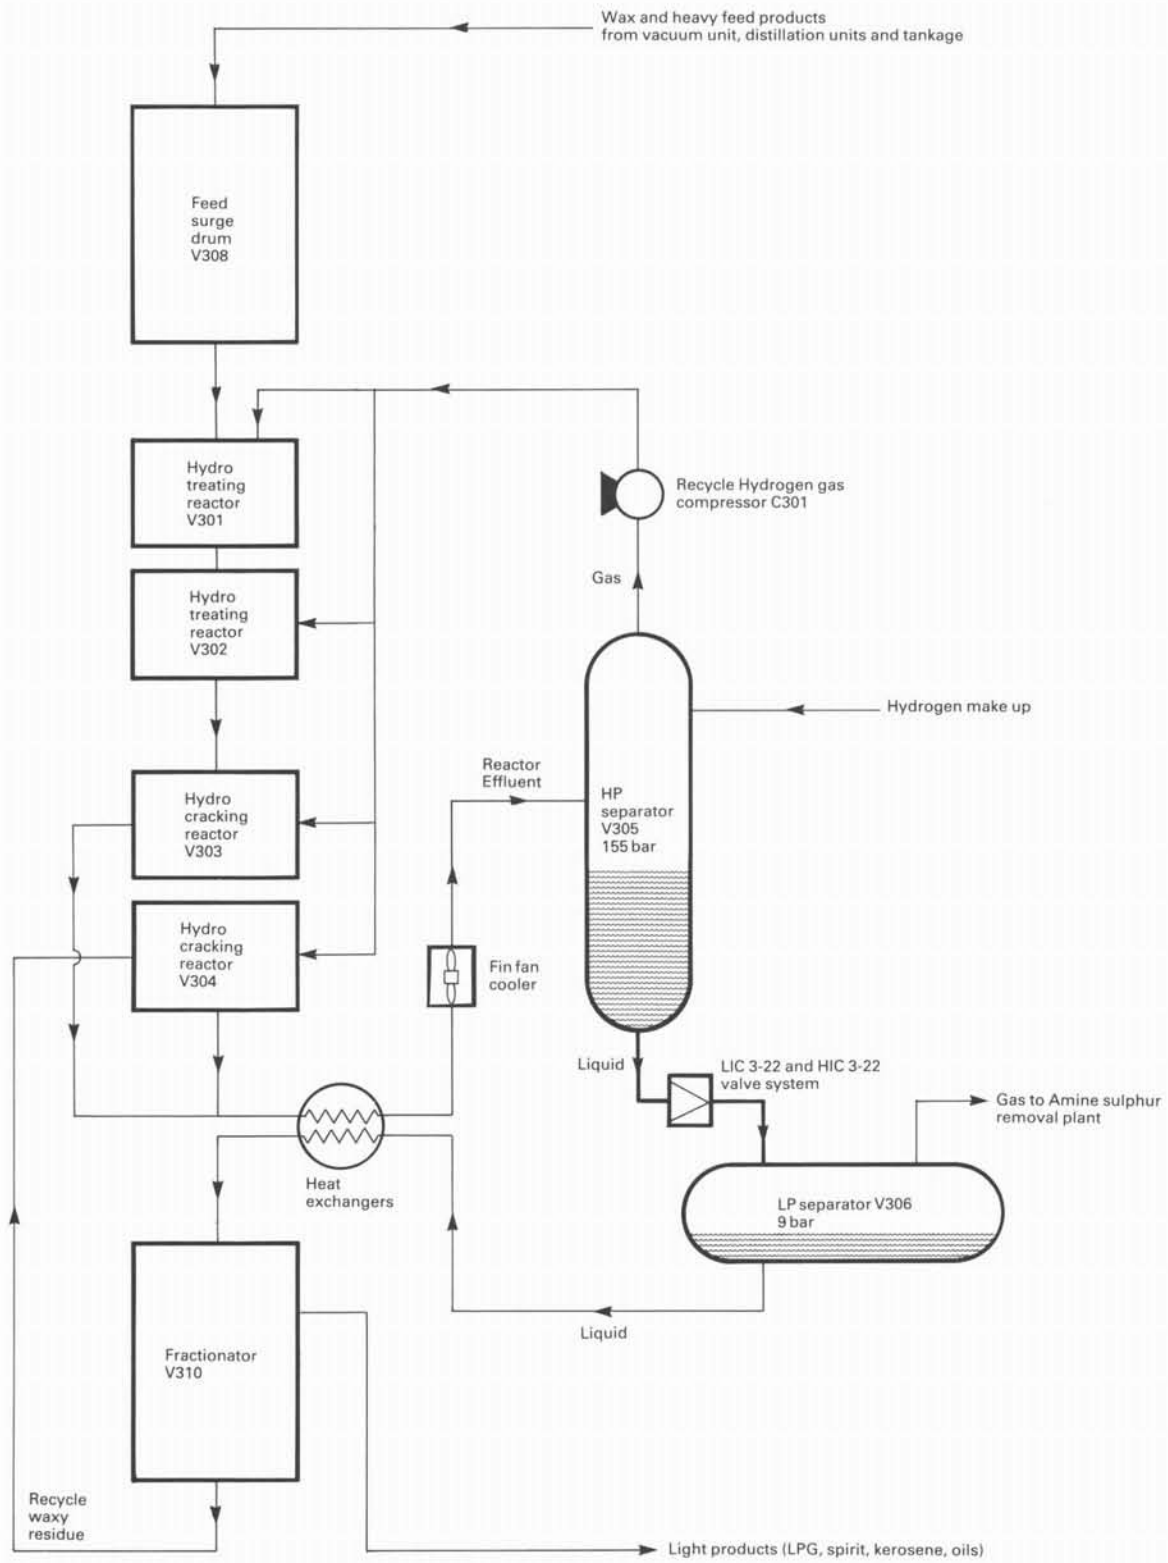
Fig 7 Hydrocracker process flow system

39 From the reactors the hydrogenated liquid/gas mixture passed forward through a series of heat exchangers and a fin fan cooler into a vertical high pressure

separator (V305) at a temperature of about 50°C. In V305 the hydrogen and light gases were separated from the liquid and passed to the inlet of centrifugal compressor C301 to be recycled to the reactors. This compressor vibrated at high differential pressures and although it gave reliable service, it was crucial to the operation of the plant. Thus vibration was closely monitored to prevent breakdown. From V305 the liquor at 155 bar and 50°C was then passed via control valves to a horizontal low pressure separator (V306) where more hydrogen and light hydrocarbon gases separated from the liquor as the pressure dropped to about 9 bar (135psig).

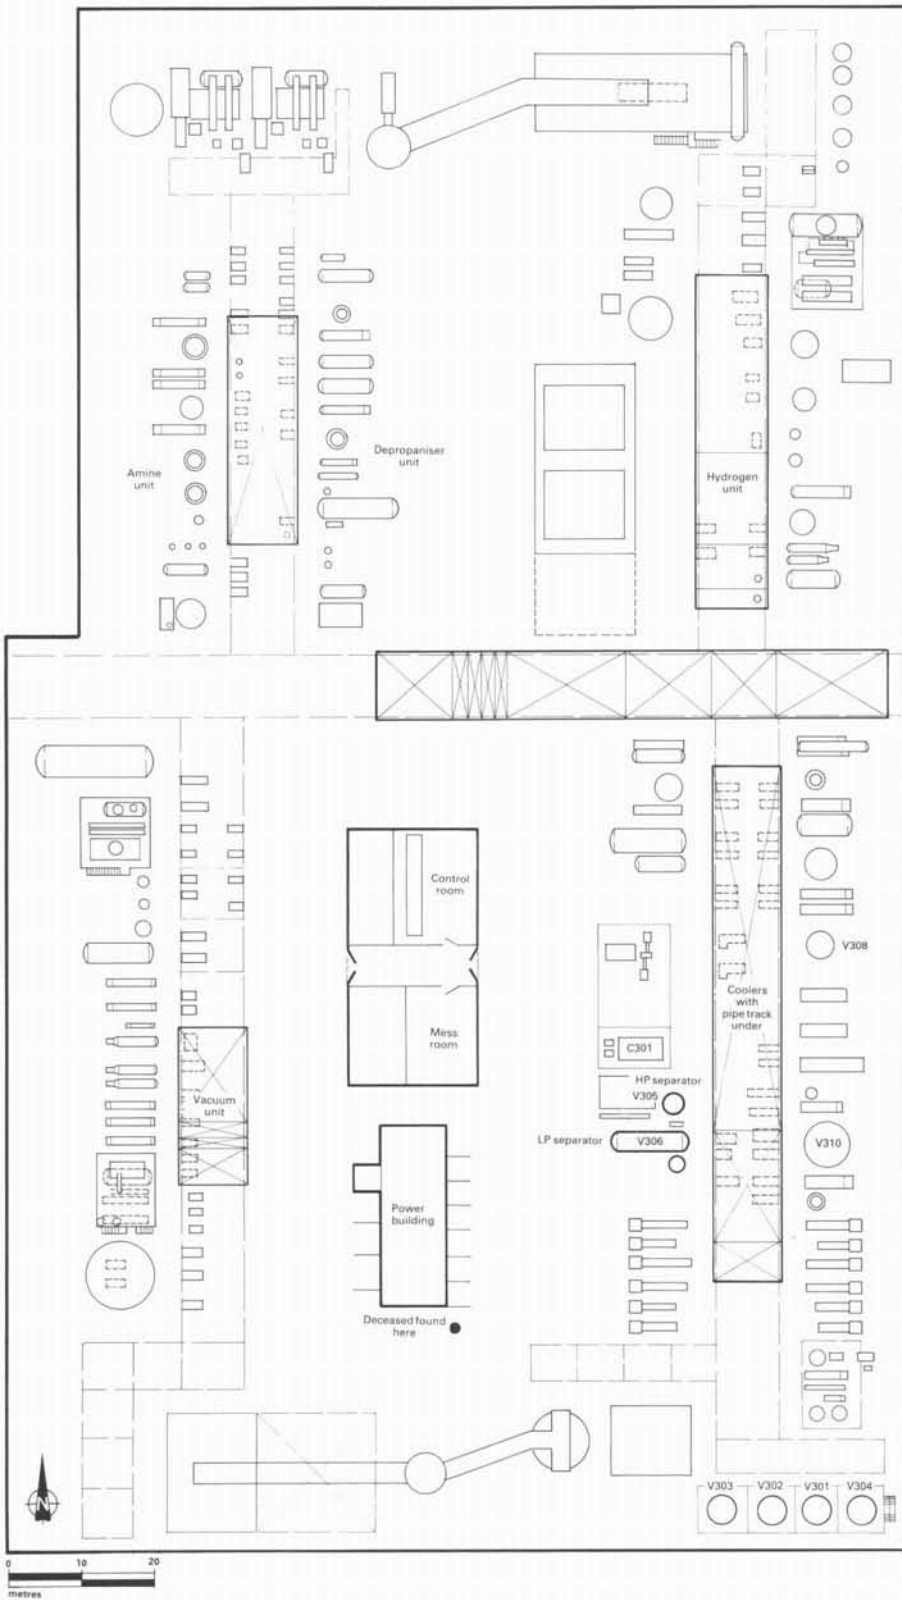
Fig 8 Plan of hydrocracker complex

explosion was heard and felt 30 km away and it caused considerable local concern. A contractor who had just left the mess-room was killed. The explosion centred on V306 which was constructed from 18 mm steel plate and weighed 20 tonnes. Photograph 4 shows the hydrocracker area with two T-shaped plinths on which V306 stood to the left of centre. The vertical HP separator (V305) is on the far left. V306 had disintegrated and large fragments were projected considerable distances. A piece weighing nearly 3 tonnes was found on the foreshore 1 km away. Another was projected over a main road into a factory where it severed a steam line. A third went through the roof of a workshop on an adjacent site. During the investigation almost all of V306 was recovered and the positions where the main fragments landed are shown in Fig 9.

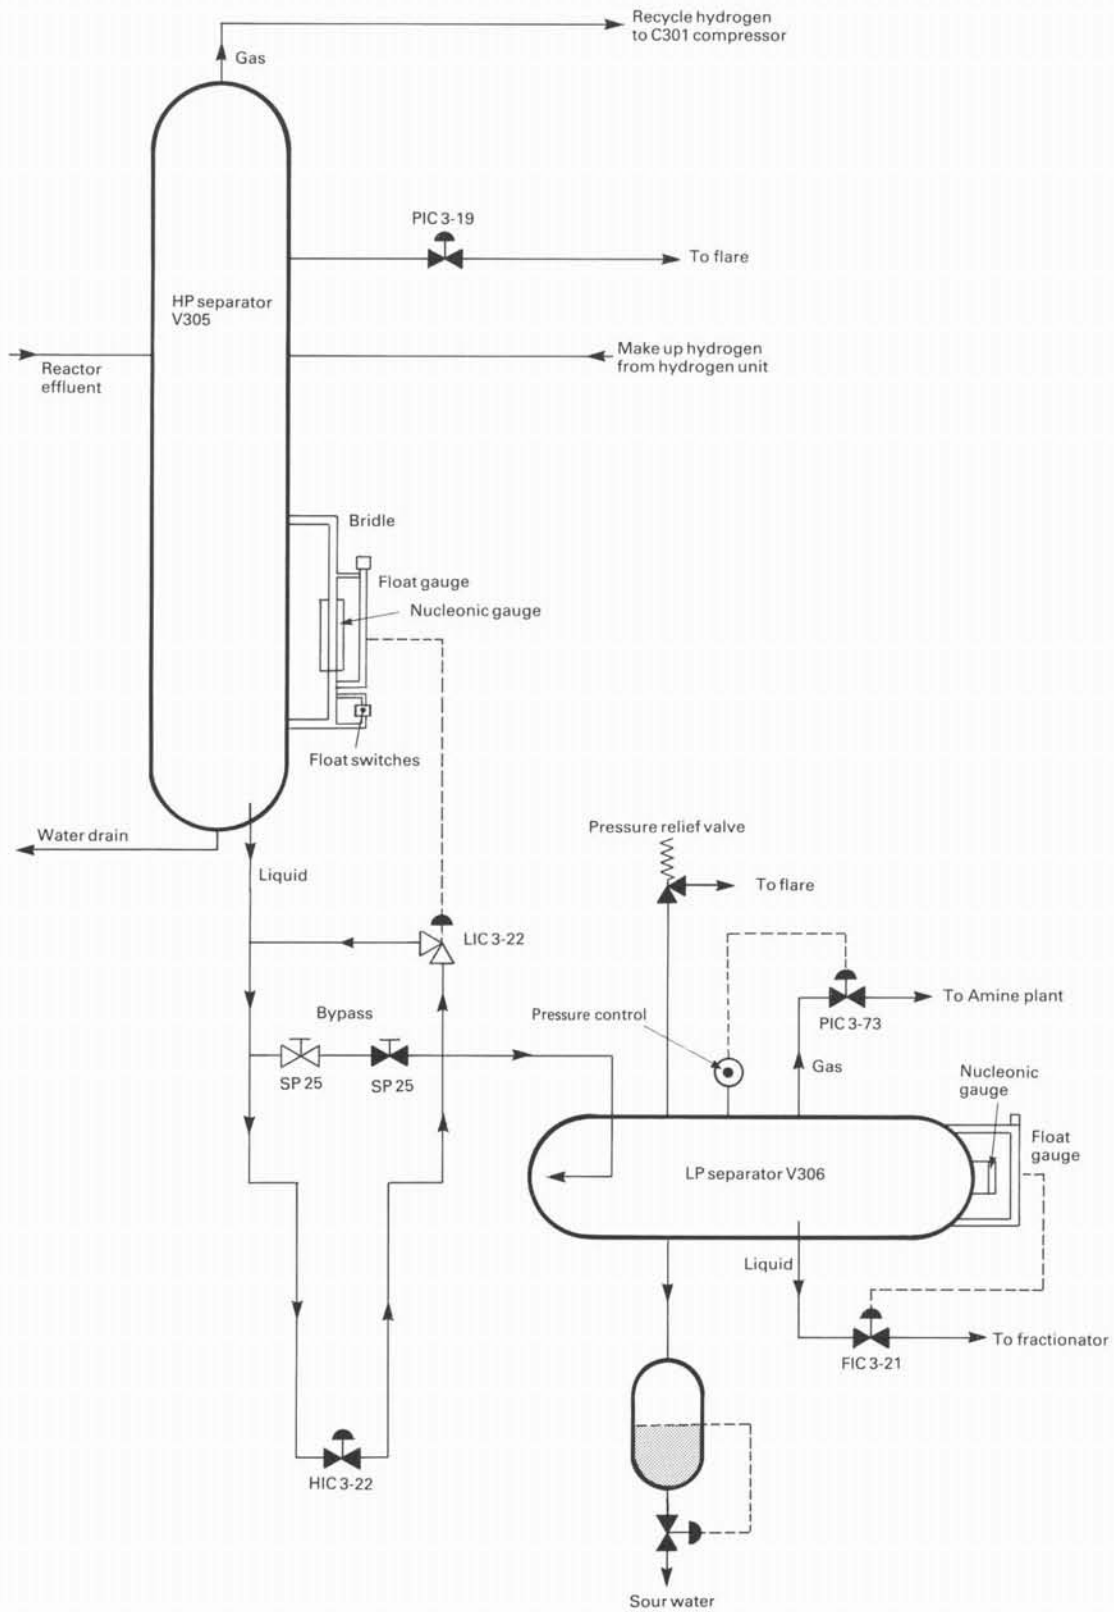
Fig 10 HP/LP separator control system

57 However the other evidence strongly suggested that there had been a breakthrough of high pressure gas from V305 to V306 leading to overpressurisation of the vessel. The liquid in V305 had drained away through an output flow control valve when the hydrocracker was being held on standby operation with no product passing, thereby allowing high pressure gas to break through. Fig 10 shows a single 300 mm diameter outlet pipe from the bottom of V305 which split into two parallel streams each with a separate flow control valve. The valve nearest V305 was the right-angled, air-diaphragm-operated valve LIC 3-22 which could be operated from the control room either in automatic or manual mode. Some distance from V305 was the air-diaphragm-operated, straight-through flow control valve HIC 3-22, which could only be operated via a manually applied control signal from the control room.

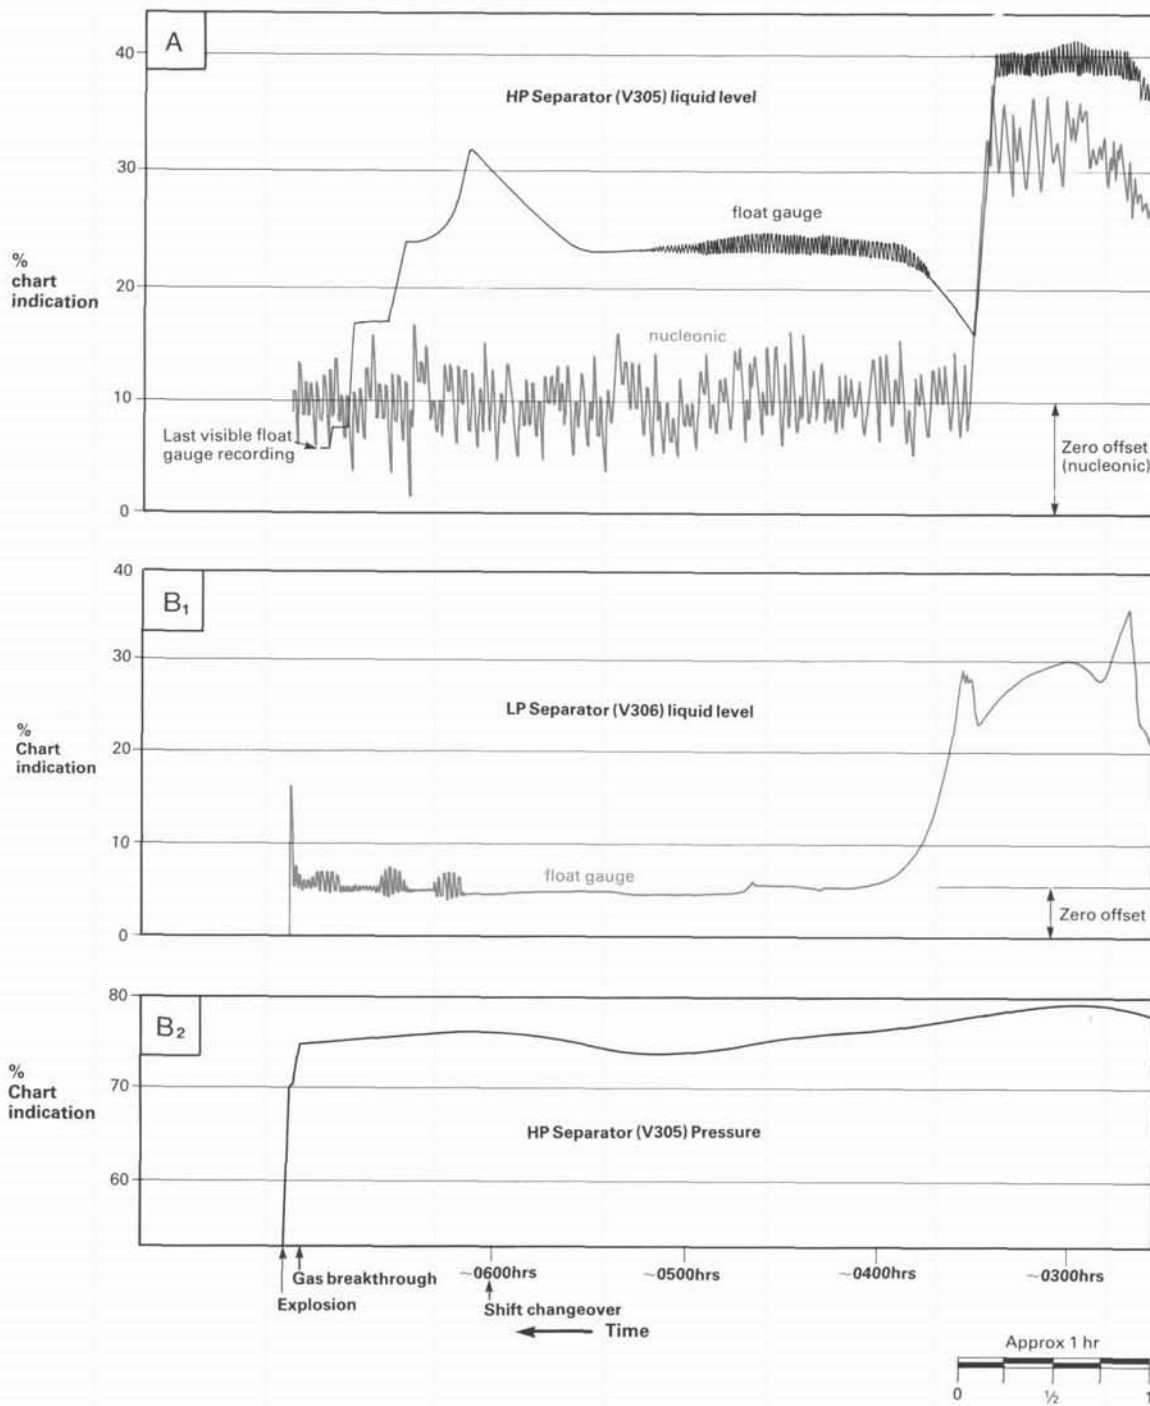
Fig 12 Diagrammatic representation of charts (traces enhanced and time corrected for clarity)

73 Trend chart recorders provided a permanent record of aspects of the hydrocracker operation. However they were not synchronised and the information they provided needed to be interpreted with care and by reference to other evidence. Several of their pens were not working. The float gauge chart did register the falling liquid level in V305 in the 45 minutes prior to the explosion, as shown in Fig 12(A), but does not show the minutes before the incident when the liquid level fell, V305 emptied, and gas breakthrough occurred. Four minutes before the explosion the chart (Fig 12B2) shows a rapid fall in V305 pressure. This along with eye witness reports, which suggested that the pressure relief valve on V306 was lifting immediately before the explosion, confirmed that gas breakthrough had occurred. The rate of pressure drop could not be explained by other mechanisms such as emergency depressurisation.

float gauge trace, assuming instead that the nucleonic chart reading which appeared steady at 10% reflected the actual level in V305. Unknown to him the pen had been offset so that a zero reading was shown on the chart as 10%. He was thus unaware of the actual level in V305 and of the imminent danger.

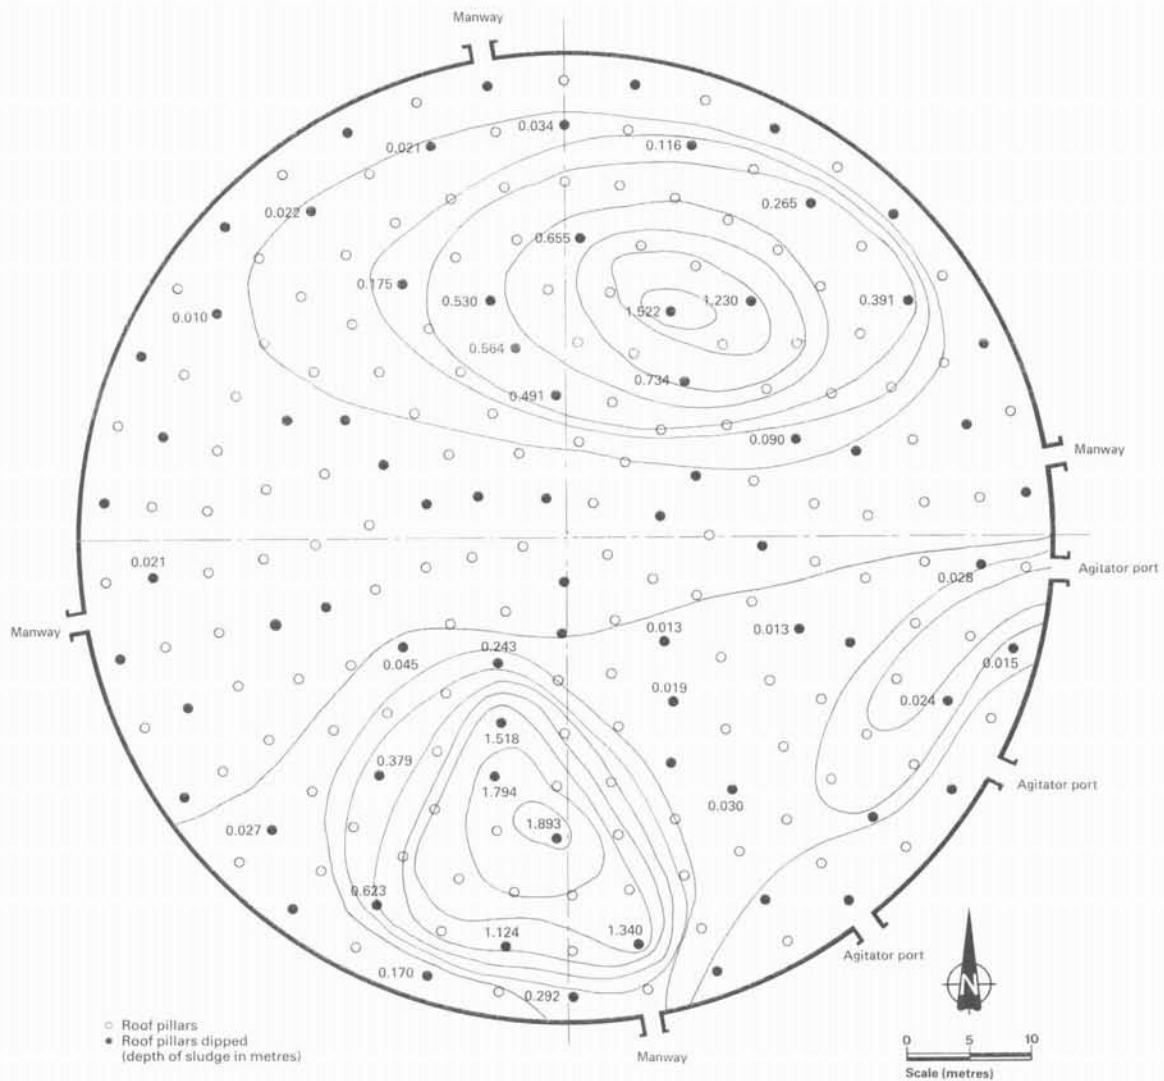
Fig 14 T807 sludge survey

92 BP had identified that T807 required a routine inspection and overhaul. At a meeting on 10 November, 1986, they scheduled its removal from service for June, 1987 aiming for completion by the end of October. Thick sludge collects on the bottom of the tanks and a survey was carried out in April 1987 by external dipping through the support column ports on the roof, which established that approximately 1000 tonnes of sludge was present, situated in two banks, shown in Fig 14. T807 was withdrawn from service on 19 May and by 22 May had been emptied of crude leaving only residual sludge. The floating roof of T807 was resting on 219 support pillars, at a height of 2.1 m. It was then isolated by spading the inlet and outlet pipes. At regular intervals around the circumference of T807 near ground level there were four manways (600 mm diameter) and three ports (740 mm diameter) for motor operated agitators. The agitators, the
