## *The Peterborough Explosion*

A report of the investigation by  
the Health and Safety Executive into  
the explosion of a vehicle carrying explosives  
at Fengate Industrial Estate, Peterborough  
on 22 March 1989

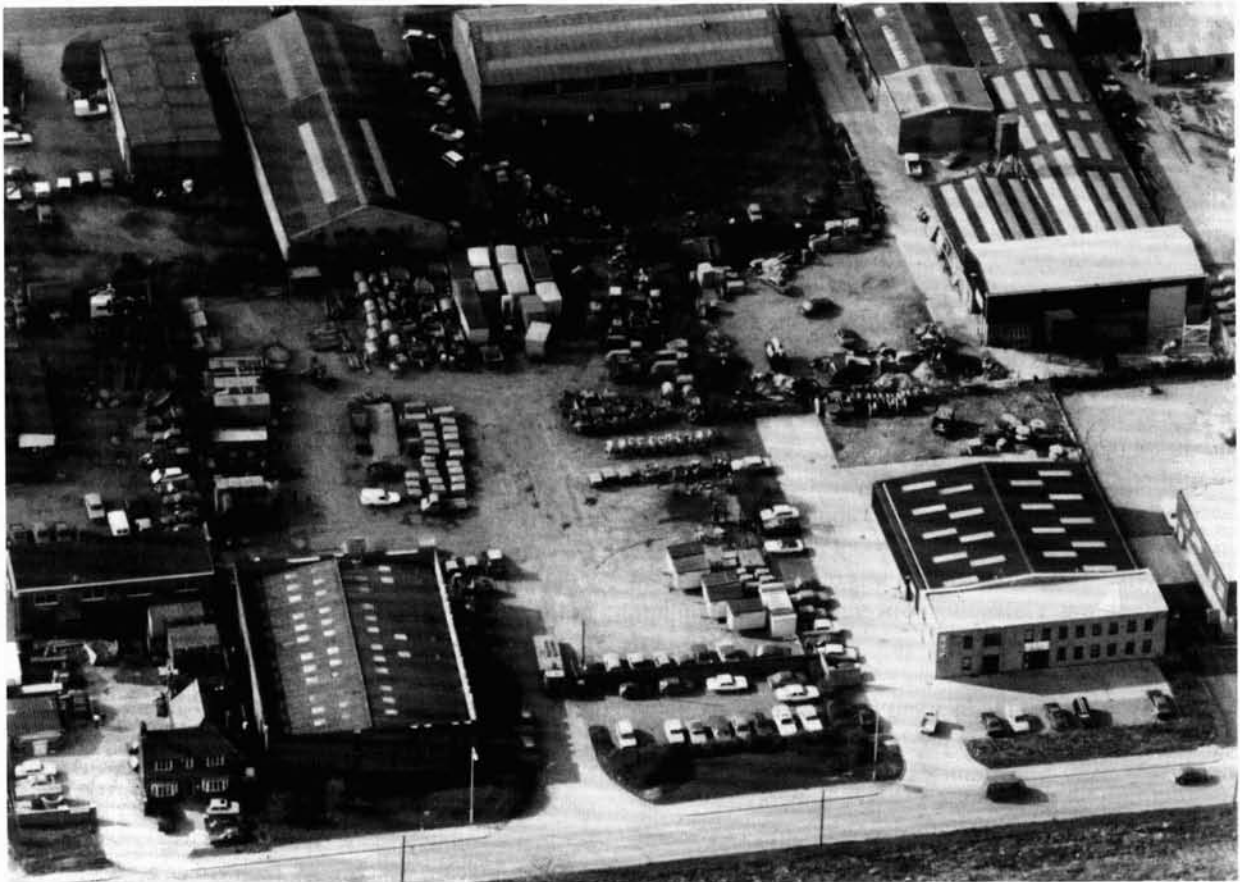
**Figure 2** Aerial photograph of area before explosion (*Photograph reproduced by kind permission of Skyviews and General Ltd*)

10 The aerial photographs in Figures 2 and 3 show the Vibroplant yard some time before, and after, the incident. The entrance to the yard is set back and separated from the road by a pavement and grass verge some 24 m wide: the yard is about 90 x 60 m, bounded on the south side by a 2 m high, 22.5 cm brick wall, and on the other sides by a chain link fence. There is a car park along the boundary wall. A wide range of contractors' plant, including portacabins, was parked around the yard perimeter, with room in the middle for manoeuvre. The yard's surface was of asphalt over hard core. There was a 'sleeping policeman' speed ramp just inside the main gate.

1 Figures 2 and 3 show aerial photographs of the Vibroplant yard some time before the explosion, and the general area after the explosion. The epicentre of the explosion is marked by a depression (46 cm deep and 3.5 m radius) in the tarmac surface of the yard. The floor of the explosives vehicle was about 1 metre off the ground.

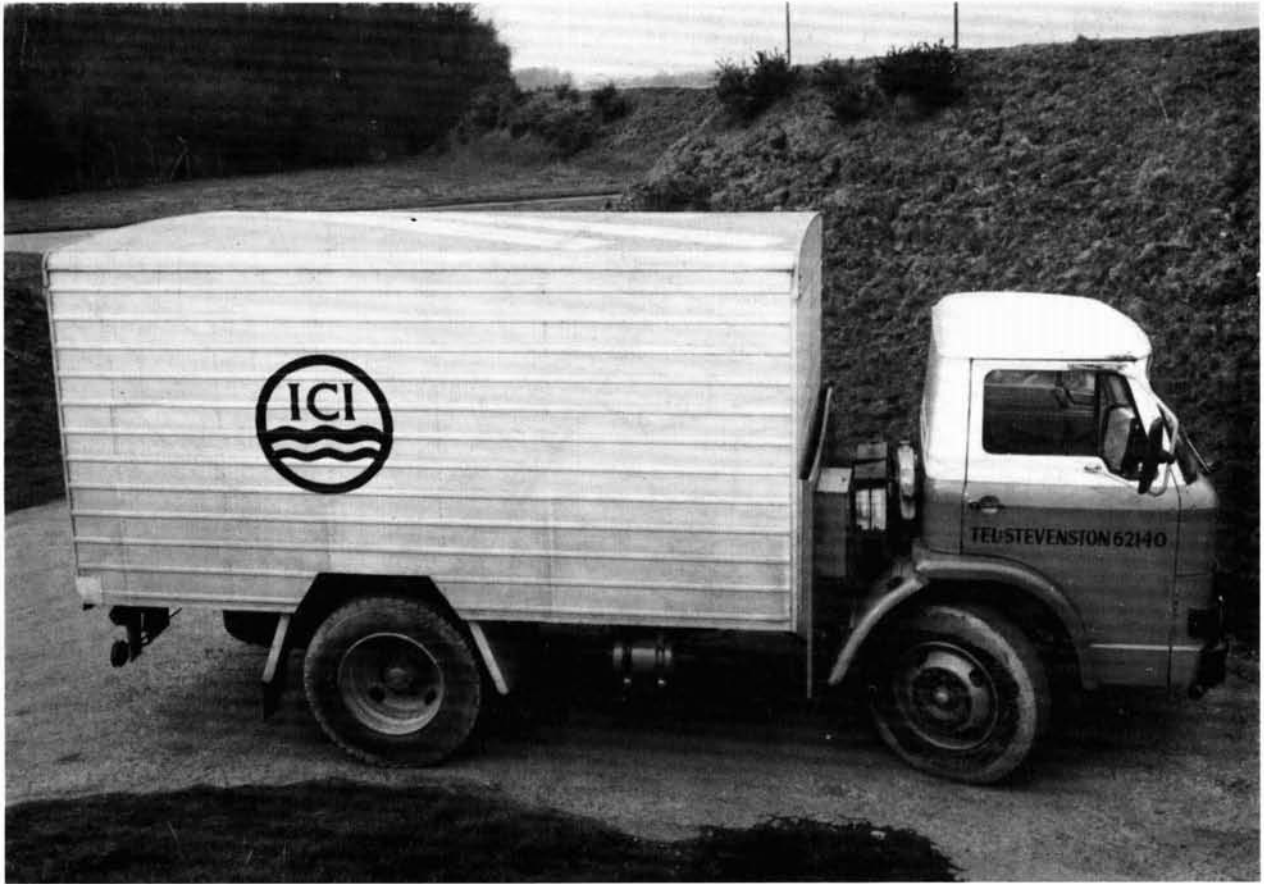
Figure 4 Vehicle of the type involved in the explosion

12 The vehicle was a Ford D series 11.5 tonne box van, registration number MSO 233W, owned and operated by Nobels Explosives Company Ltd, a subsidiary of ICI. A photograph of the type is shown in Figure 4. It was one of a fleet of vehicles, specially modified to carry up to 5 tonnes of explosives in order to comply with legal requirements concerning the carriage of explosives, the Order of Secretary of State No 11 dated 1924, made under the Explosives Act 1875 and as amended from time to time.

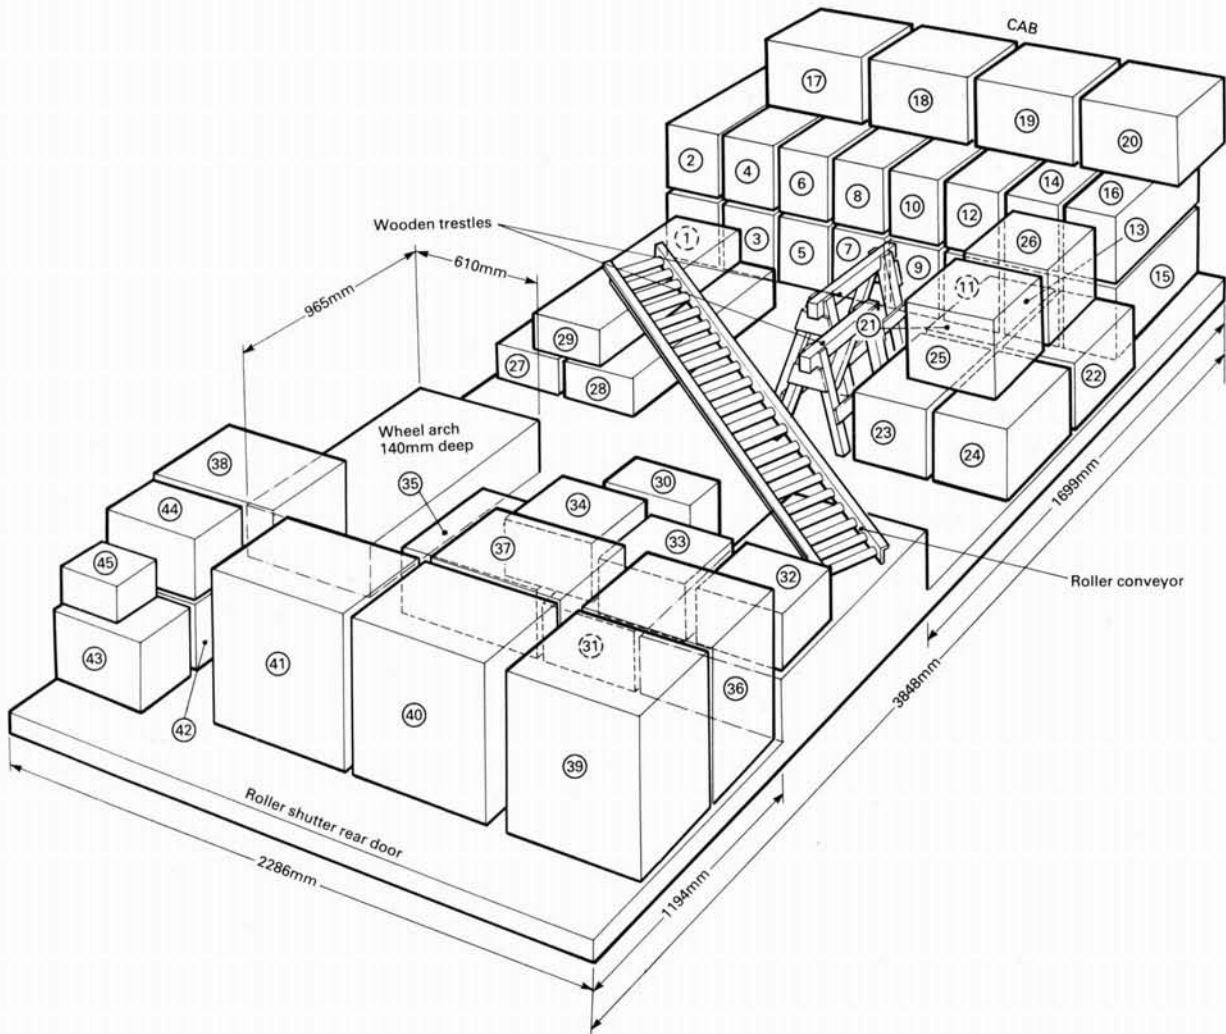
Figure 6 Layout of vehicle load

17 The vehicle was loaded by the driver and his attendant at the NEC Fisherwick Depot, Lichfield, Staffs, at approximately 06.00 on the day of the incident. The load included two consignments of blasting explosives to be delivered on route to Peterborough, the fuseheads for Le Maitre, and a further consignment of high explosives for a destination beyond Peterborough. The first two deliveries were made at 07.15 and 08.00. It would be normal practice to rearrange the load as deliveries were made, and this was done at the second stop, before the vehicle departed for Peterborough. The new arrangement of the load is shown in Figure 6.

35 Information was obtained from the driver and attendant about the loading arrangement using similar packages and a similar vehicle in practical tests at the NEC depot at Fisherwick. It was established that the vehicle was loaded as shown in Figure 6, with blasting (high) explosives at the front of the compartment, primers in the middle, and detonators and fuseheads at the rear close to the shutter door. The fuseheads were at the nearside of the compartment.

55 Although the OSS11 provisions allowed the use of the vehicle involved in the explosion to carry the types and quantities of explosives which were on board, there were aspects of non-compliance. Bye-law 2(c) in particular required detonators to be stowed as far away from other explosives as reasonably practicable, and that was not the case, as might be seen from Figure 6. According to evidence from the driver, the arrangement complied with the Bye-law at the beginning of the journey, but the load was rearranged after the second stop.

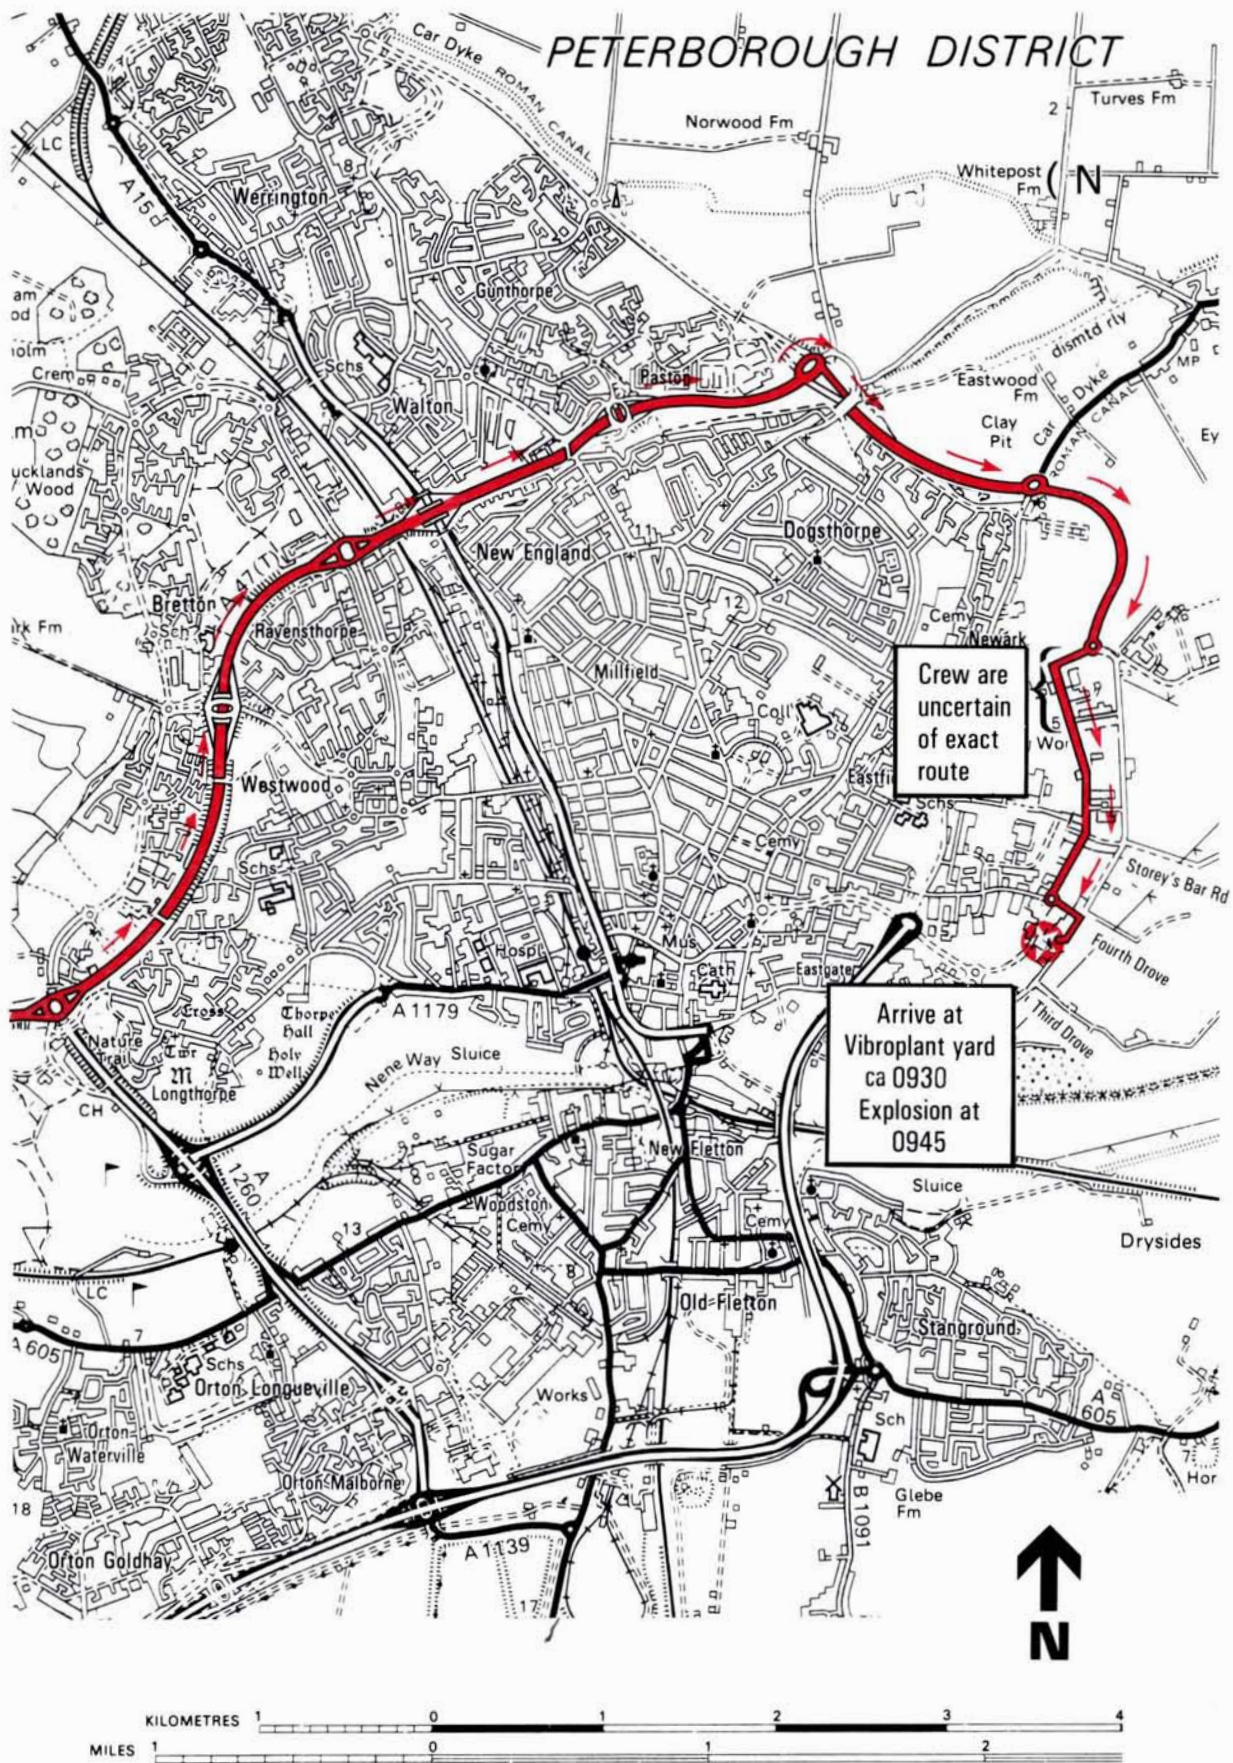
Figure 7 Plan of the route around the ring road

B4114, then along the A47 to the outskirts of Peterborough. The vehicle entered the Fengate Industrial Estate along the outer ring road (Figure 7). It was heading for the Le Maitre Fireworks Factory, Fourth Drive, on the Fengate Industrial Estate but missed the left hand turning. The driver decided to continue along Fengate and turned right into Vibroplant's yard to turn around. The precise time of entry into the yard is not known but was probably shortly after 09.30 am.
