The fire at **HICKSON & WELCH LTD**

A report of the investigation by the
Health and Safety Executive into the fatal
fire at Hickson & Welch Ltd, Castleford
on 21 September 1992

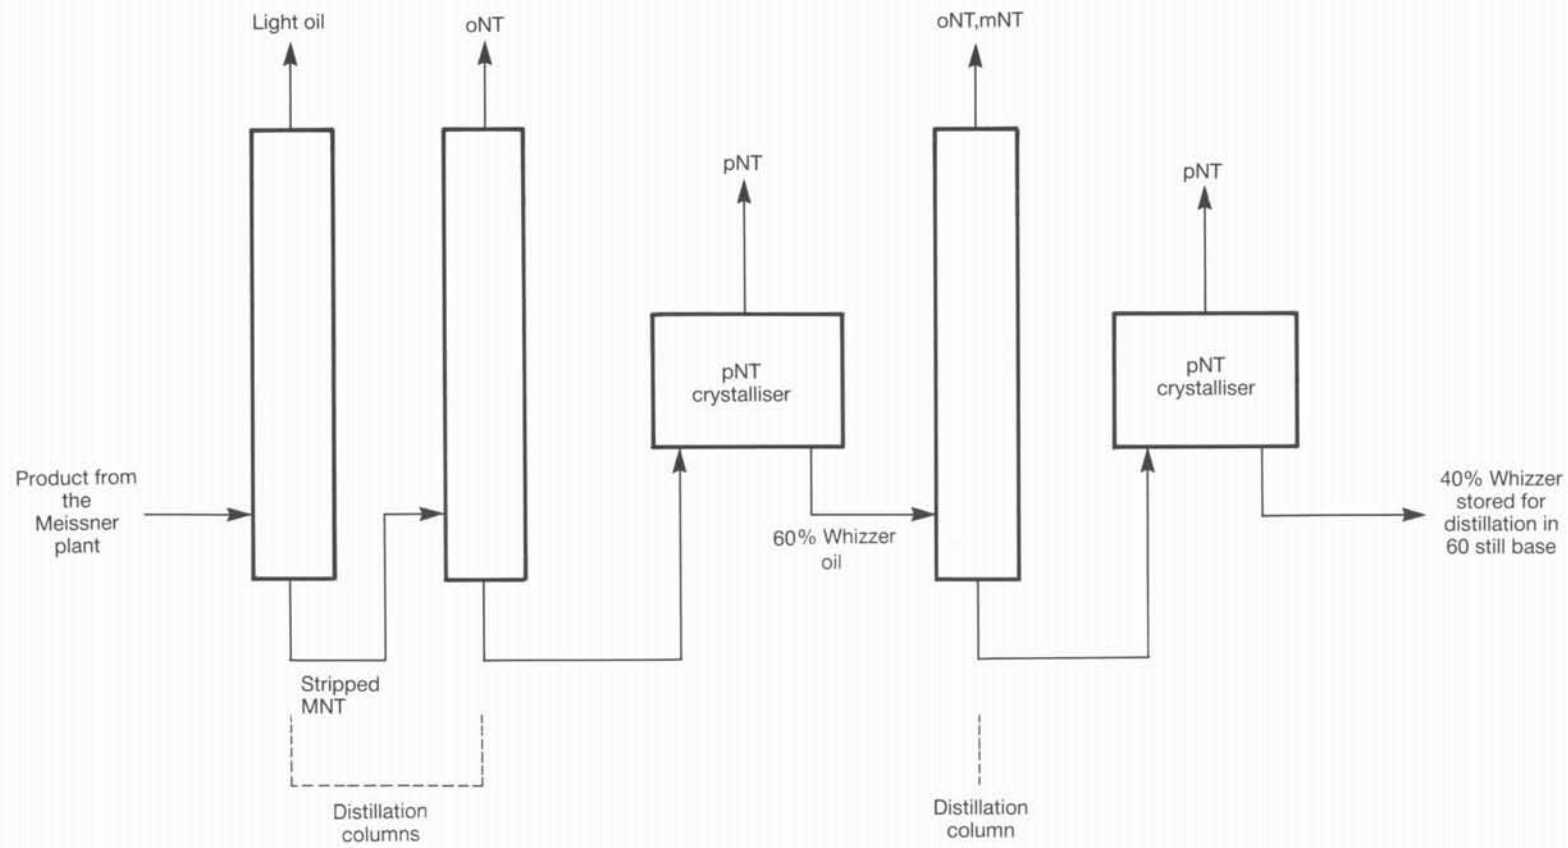
Figure 2 Simplified flow diagram of the MNT separation

- 15 At the time of the incident MNT isomers (oNT, mNT and pNT) were separated from each other and from DNT and nitrocresols via a complex sequence of distillations and crystallisations which have been summarised in a simplified flow diagram (Figure 2).

- 16 The first distillations in two fractionating columns removed oNT, unreacted toluene and water. The bottom liquors from the second column were rich in pNT and they were passed through box crystallisers where the pNT crystallised to leave a liquor that was called '60% whizzer oil'. This liquor was collected and distilled through the second or similar fractionating columns to remove a mixture rich in oNT and mNT. Bottom liquors leaving that were rich in pNT. They were passed through box crystallisers to remove the pNT leaving a liquor known as '40% whizzer oil'. This material was kept in a number of large vertical storage tanks (see Figure 4) ready for distillation in 60 still base.

- 17 The successive distillations and crystallisations raised the concentration of the less volatile DNT and nitrocresols from circa 0.5% and 0.7% respectively to 14% and 19%, in 40% whizzer oil. The final separation involved batch distillation of this material in 60 still base to recover more MNT.

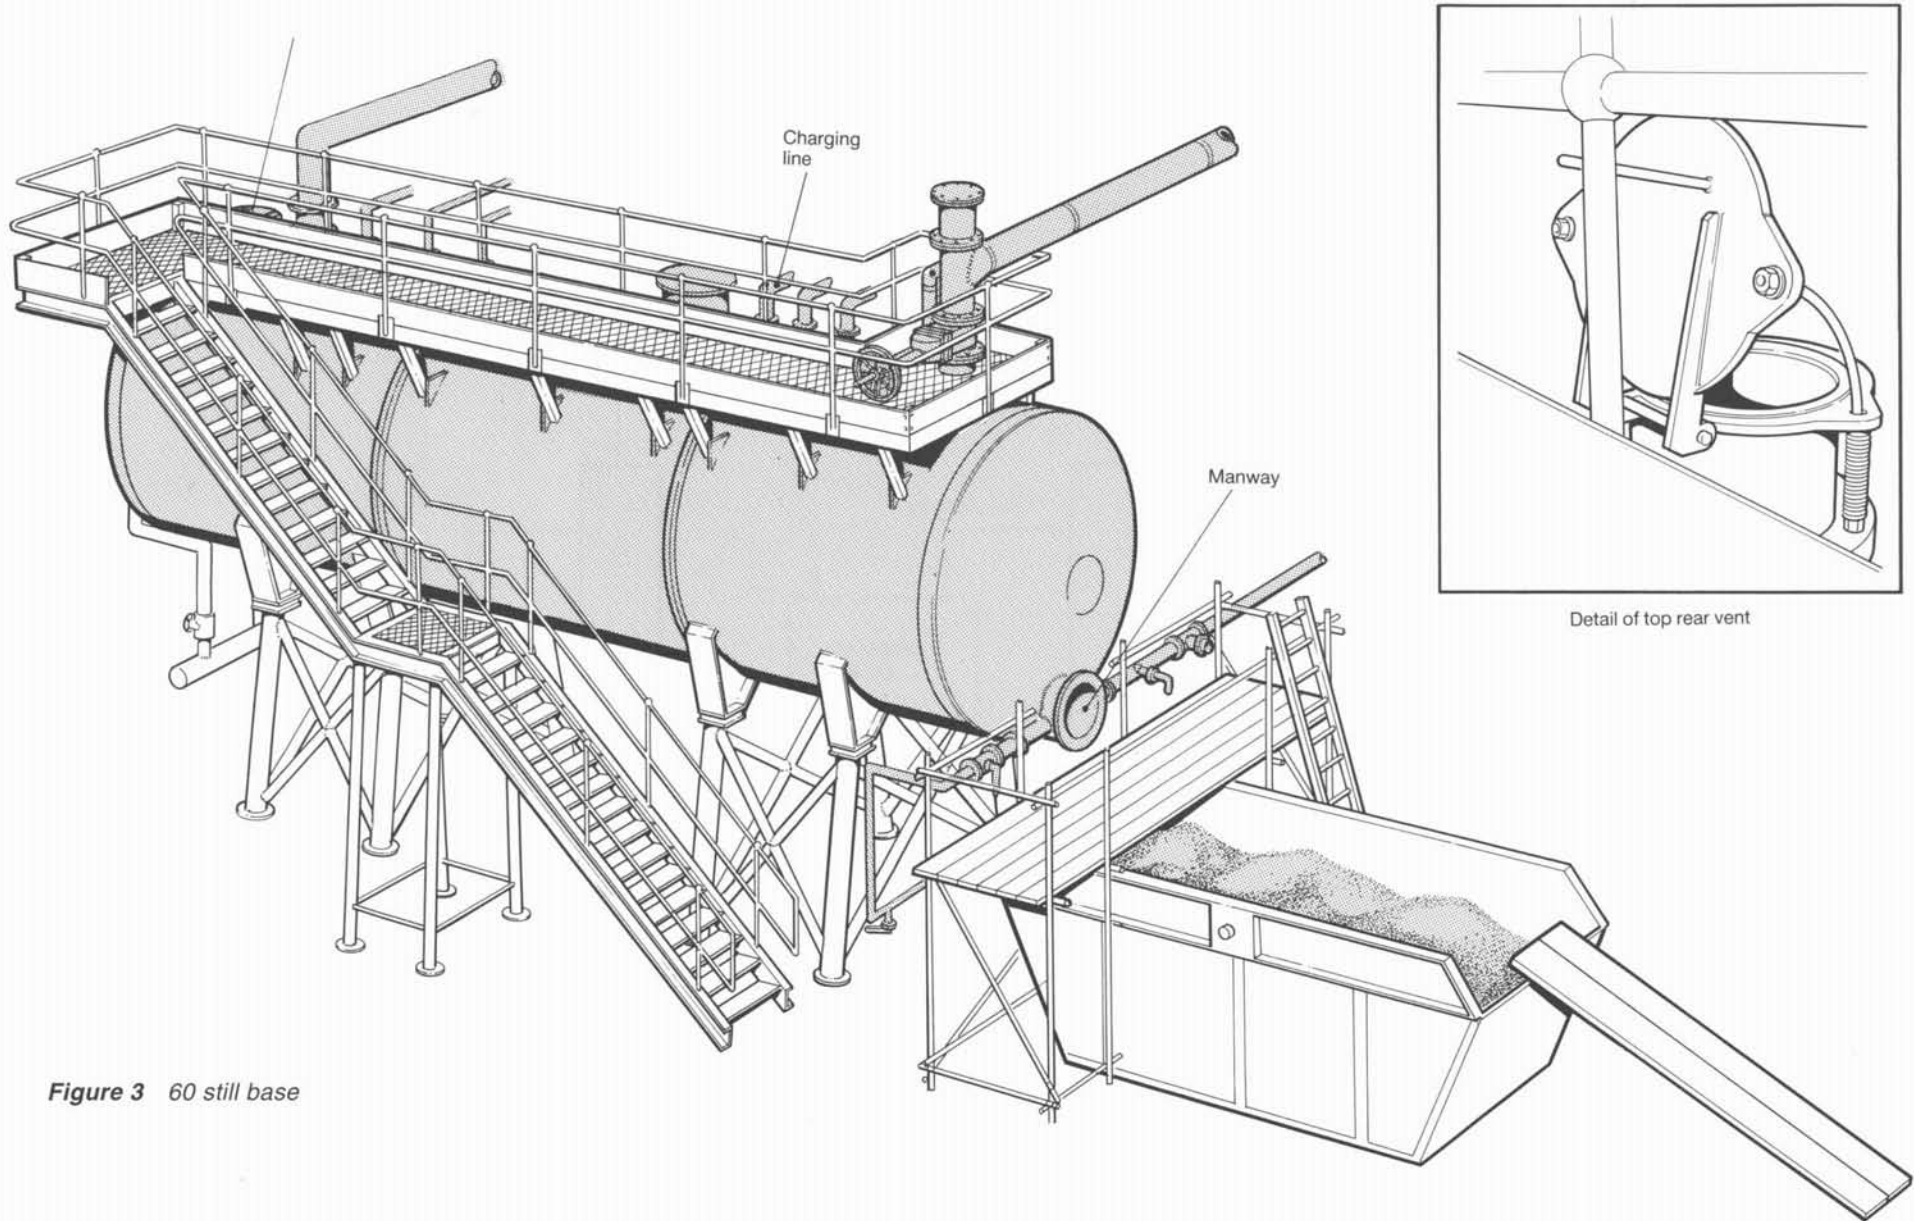
Figure 3 60 still base

- 20 60 still base was a 45 500 litre horizontal, mild steel, cylindrical tank 7.9 m long and 2.7 m in diameter. It stood on iron tube legs 2.9 m off the ground (Figures 3 and 4). The tank sloped slightly towards the front to allow discharge through an off-take line mounted at the base of the front face manway. The off-take pipe was attached to a pump which transferred run-off at the end of distillation to storage tank 193 (Figure 4).

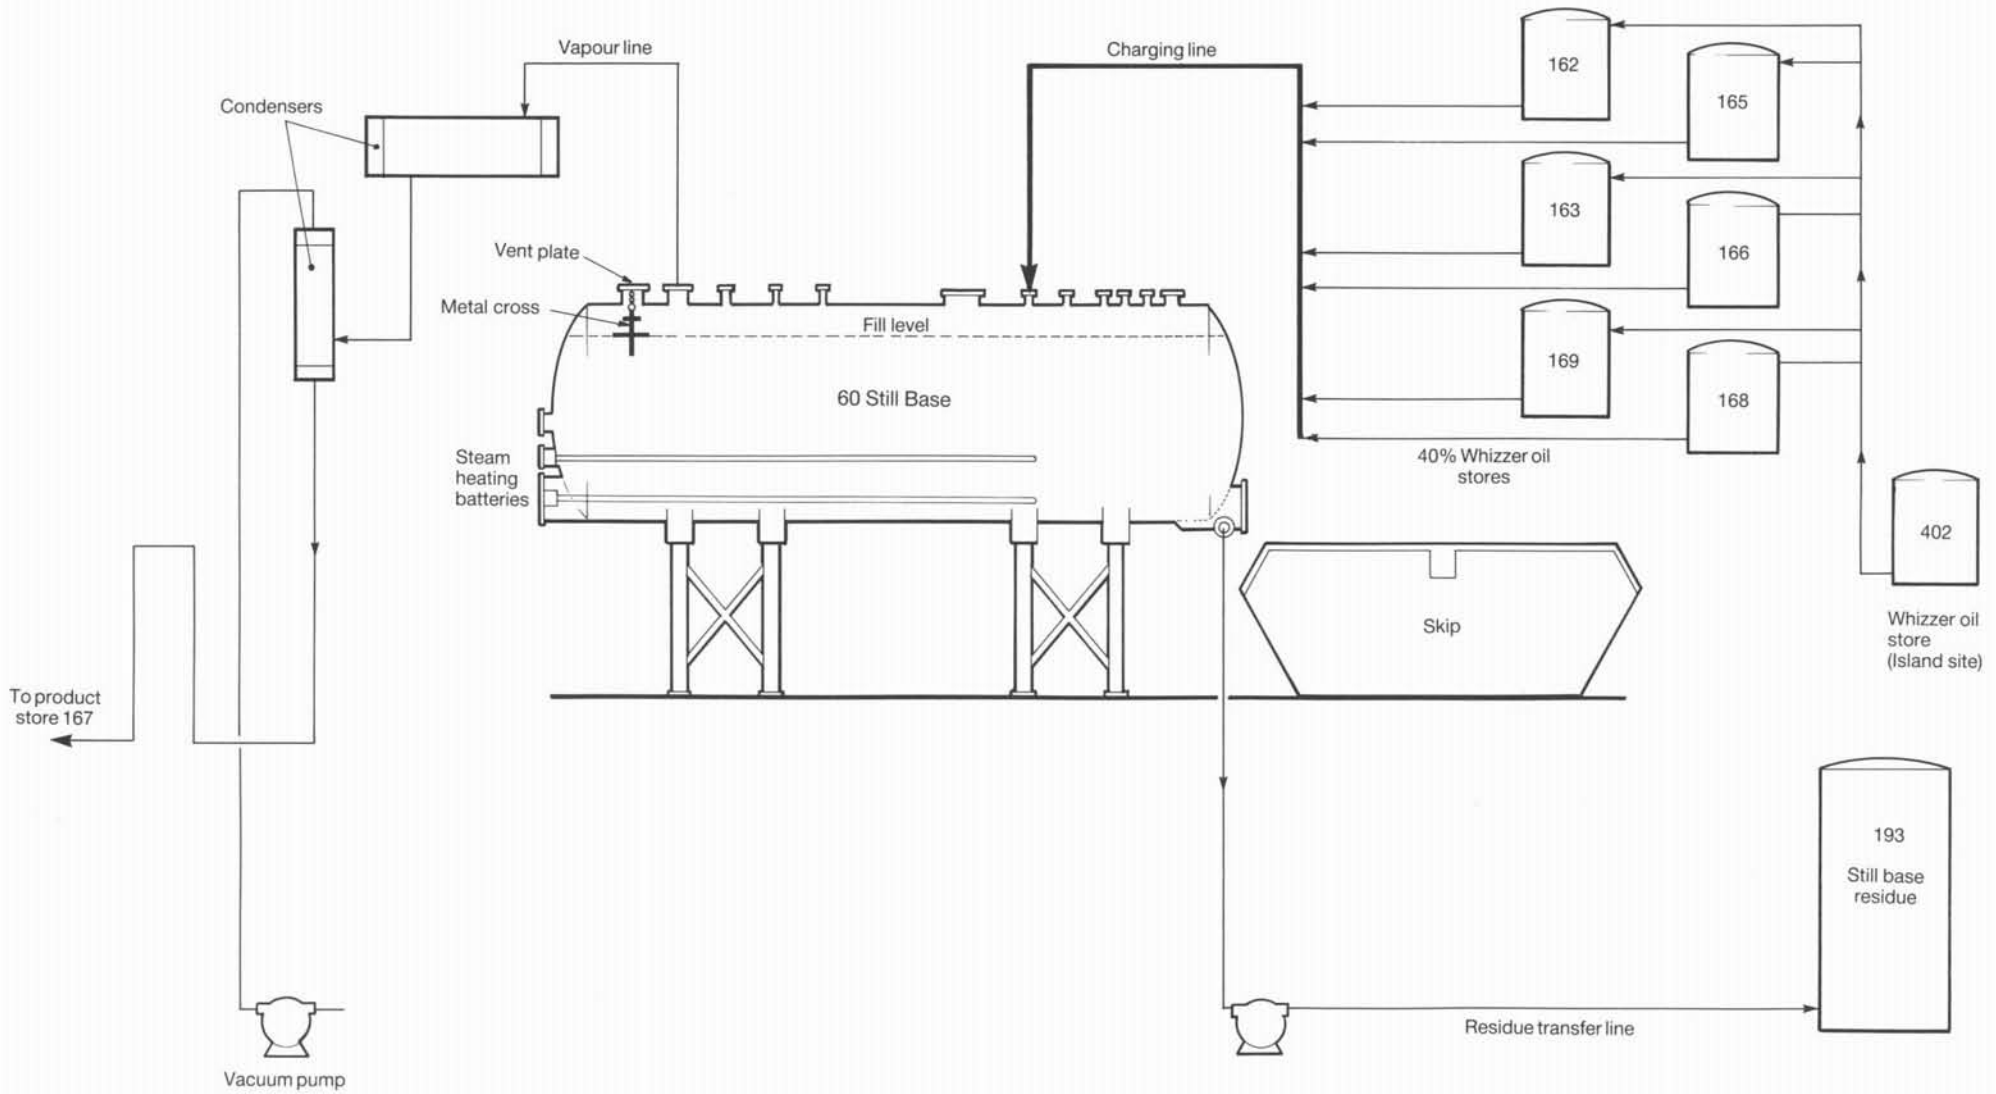
Figure 4 Schematic diagram of 60 still base and associated plant (including metal cross fill level device)

- 26 Since it was first installed in the nitrotoluenes area, in 1961, 60 still base had never been opened for cleaning. Following the process change in 1988, manufacturing problems affecting quality and production were experienced in the nitrotoluenes area. The continuous stills were stripped and cleaned to remove residues and operators working on 60 still base began to notice and reported a build up of sludge in this vessel which was slowing the rate of distillation. Various estimates were made about the depth of sludge but the general consensus was that there was as much as 1820 litres equivalent to a uniform depth of about 10 cm (4 in). A senior employee had reported a depth of 29 cm (12 in) several months before the incident and on 21 September 1992, the day of the accident, the same employee dipped the still base on the instructions of his area manager. He used a metal dipping rod and estimated that the sludge was approximately 34 cm (14 in) deep.

- 28 The removal of residue from 60 still base was discussed by a shift manager and the area manager (AM) on Thursday 17 September 1993 (paragraph 27). The shift manager had been told by employees that the vessel had never been cleaned out. He realised that the bottom steam battery was covered by sludge and he advised the AM. They discussed preparation for the clean-out which required removal of steps and a platform in front of the vessel and provision of a scaffold and skip so that the sludge could be removed from the front face manway (Figures 4 and 7).

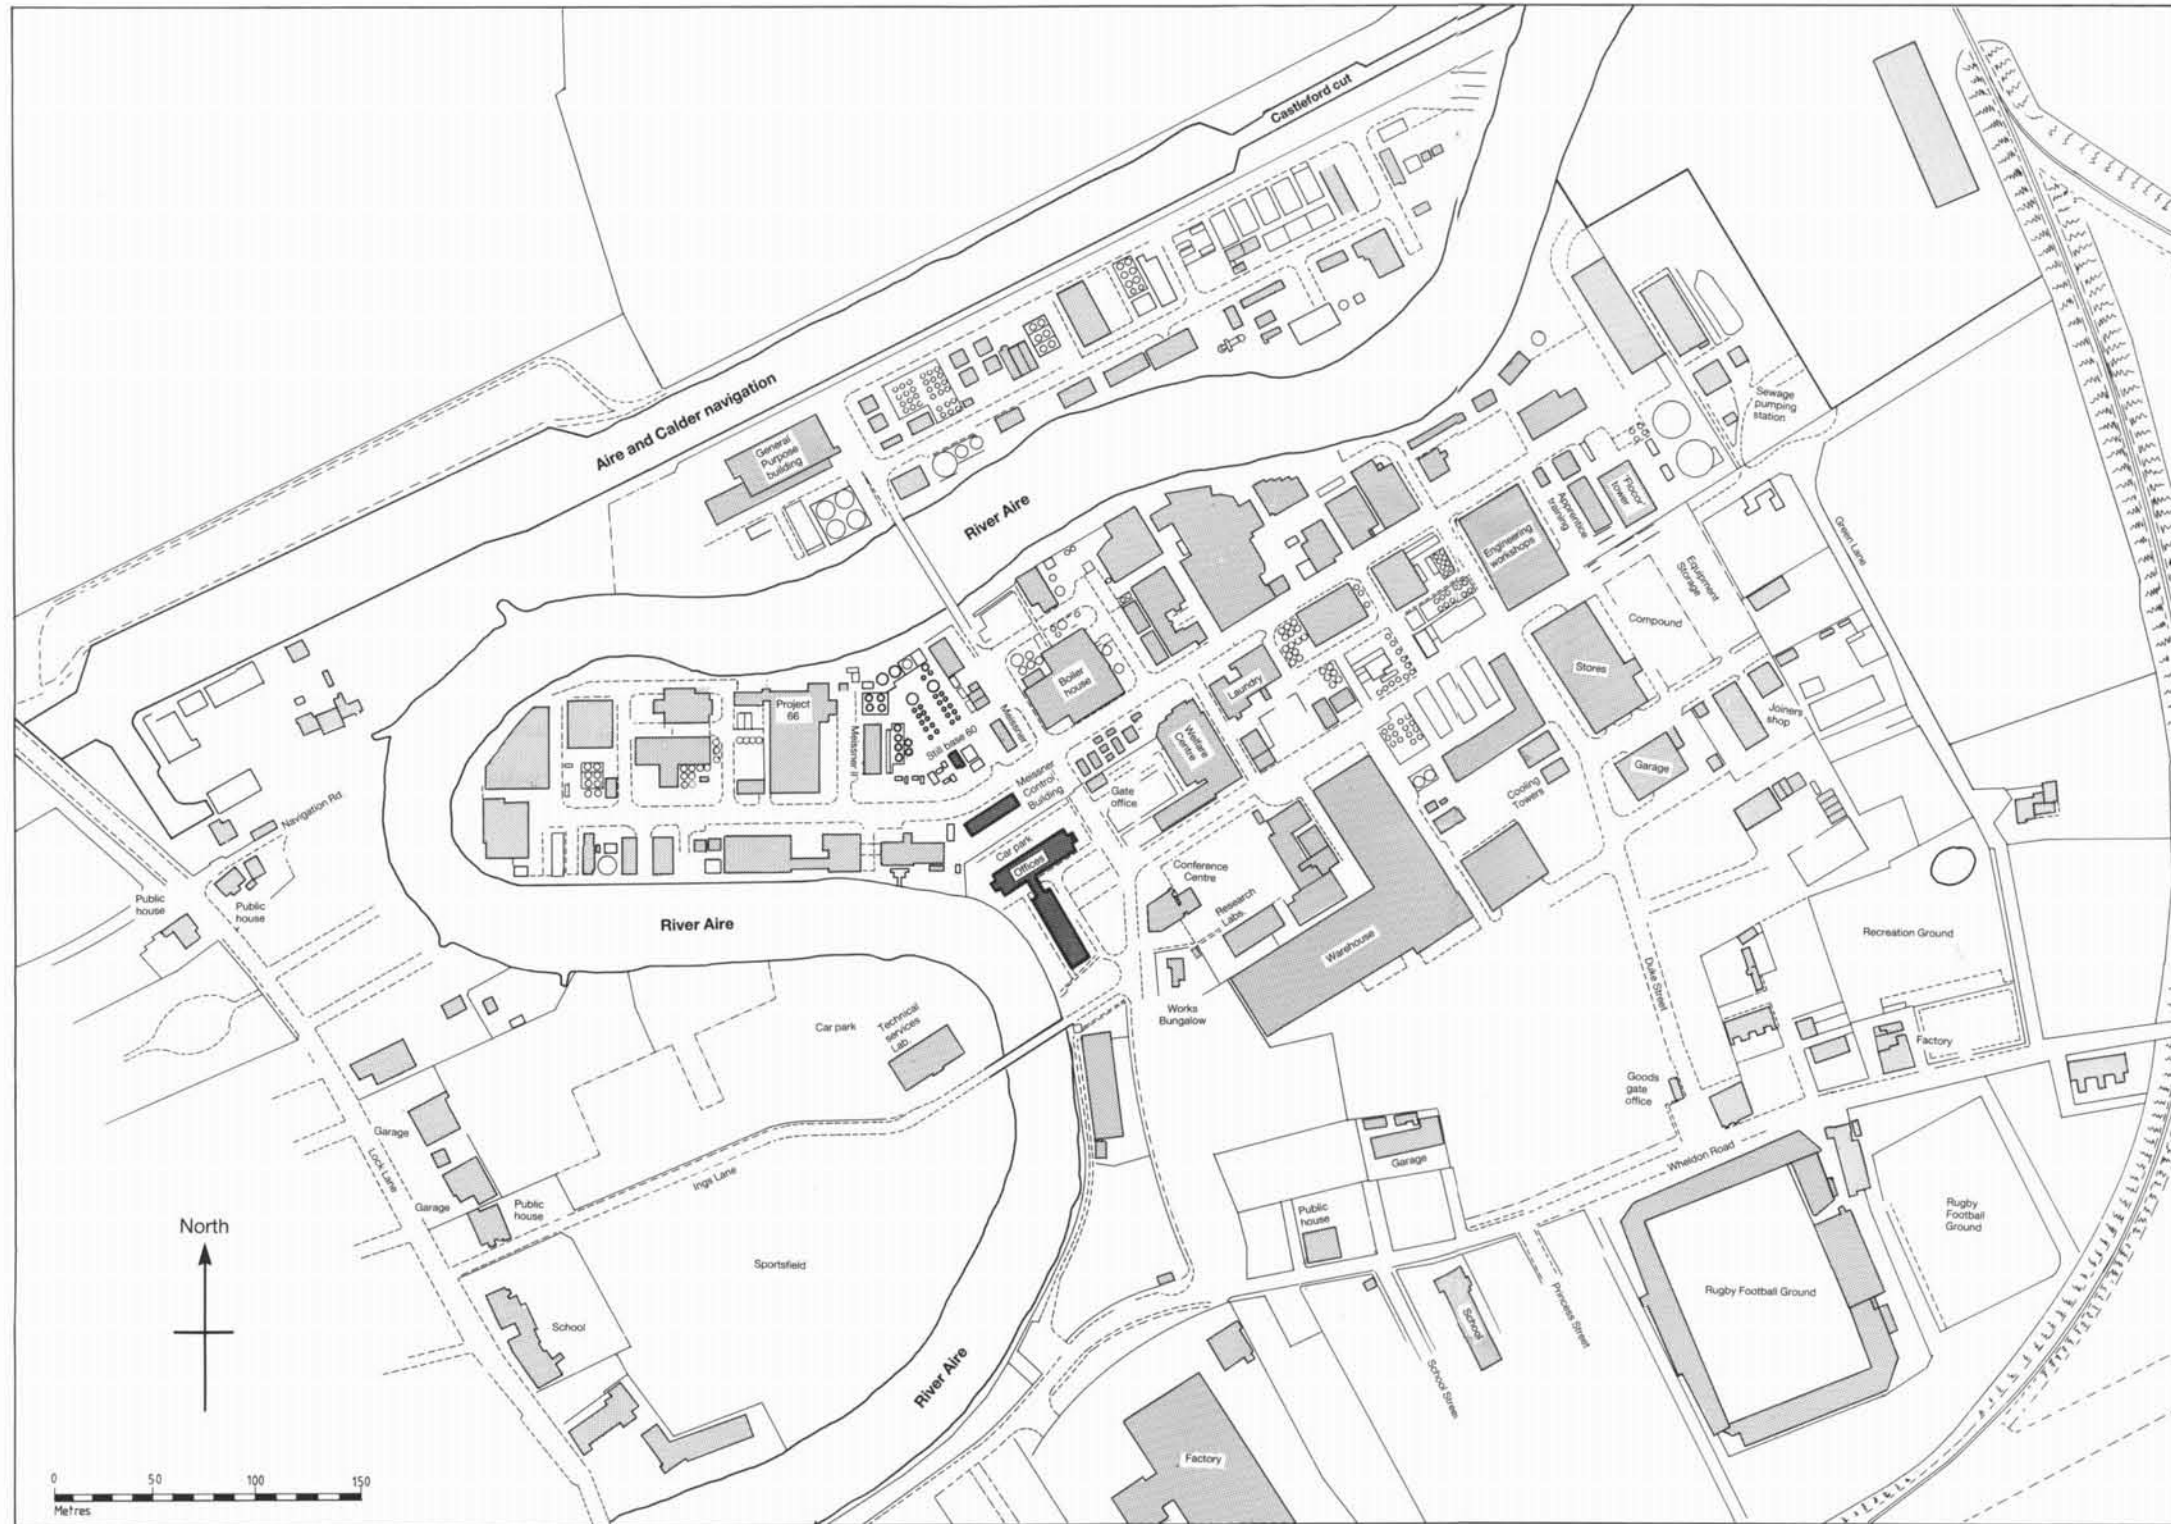
Appendix 2 Plan of Meissner control building showing extent of fire damage

- 35 At approximately 1.20 pm the operative left on the scaffold had stopped raking and was bending down level with the manway when he saw a blue light which turned instantly to an orange flame. As he leapt from the scaffold, towards the panel room, an incandescent conical jet erupted from the manway and was projected horizontally towards the Meissner control building. The fitter, who was blanking the still base inlet, saw a vertical jet shoot out of the top rear vent (Figure 3) to the height of the distillation column nearby (Figure 8). He jumped from the top of the still base stairway (approximately 5 m) and ran clear. Witnesses estimate that the jet lasted for approximately one minute before subsiding to localised fires around the manlid and buildings nearby. The force of the jet destroyed the scaffold and propelled the still base manlid which was on it into the centre of the Meissner control building. The jet severely damaged this building and then impacted on the north face of the main office block.
