The explosion and fires at the Texaco Refinery, Milford Haven, 24 July 1994

A report of the investigation by the Health and Safety Executive into the explosion and fires on the Pembroke Cracking Company Plant at the Texaco Refinery, Milford Haven on 24 July 1994

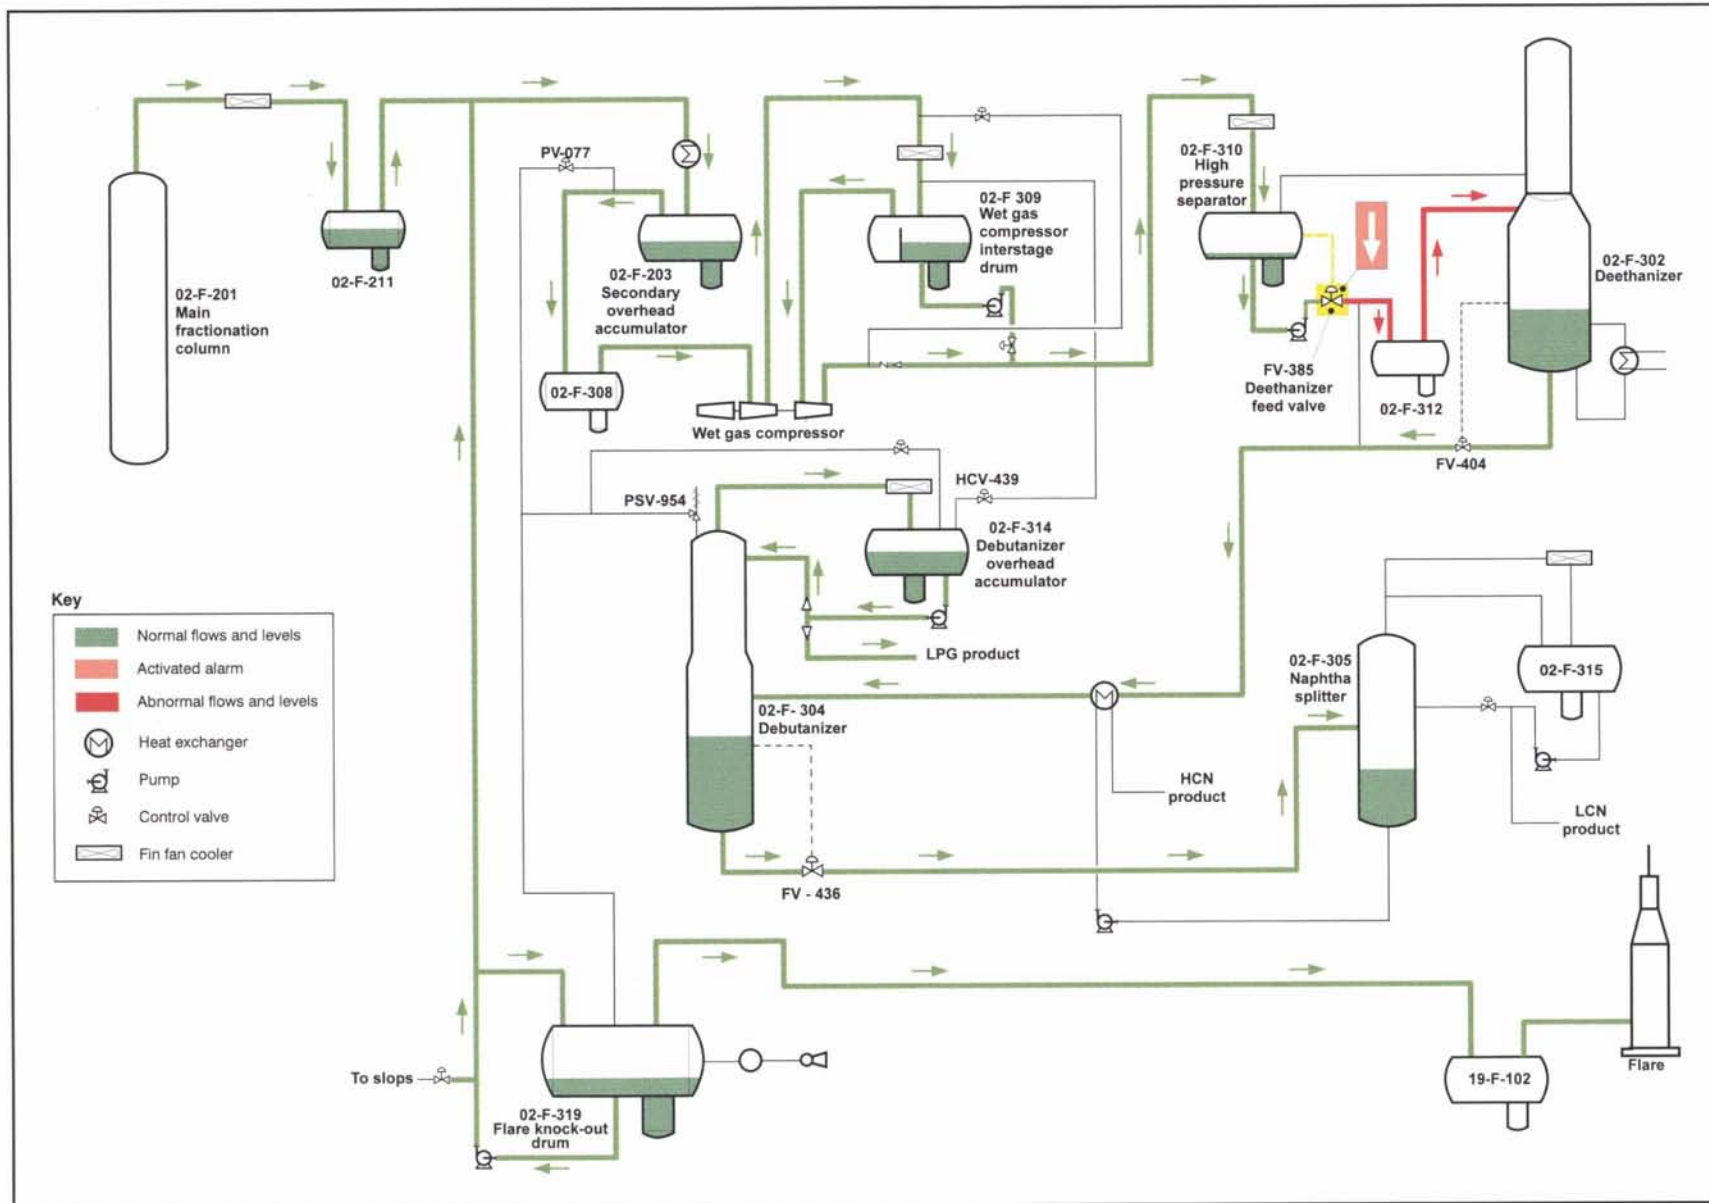
Figure 11

- 5 The flow from the deethaniser to the debutaniser via valve 02-FV-404 was about $450 \text{ m}^3\text{h}^{-1}$ at this point, consequently with no feed the deethaniser rapidly emptied and after five minutes the liquid level controller 02-LC-402 recorded zero. The level control was cascaded to the deethaniser output flow valve 02-FV-404 which closed to retain a liquid level in the deethaniser. The flow of liquid to the debutaniser was lost and as a result liquid levels in the debutaniser began to fall.

- 6 At 08.39 the debutaniser level controller cascaded to the debutaniser control which started to close the output valve (02-FV-436) to maintain the debutaniser liquid level. The liquid retained in the debutaniser by this action was material from the deethaniser which was relatively rich in low molecular weight hydrocarbon. At the higher temperatures of the debutaniser this material rapidly vaporised and at 08.46 the debutaniser pressure started to rise rapidly.

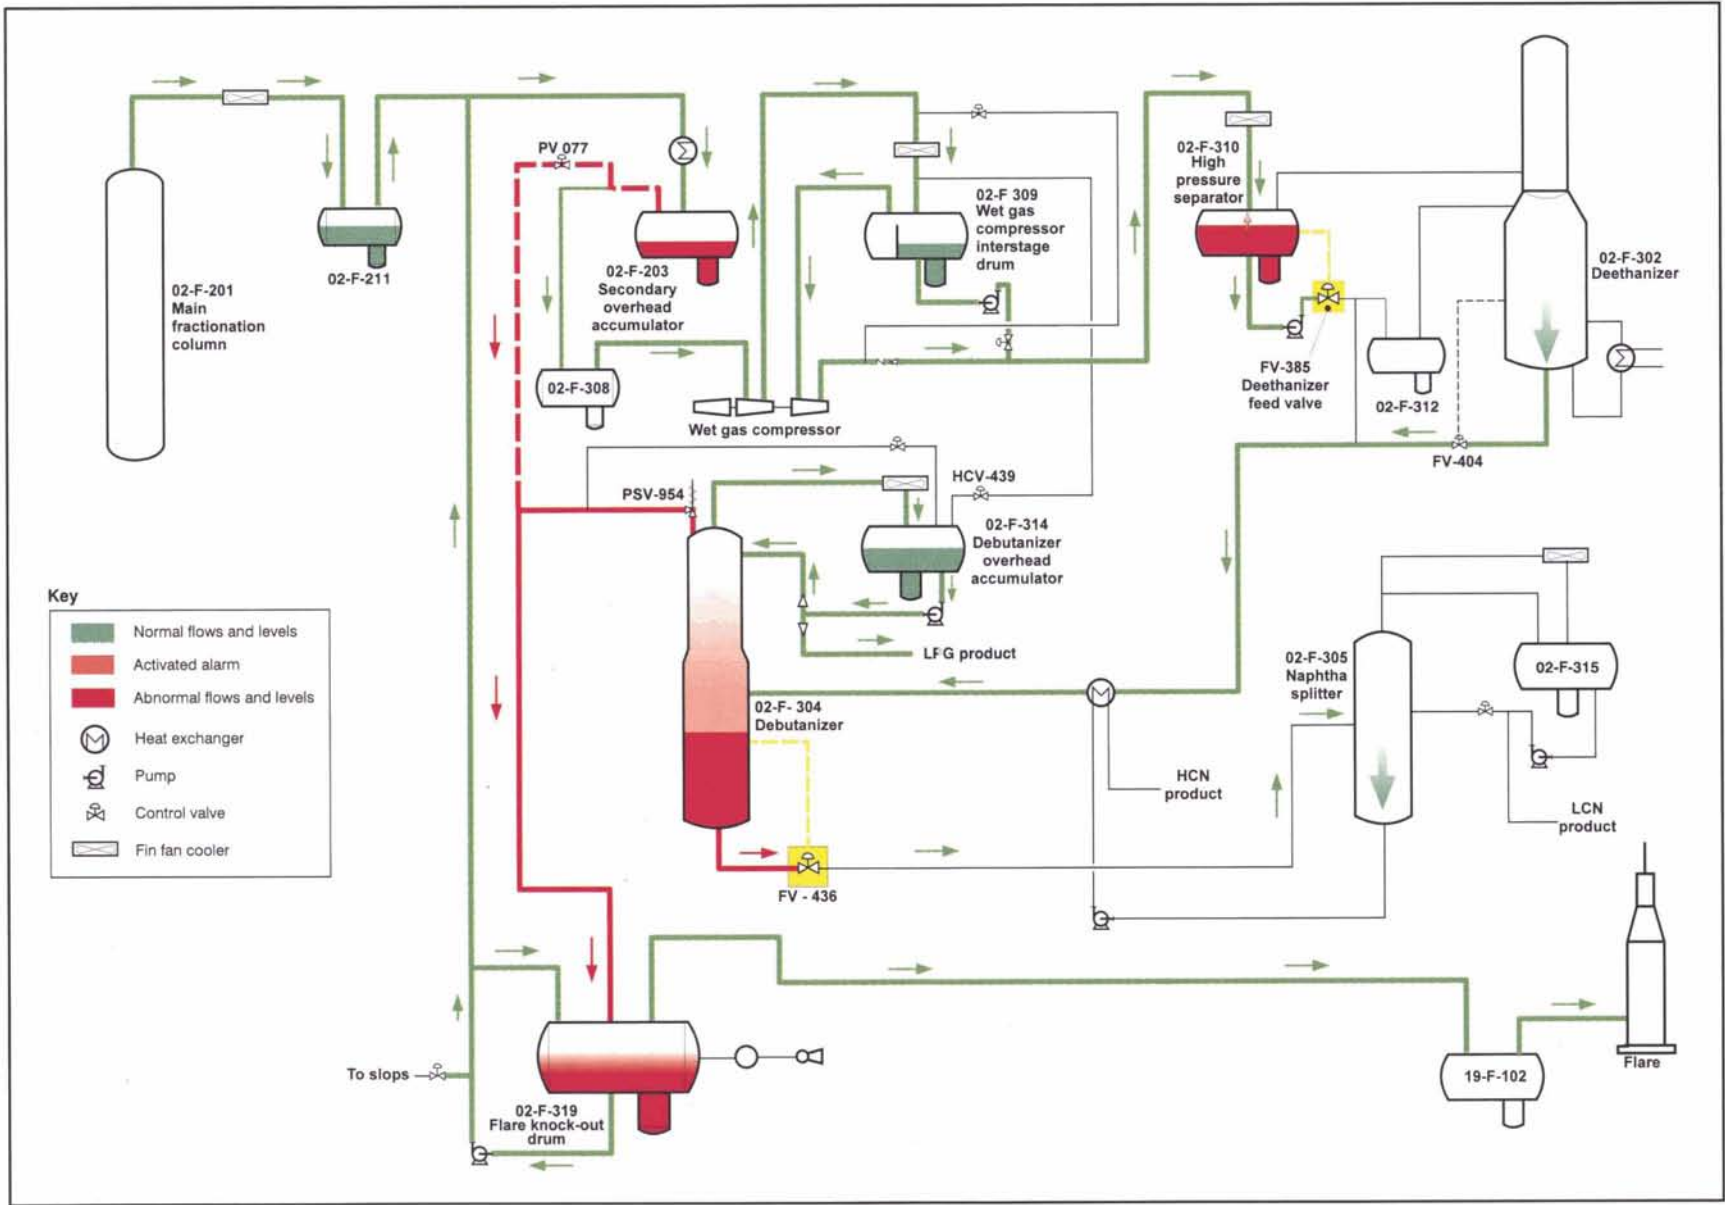
Figure 12

- 12 The pressure in the debutaniser rose because of the composition of the materials it contained. These included a high proportion of lighter fractions which would normally have been extracted by the deethaniser. On this occasion they had not been extracted because the deethaniser had emptied so quickly.

- 13 One of the four pressure relief valves (PSV954 A-D) on the debutaniser lifted (at

around 08.53) and a mixture of gas and liquid was released to the flare knock-out drum (02-F-319).

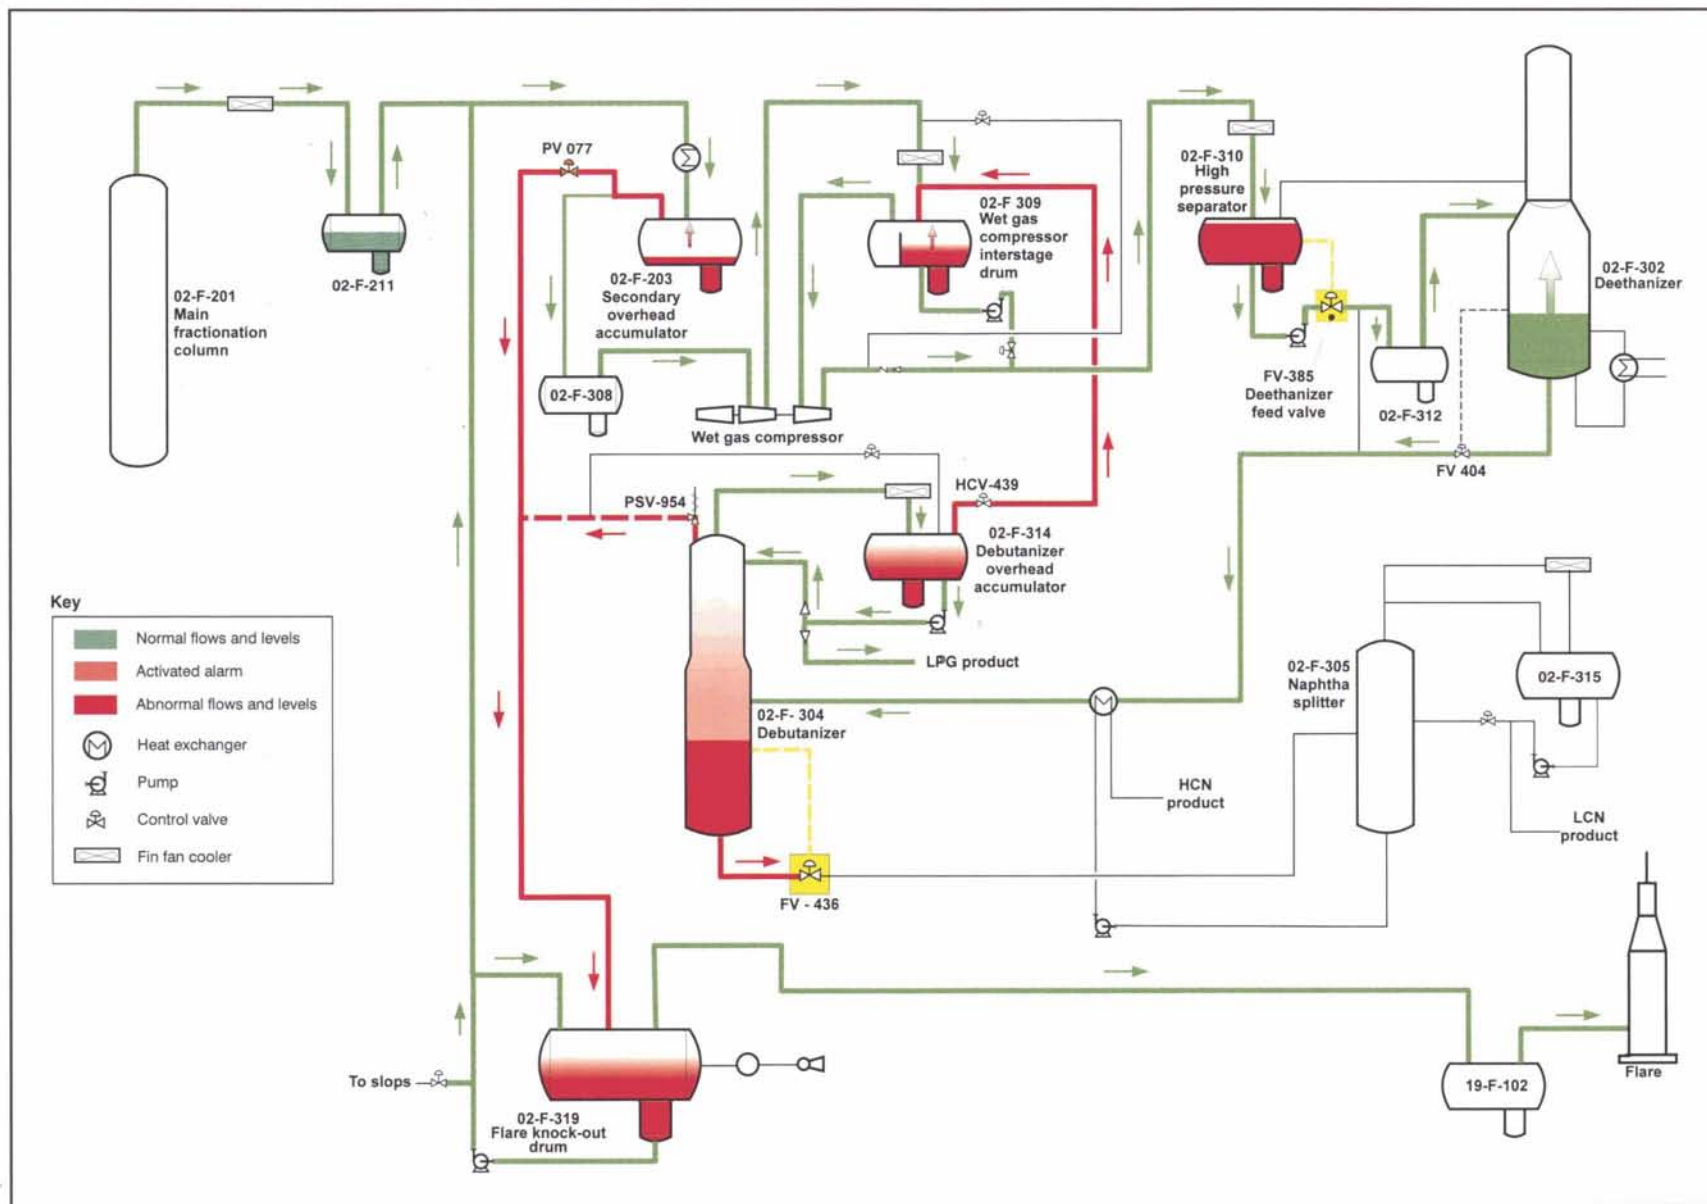
Figure 13

- 25 At 09.40 the hot oil flow to the debutaniser reboiler was reduced to zero, because the temperature was around 187°C, and still rising.
- 26 In the next ten minutes a series of events occurred as the debutaniser temperature and pressure continued to rise. The debutaniser liquid level gauge stayed fixed at 79% of its range. The liquid level probably exceeded this, as the column flooded. The debutaniser overhead accumulator filled with liquids and vapour due to the transfer of excess material from the debutaniser. Many of the level transmitters on the plant were of a differential pressure type. The installation design was such that following high liquid levels they could be inaccurate.

- 27 At this point the plant was in a very upset condition and the composition of the process liquids and gases was not normal. The overheating of the debutaniser column, which contained material of greater volatility than normal, therefore resulted in the rapid evolution of both liquids and gases from the top of the column into the overhead accumulator. In effect, it 'boiled over'.

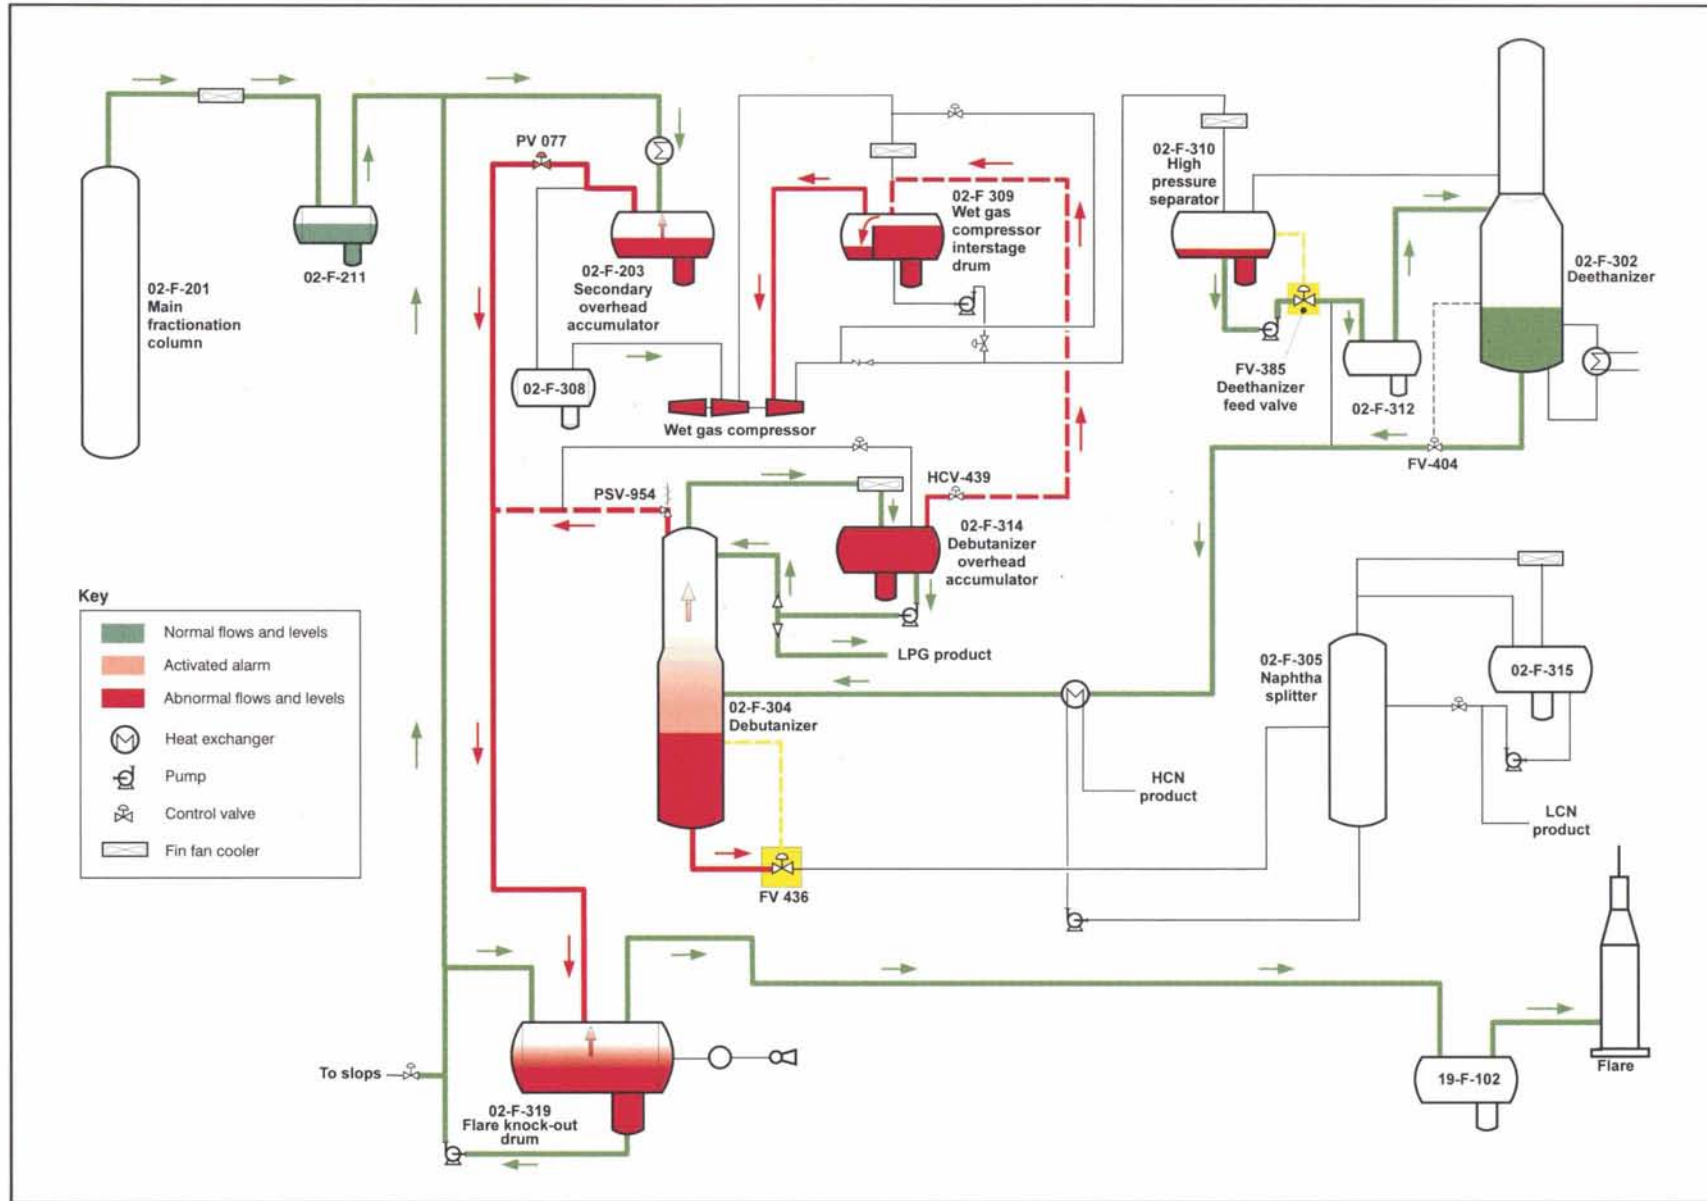
Figure 14

- 31 At 10.01 the debutaniser was liquid-logged and the pressure exceeded the PSV set pressure again. Pressure peaked at 12.2 barg and discharge via the debutaniser PSVs continued for 16 minutes. At 10.10 the liquid level in the knock-out drum began to rise rapidly, and rose from 61% to 93% over the next 14 minutes. This corresponded to an increase in liquid volume of 44 m³, and assuming a density of 630 kgm⁻³ (pentane), this represented a liquid flow rate of 33 kgsec⁻¹. This relief rate is consistent with that which could have discharged from the debutaniser PSVs.

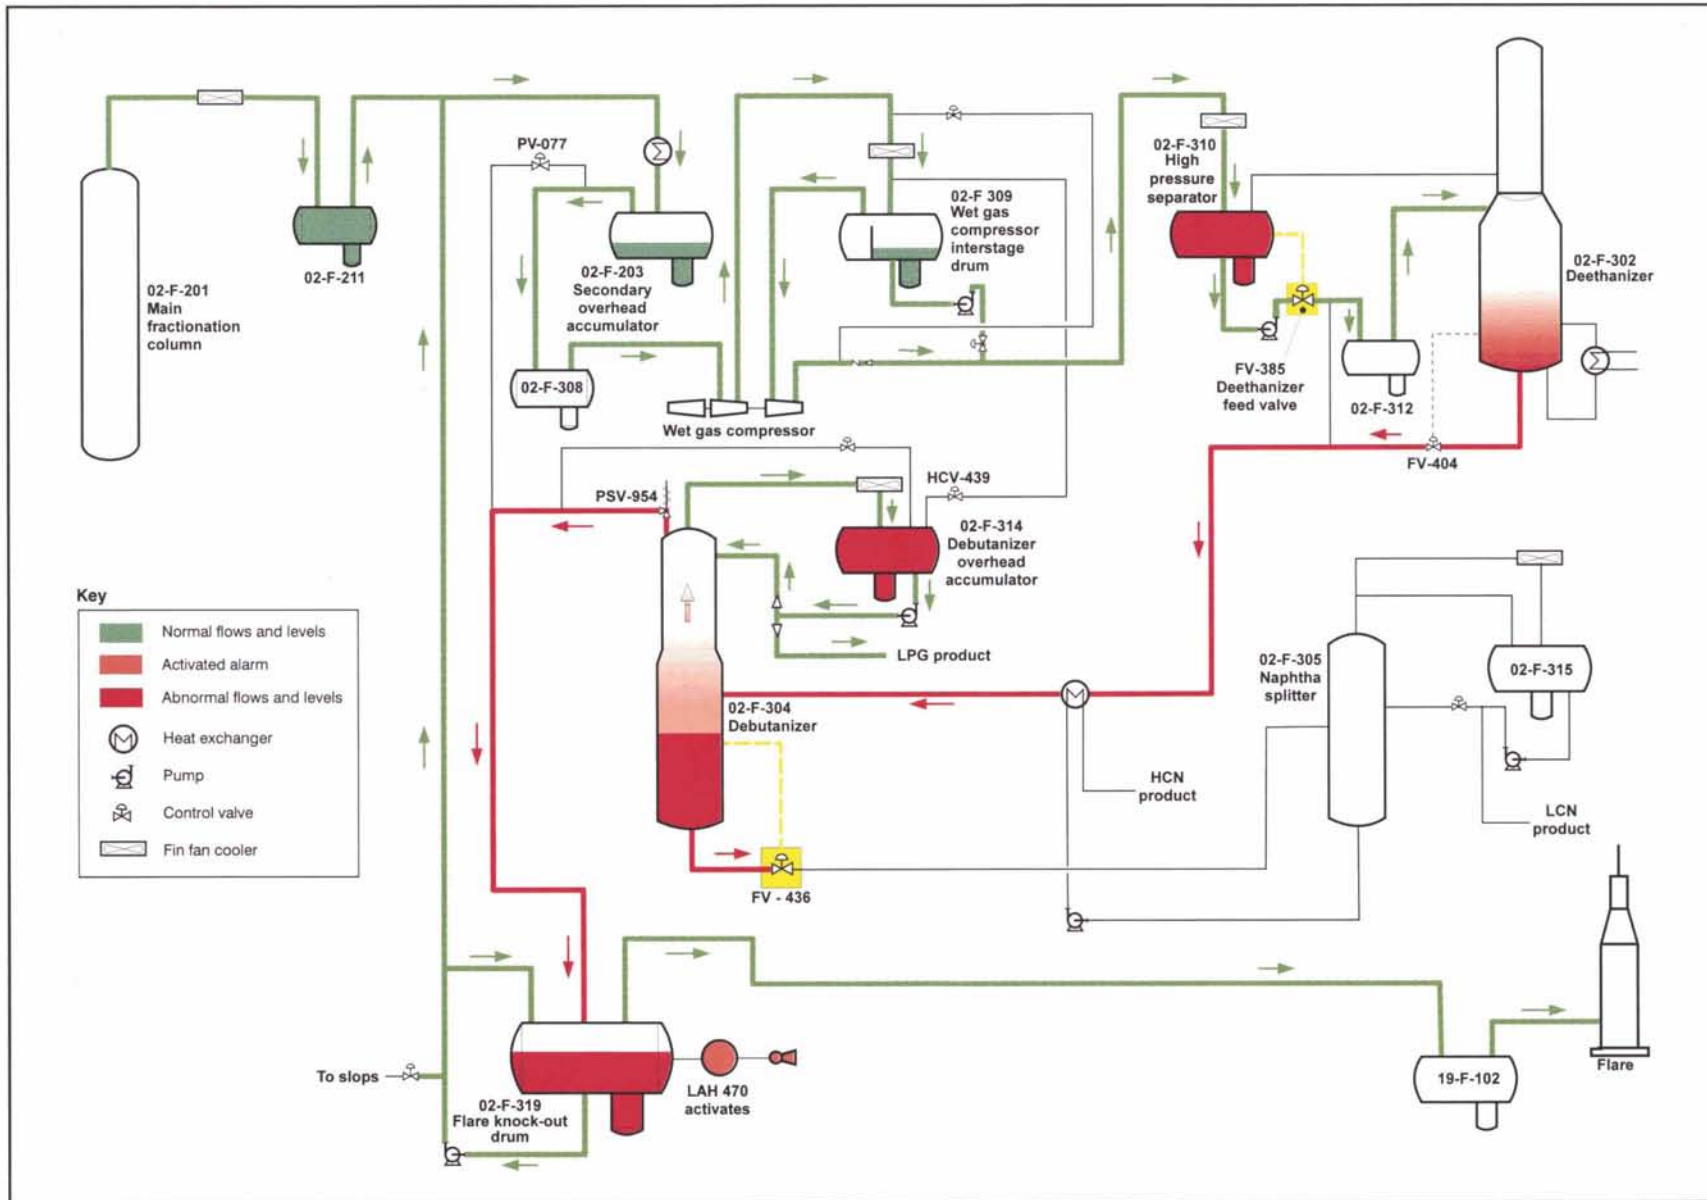
Figure 15

- 38 Shortly after the wet gas compressor restarted, the debutaniser pressure started to rise and by 12.46 again exceeded the relief valves' set pressure. The consequent venting to flare continued until the explosion. Assuming a density of 660 kgm^{-3} the liquid flow from the relief valves has been estimated to have peaked at 110 kgsec^{-1} at 12.40 then declined to an average of 82 kgsec^{-1} between 12.46 and 13.05, then further reduced to 64 kgsec^{-1} until 13.21.

- 39 From 12.46 the debutaniser pressure exceeded the PSV set pressure for about 40 minutes, reaching a maximum pressure of 12.8 barg. Between 12.46 and 12.56 the amount of liquid in the flare knock-out drum increased by 60.5 m³. This is equivalent to a liquid flow rate of 63.5 kgsec⁻¹ and is corresponds with the recorded rate of liquid input to the debutaniser over the same period.

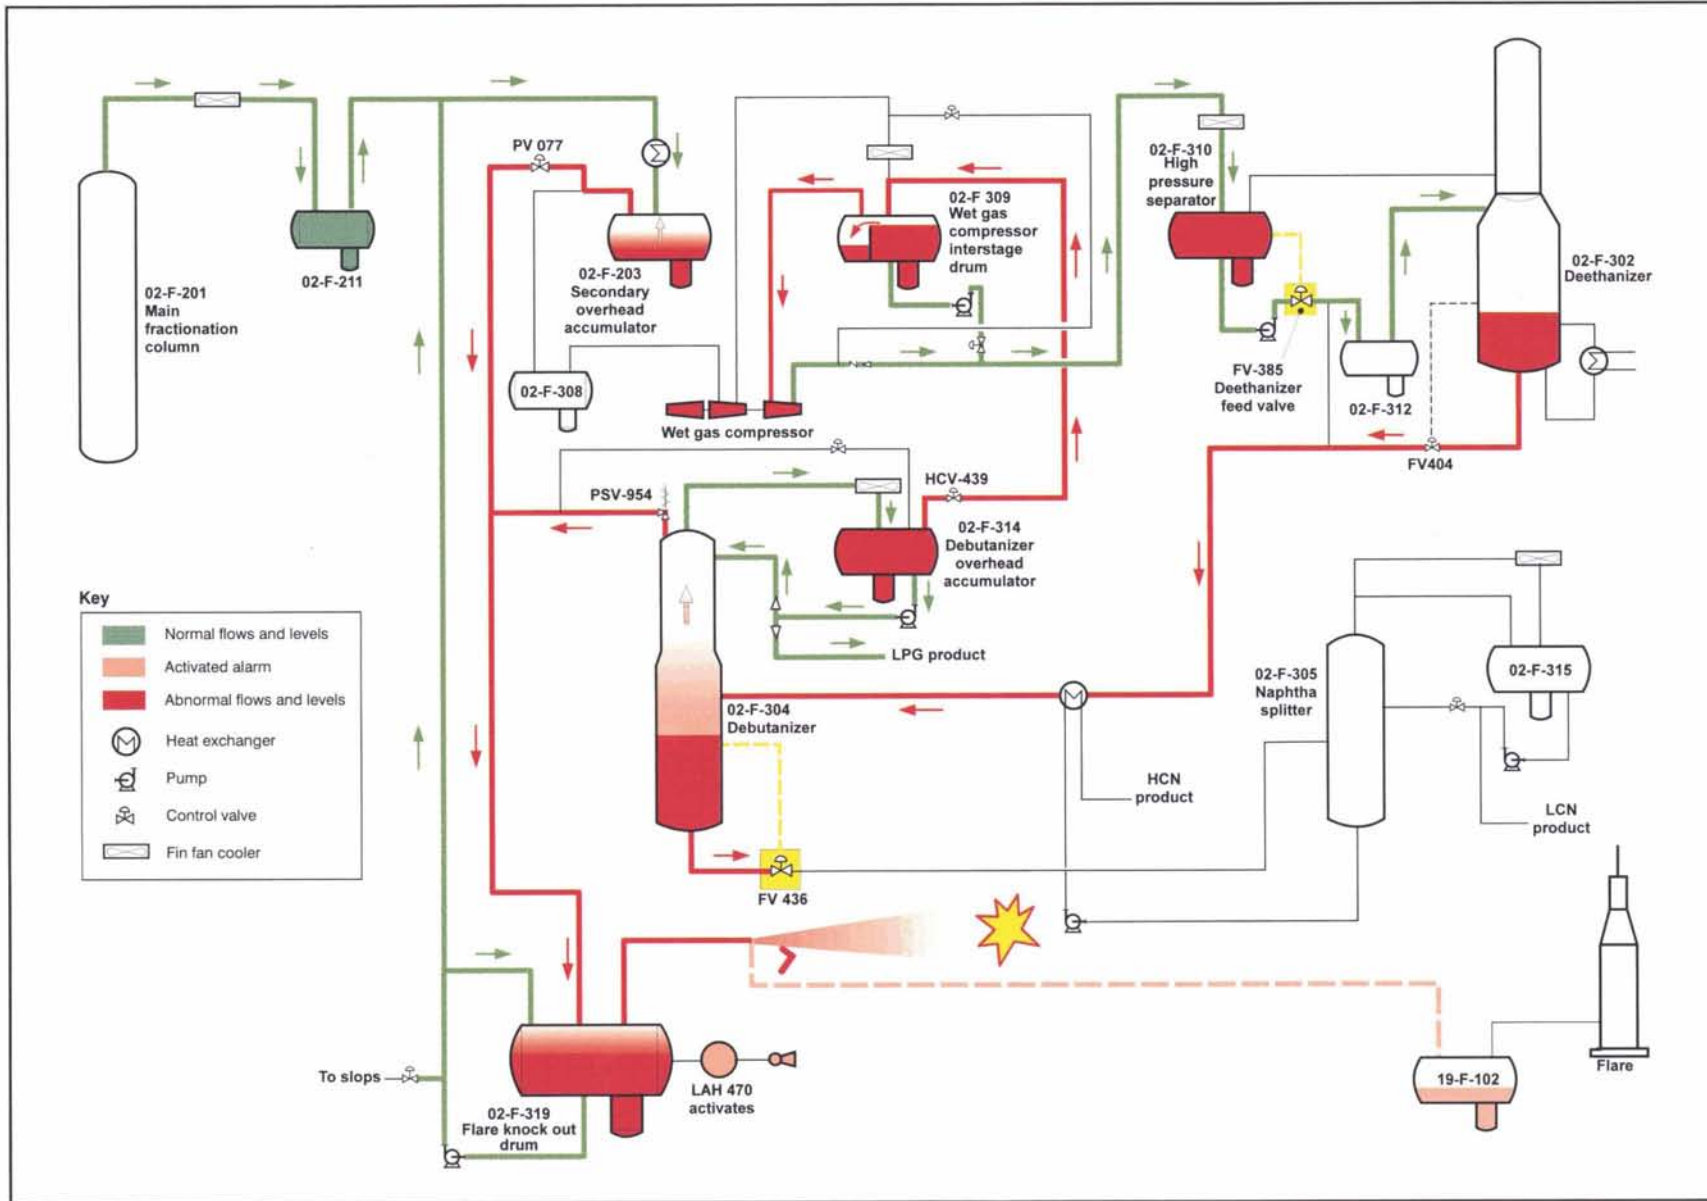
Figure 16

- 47 The debutaniser pressure was still not dropping so 02-HCV-439 was manually opened further to 80% and then to 100%. With hindsight, this was merely compounding the problem as the vented material was staying within the recovery section and tending to exacerbate the filling of the interstage drum.

- 48 At 13.18 the interstage drum wet end level rose to 67% and the bypass to the dry end drainage valve, was requested to be opened. The outside operator reported the valve was fully open, and at 13.21 the wet gas compressor tripped automatically for the second time, which was reported by the outside operator.
