How stressed is your facility?

Trish Kerin, Director, IChemE Safety Centre, Level 7, 455 Bourke St Melbourne, Australia

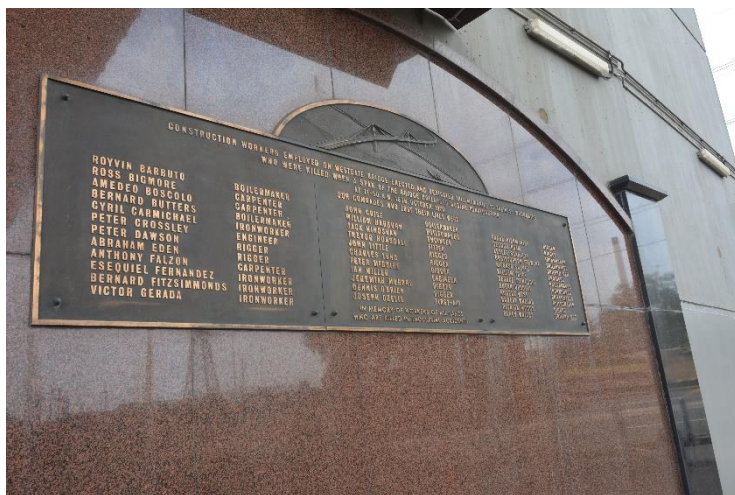
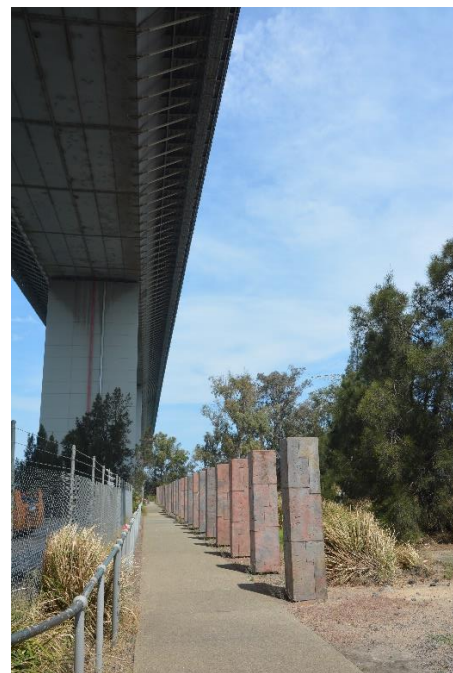
The West Gate Bridge is a steel box girder cable-stayed construction that spans the Yarra River in Melbourne Australia. It is a length of over 2.5km and sits at a height of 58 m above the water. During construction, on 15 October 1970 a 367 ft span suddenly collapsed. Thirty-five men were killed as a result, either they were working on the bridge at the time or resting in construction huts located directly below the span. A memorial is now at this location (see Figure 3). This incident occurred four months after a similar box girder bridge collapsed in construction near Milford Haven, Wales, killing four workers. There were also three other box girder bridges that collapsed due to inappropriate stresses during construction around this time. (Engineers Ireland, 2016) Lessons were taken from the Milford Haven bridge and additional stiffening was incorporated into the West Gate construction method, however the nature of the stresses was not understood (Barber, 1971). During construction an attempt was made to correct an error in the camber of the bridge by placing several heavy weights, known as kentledges, to force the box girder into line. This application of weight caused the buckling of one of the top plates, known as a flange (see Figure 4). In an effort to correct the buckling, several bolts on the transverse splice were removed in the upper flange near the centre (see Figure 5). This caused the section to spring loose and collapse, falling to the ground below. It was determined that the bridge did not have adequate margins of safety during construction, nor would it have had adequate safety margins during operation had it been erected (Barber, 1971). When the collapse occurred several areas of the steel were torn (see Figure 6). An enquiry found that the project engineer reluctantly agreed to the use of the kentledges because he could not raise any “rational” objections. (Barber, 1971) The engineer could not prove it was unsafe, therefore it was assumed to be safe. This requirement to justify that a course of action is unsafe to prevent it occurring is a factor in other incidents, such as the launch decision for Space Shuttle Columbia (Rogers, 1986). The rocket booster engineers could not prove it was unsafe with the data they had; therefore, it was assumed to be safe. The bridge was later completed in 1978 and still stands today, though it has had a major strengthening project completed. When it was opened it was carrying 40,000 vehicles per day, and in 2006 it was carrying approximately 160,000 vehicles per day. (Upgrade, 2015)

Figure 3. Memorial to workers killed at the base of the pier where the collapse occurred and 35 stone pillars representing those lost.
