The Flixborough disaster

Report of the Court of Inquiry

**Formal Investigation into Accident on 1st June
1974 at the Nypro Factory at Flixborough**

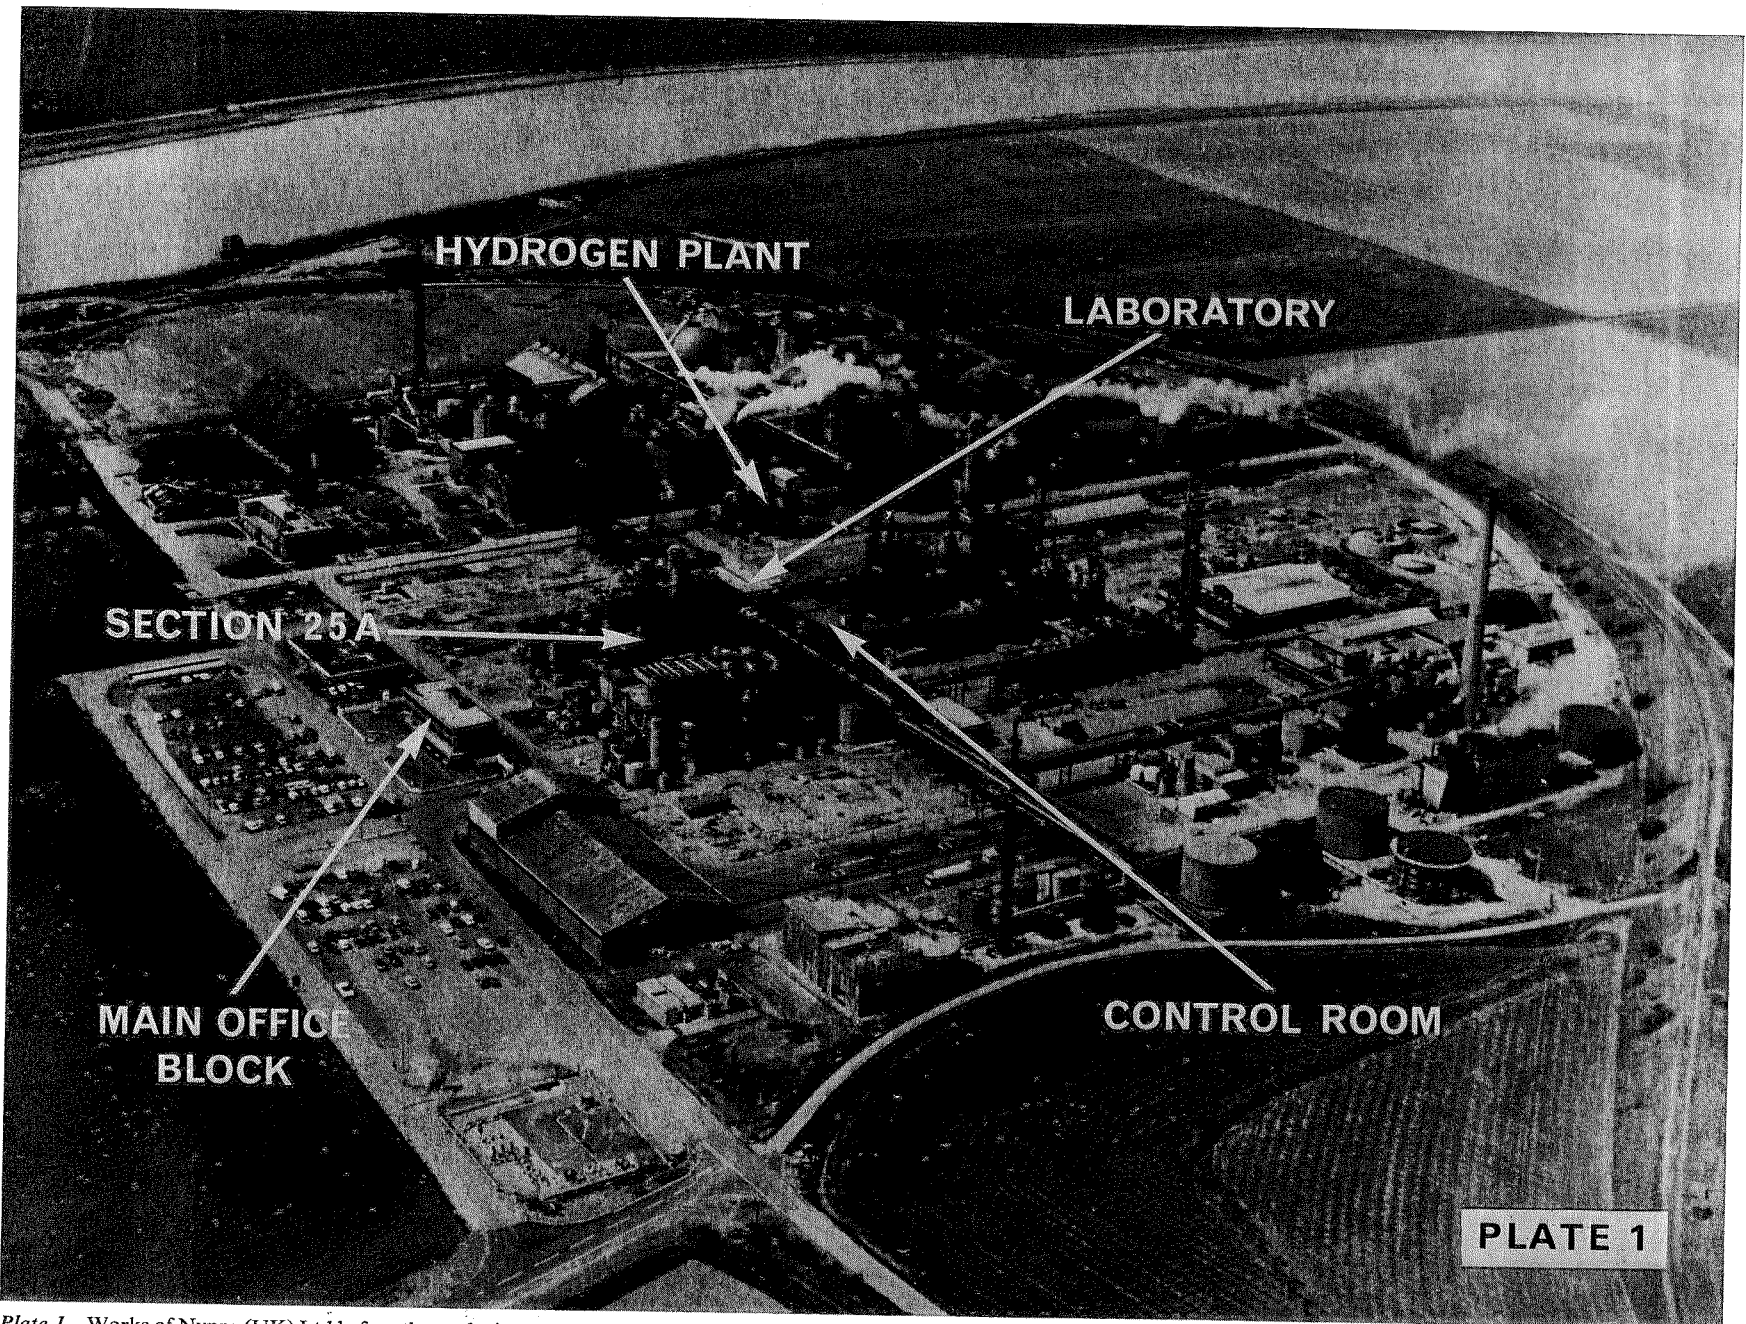
PLATE 1

Plate 1 Works of Nypro (UK) Ltd before the explosion. View from the south-east.

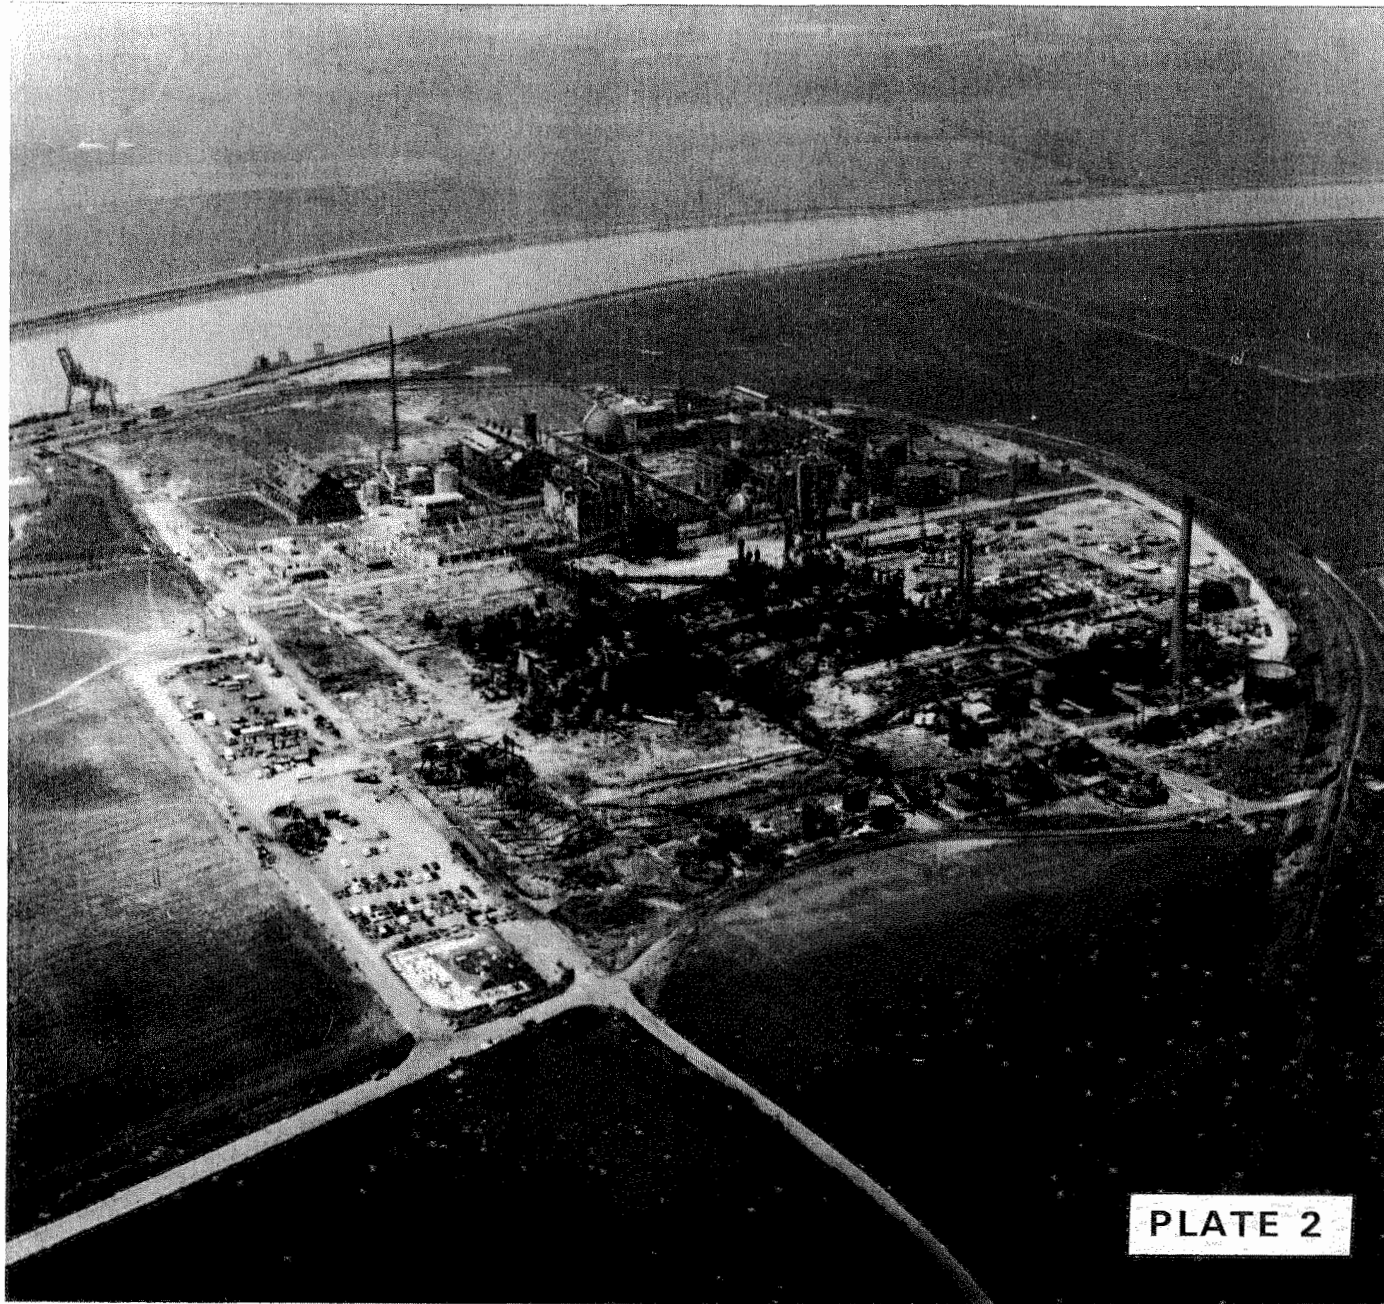
Plate 2 Works after the explosion. View from the south-east.

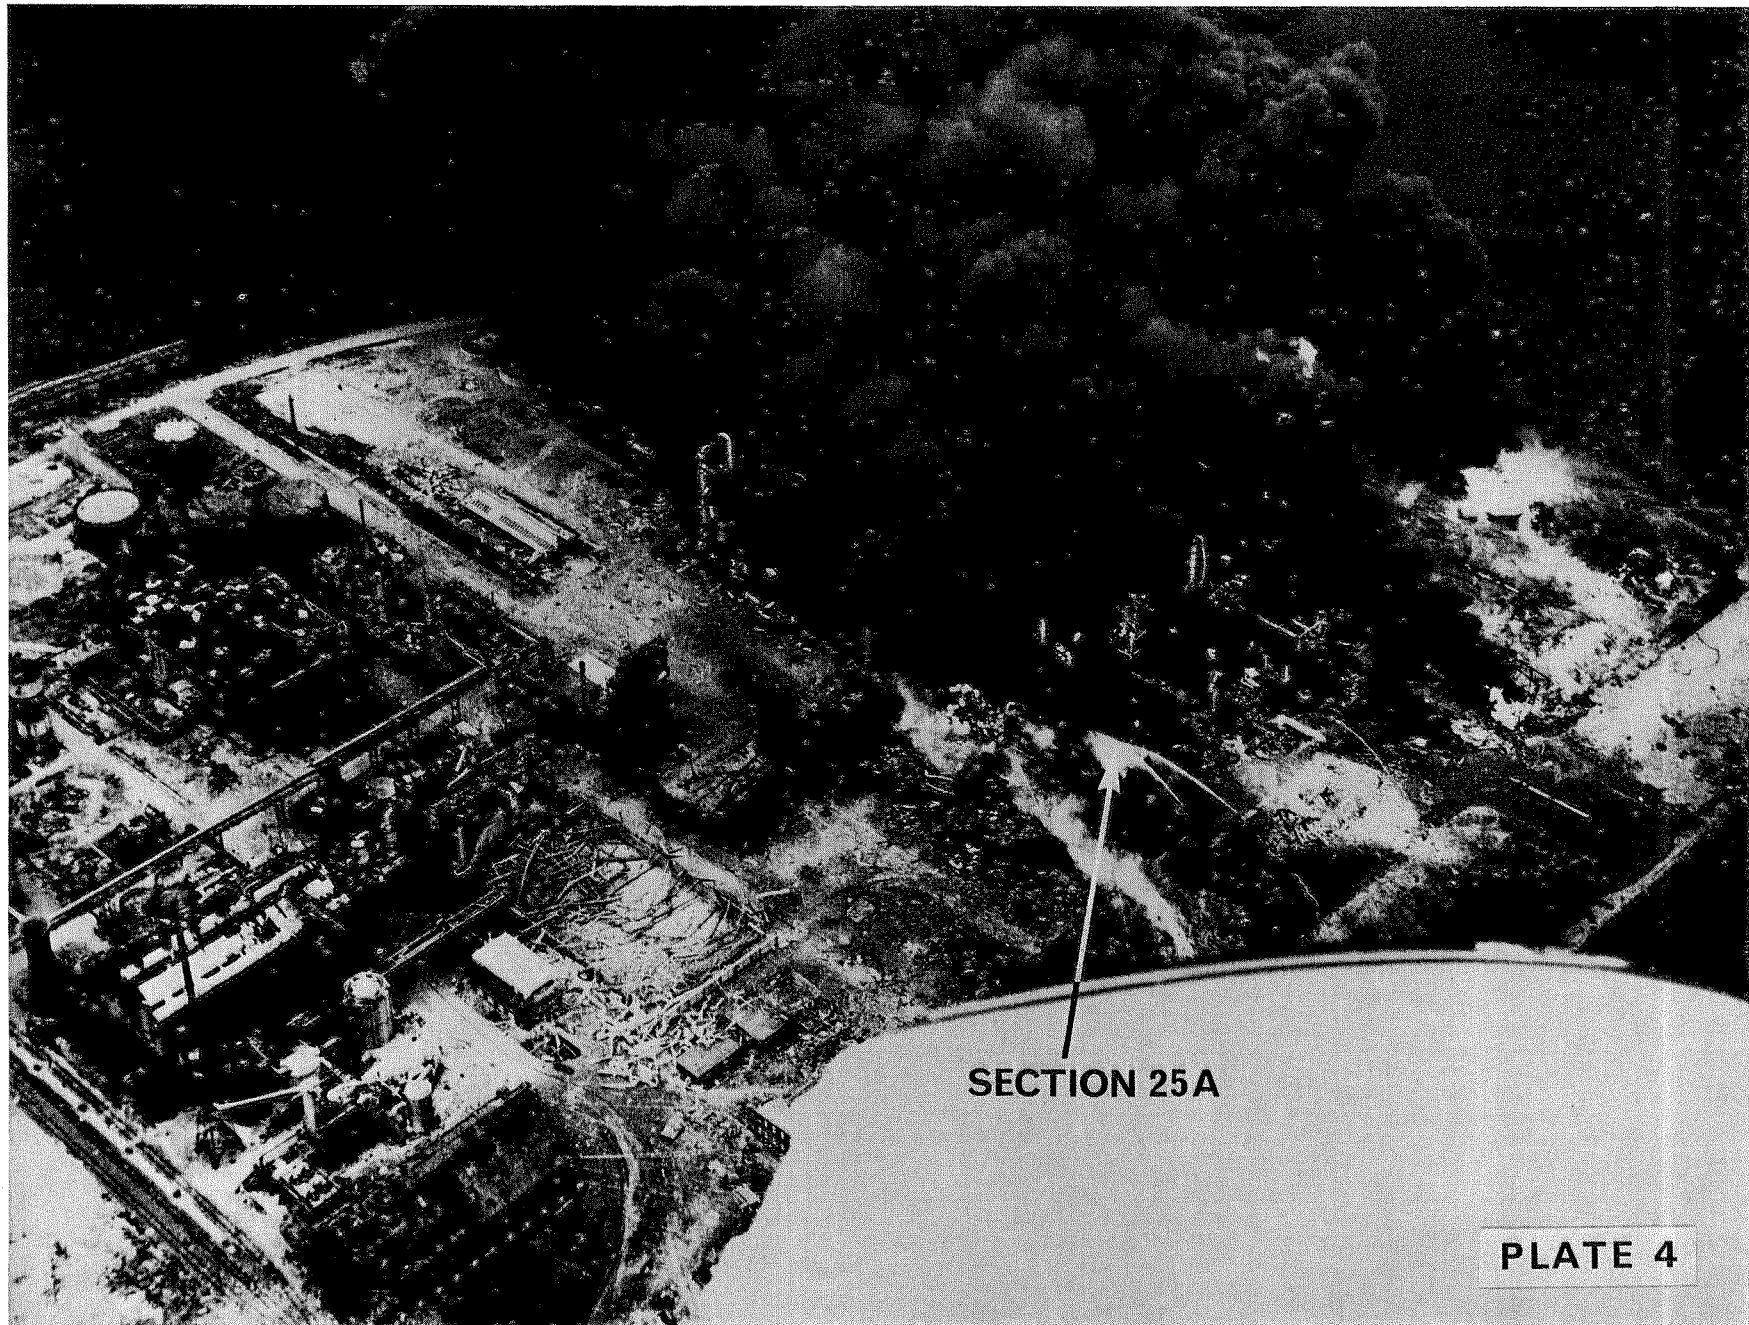
PLATE 4

Plate 4 The conflagration, seen from the south-west.

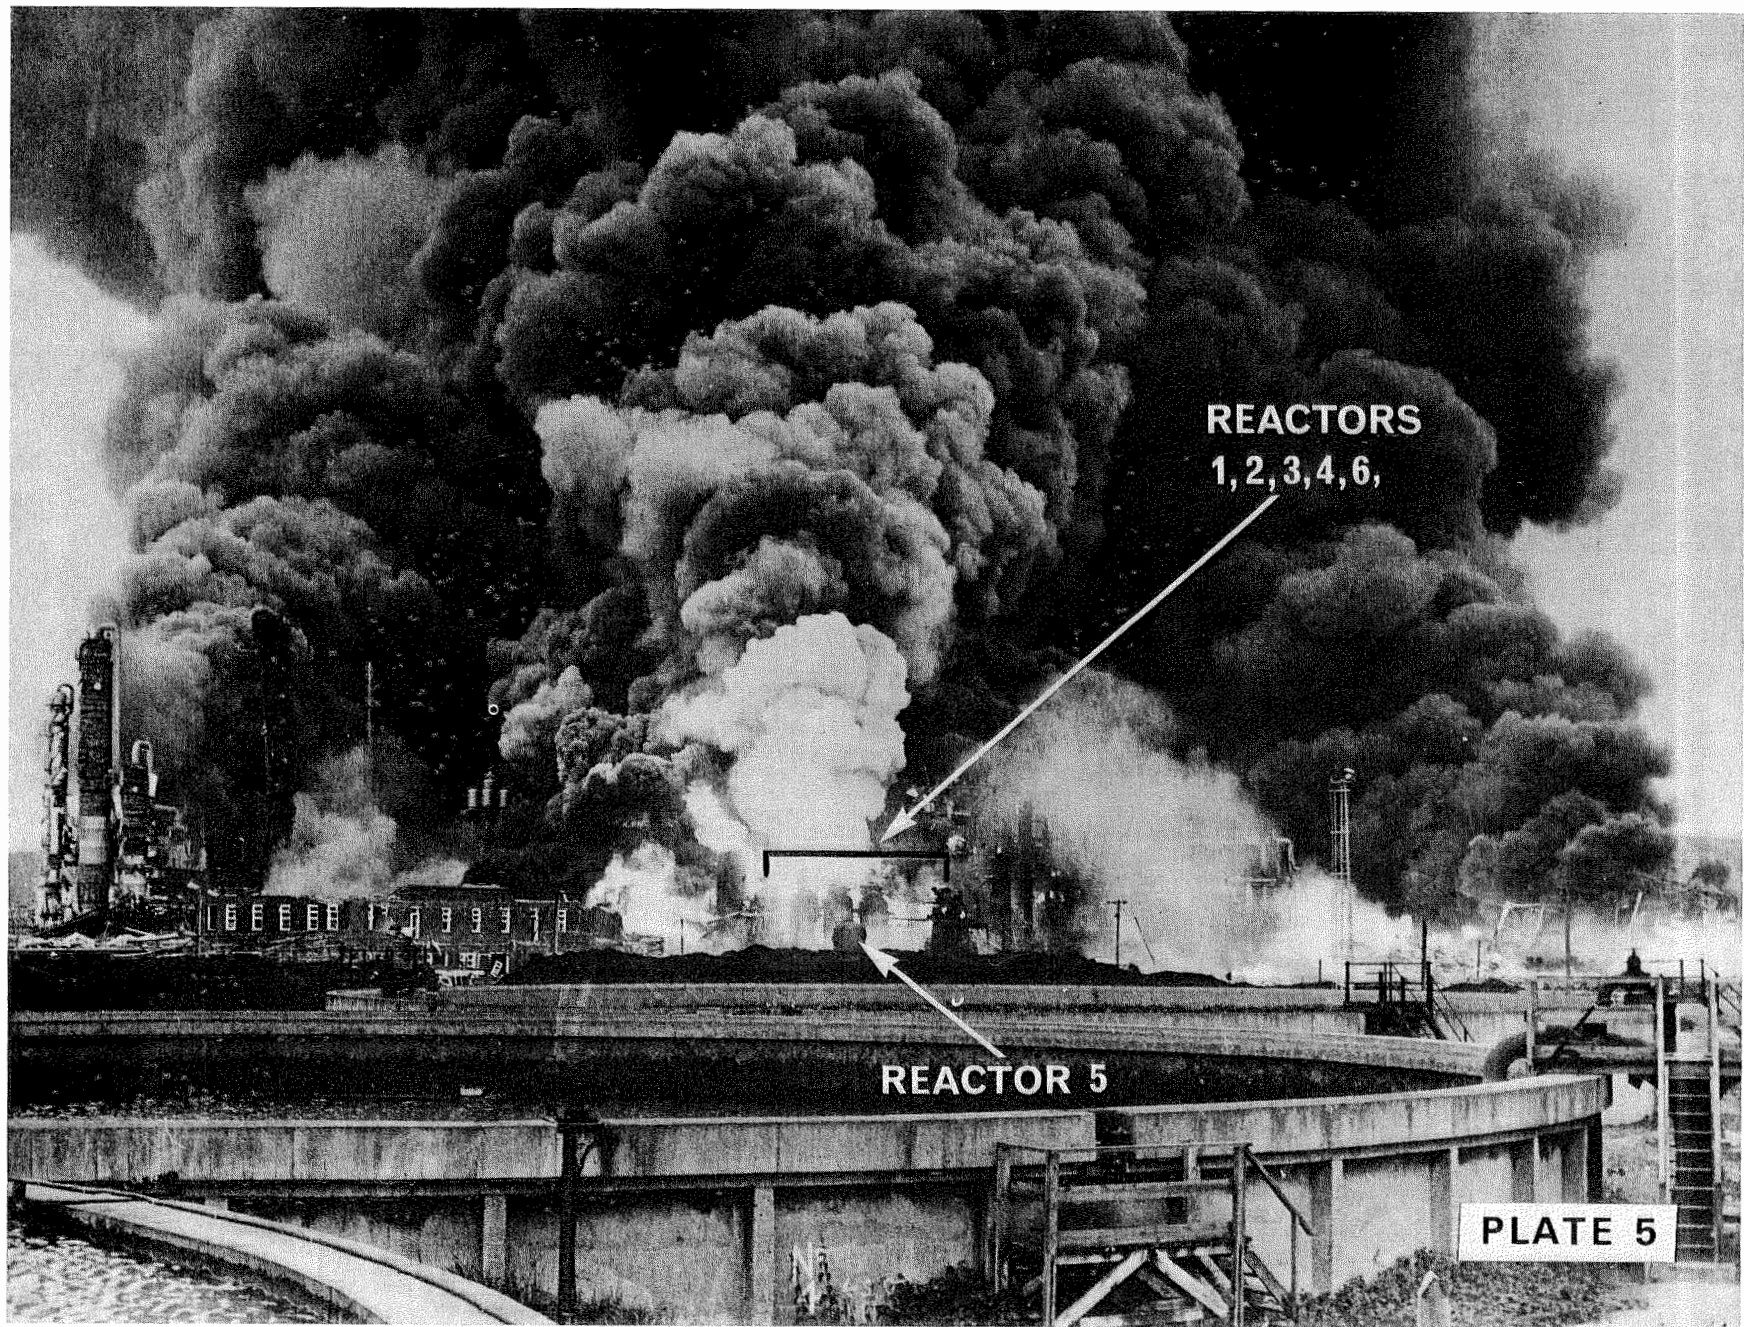
Plate 5 The fires seen from the south-west.

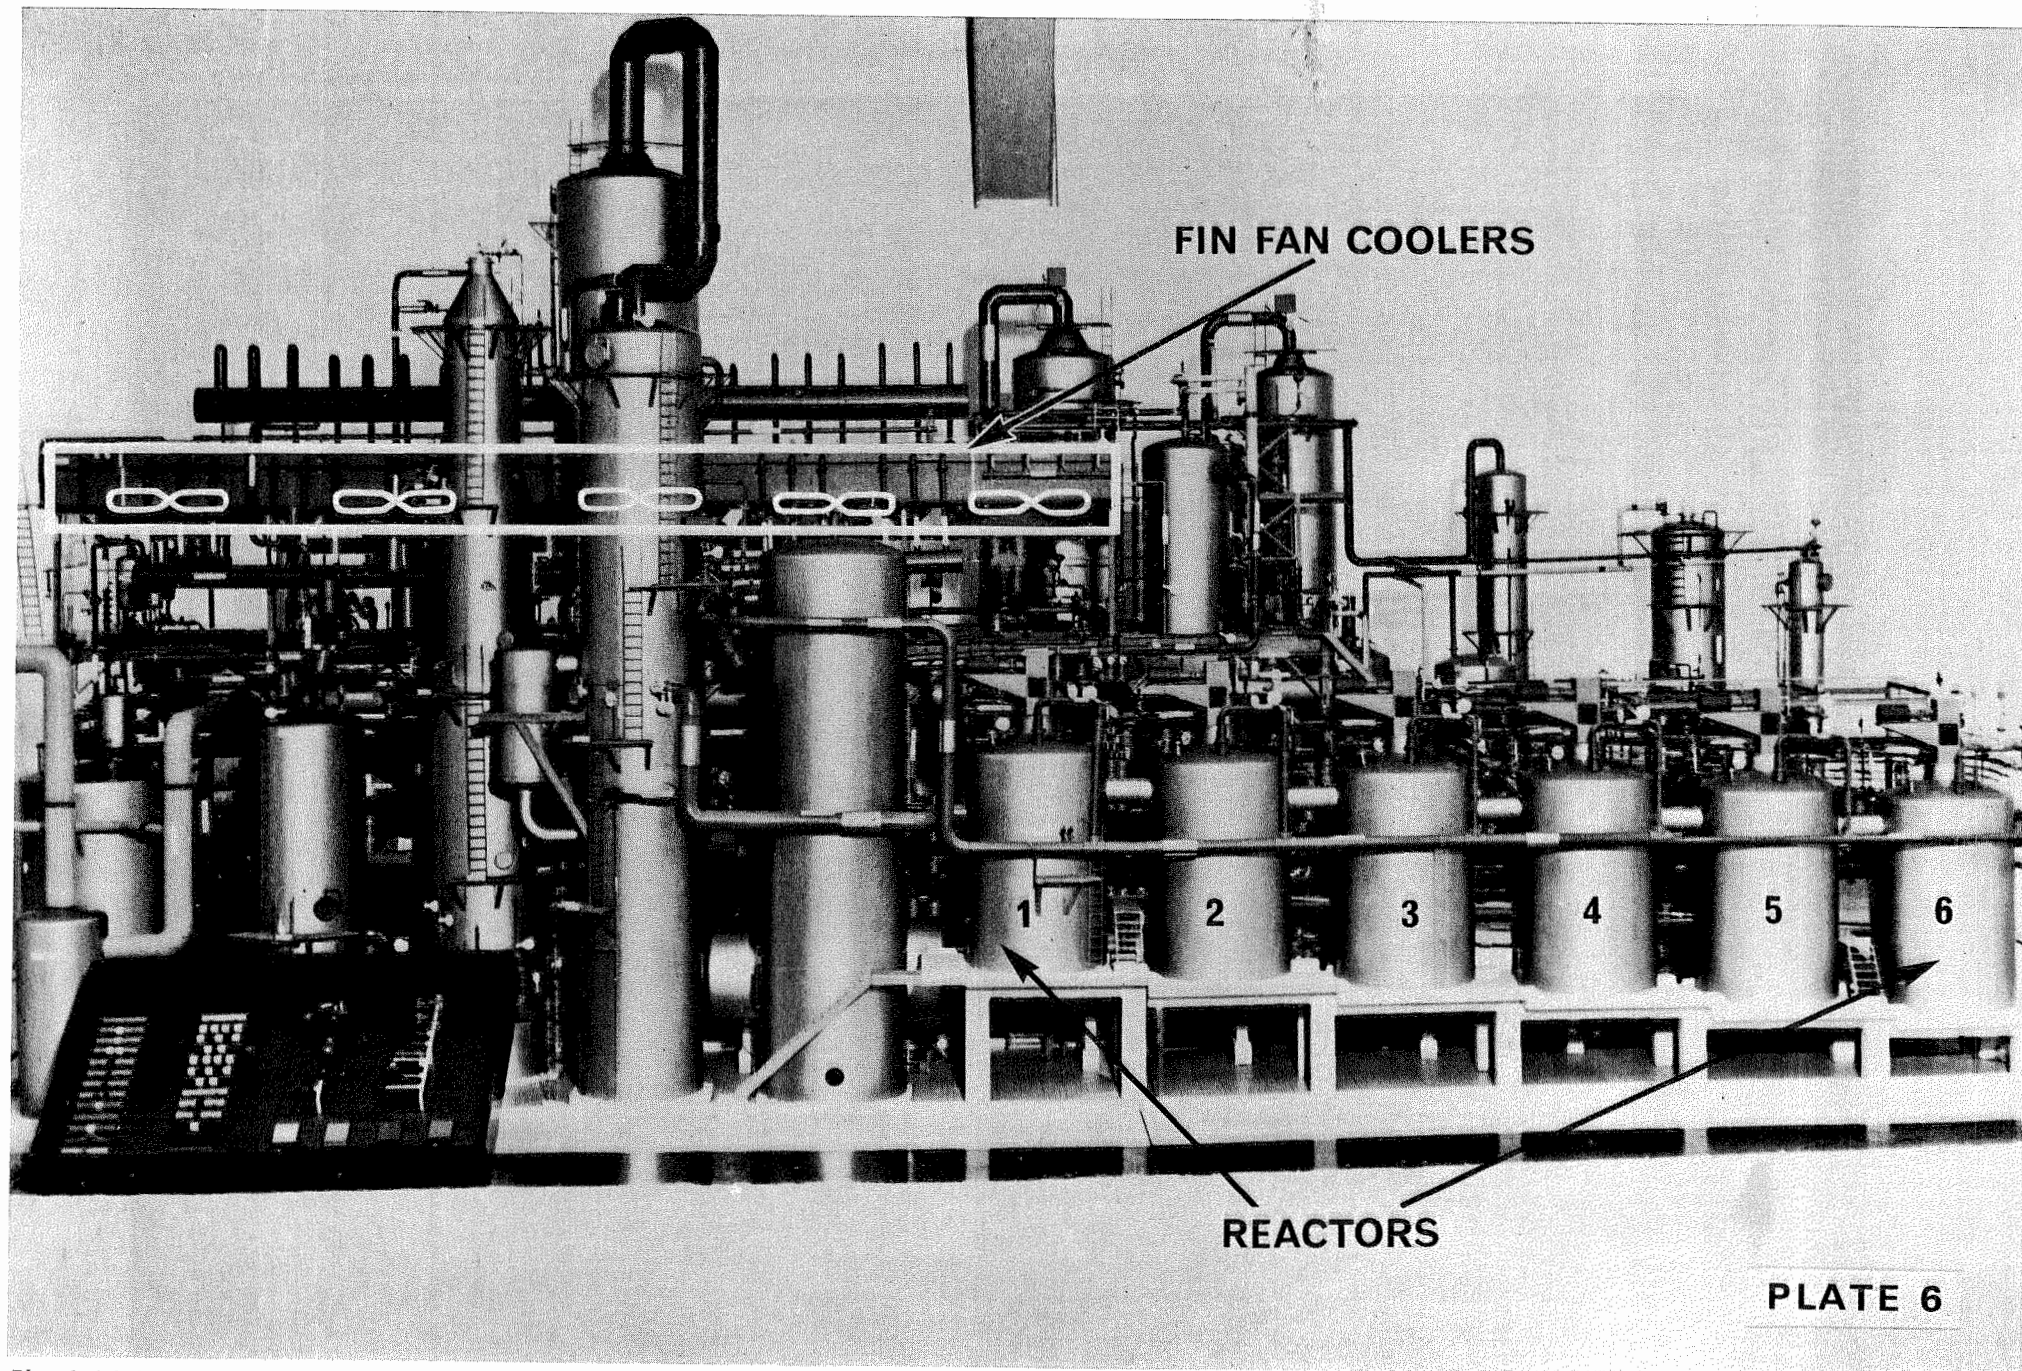
Plate 6 Model of section 25A kept in the control room and destroyed in the explosion.

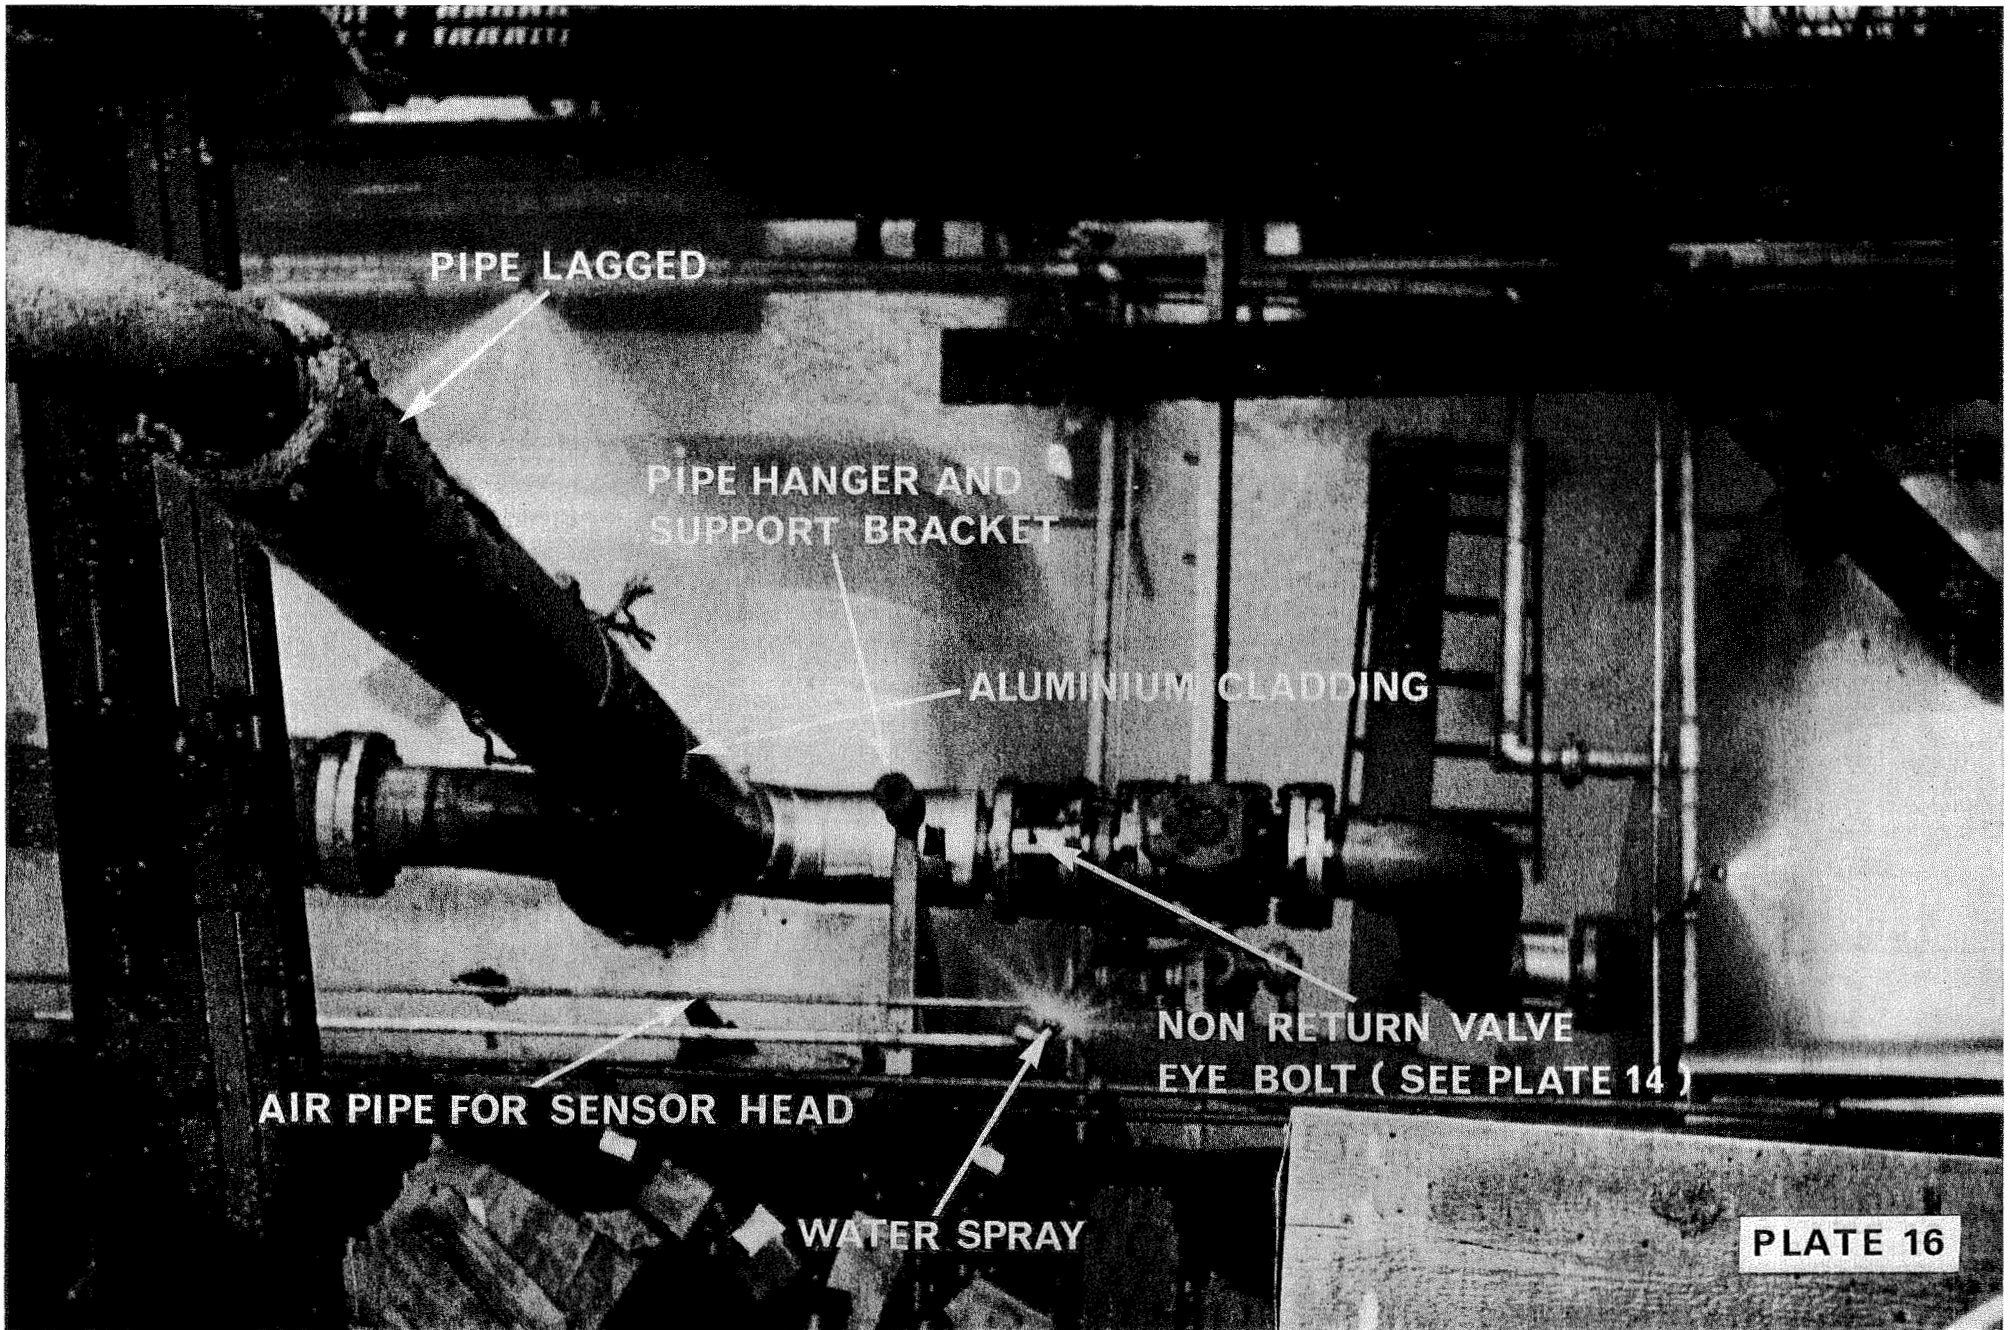
Plate 16 View of the 8 inch pipe while testing of water spray system during plant acceptance tests. (Pipe partly lagged.)

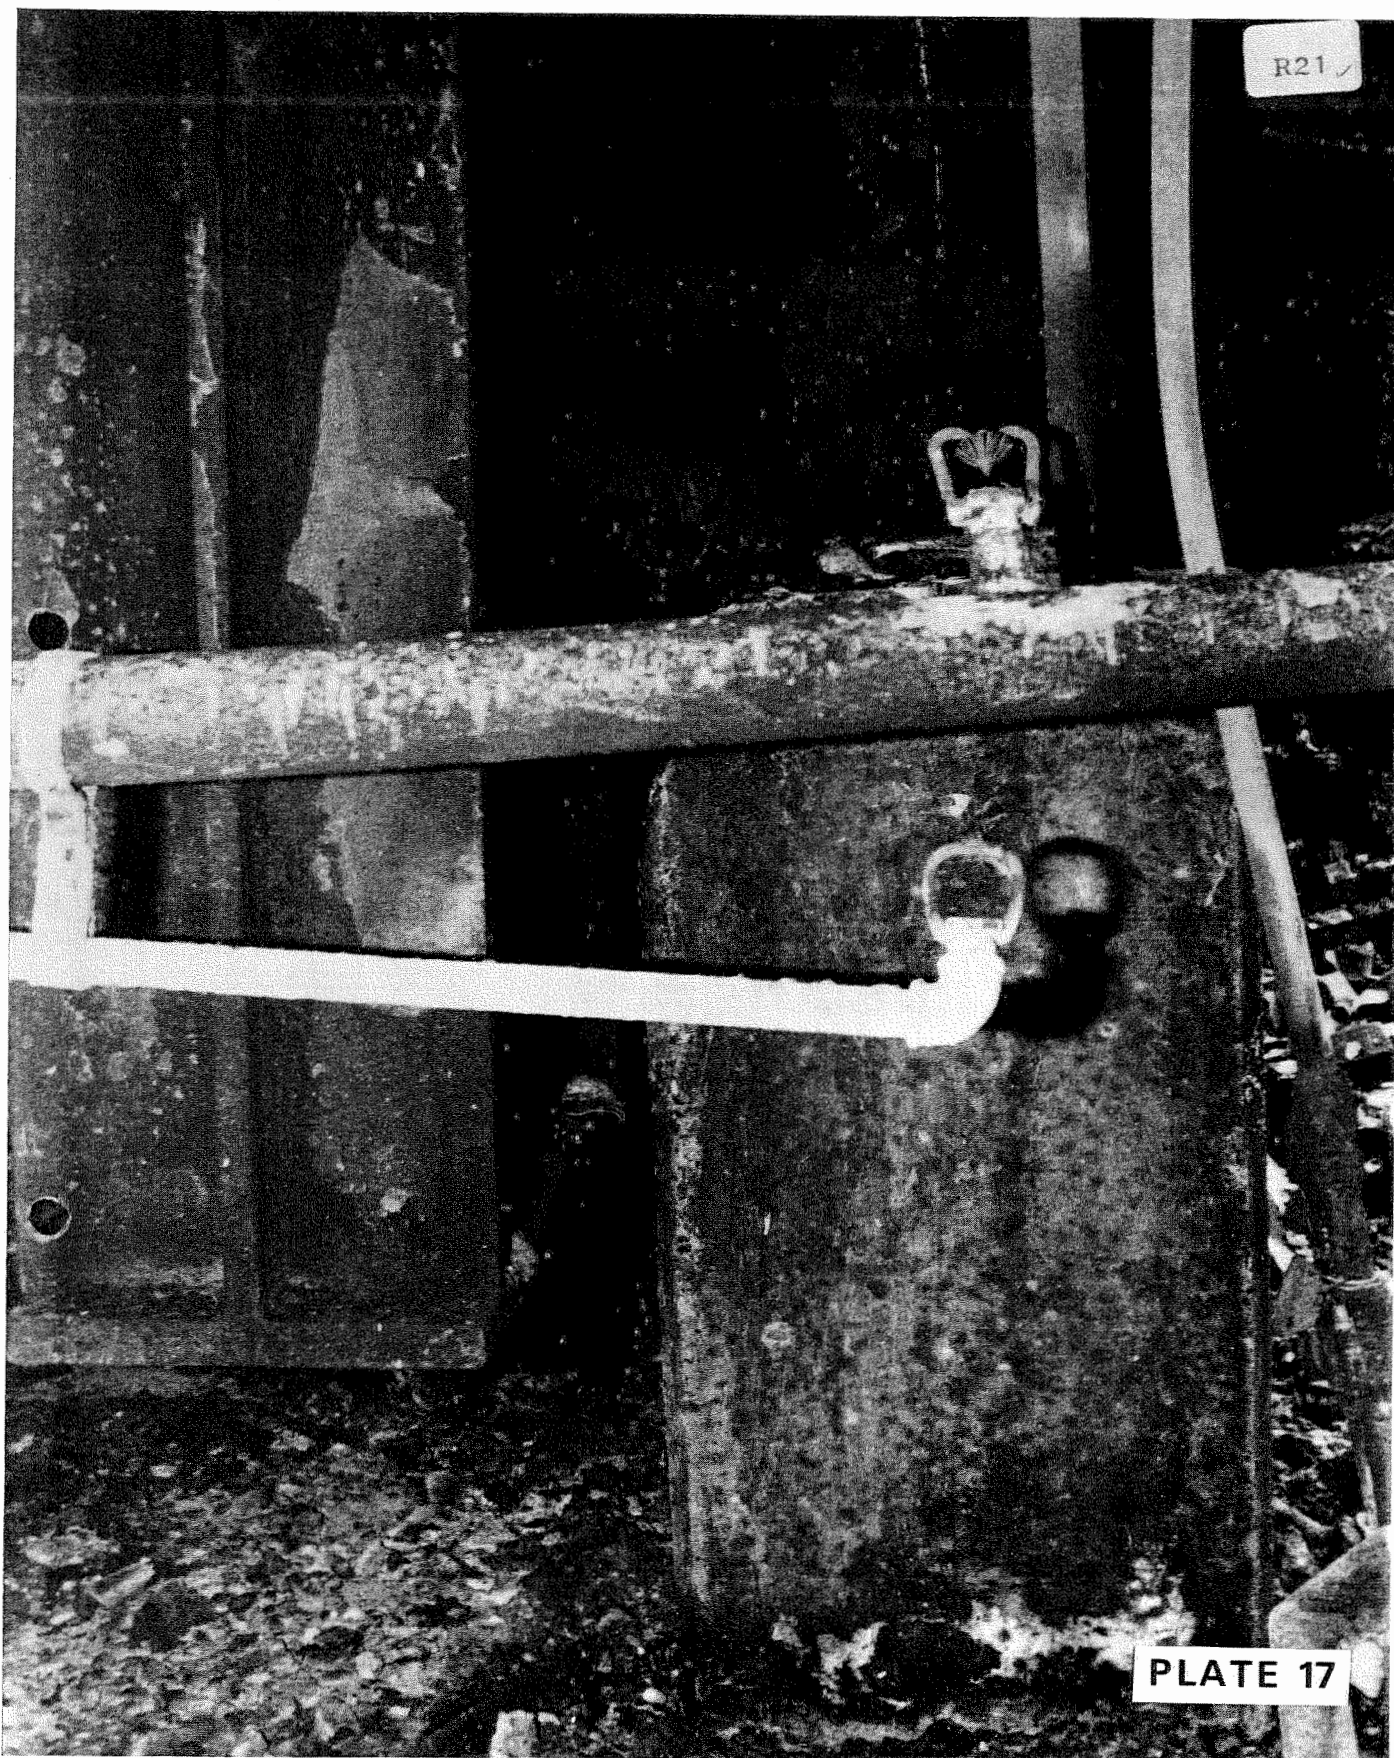
Plate 17 Typical water spray nozzle with air-operated sensor below. Photograph taken after the explosion.

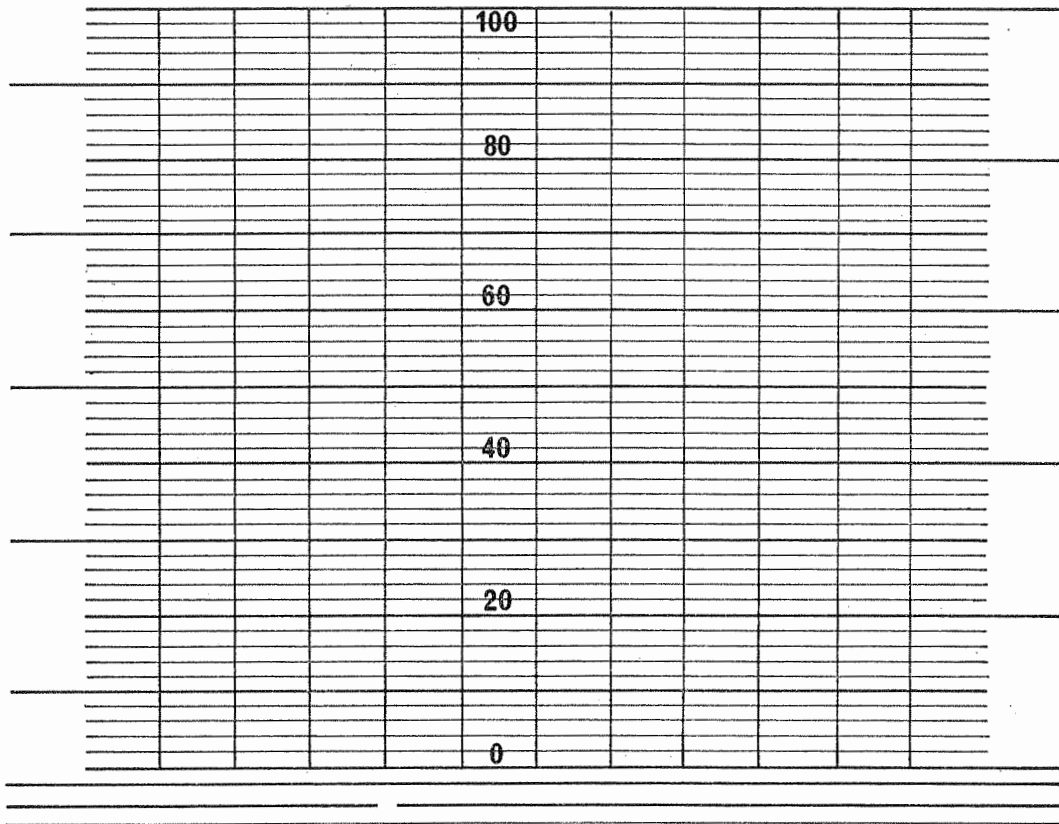
Fig. 5

- (a) The pressure is recorded on the chart by a red ink pen.
- (b) On the right hand side of the instrument there was a red mark to indicate 8.5 kg/cm^2
- (c) On the left hand side of the instrument there was a variable red set point indicator.

**SECTION 25A –
CHART USED FOR RECORDING OXIDATION SYSTEM PRESSURE**

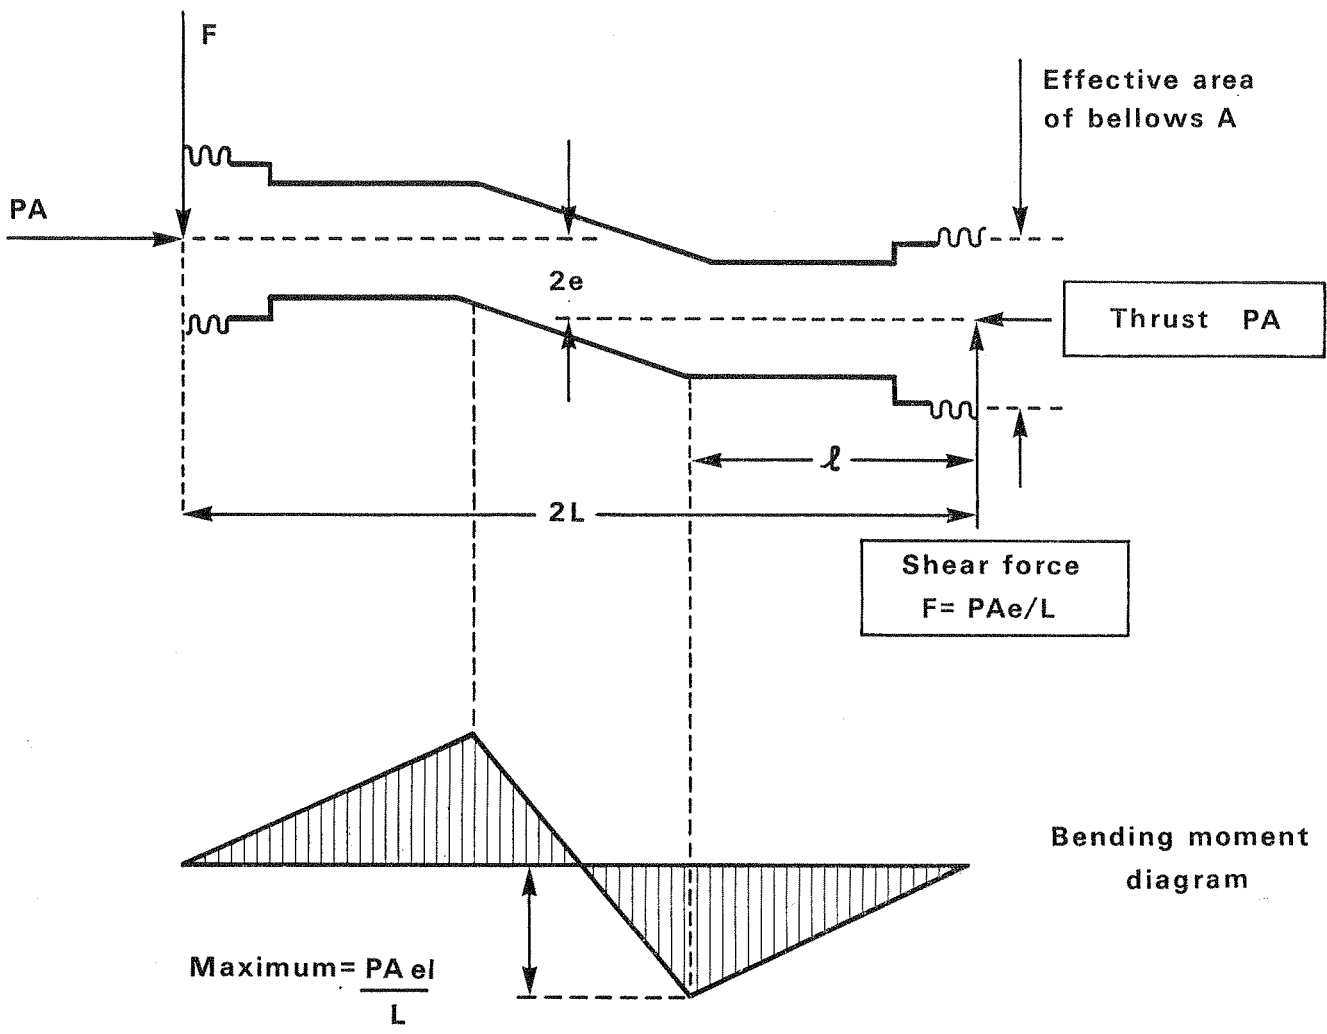
Fig. 6

16 Calculations by Professor S S Gill and Dr R Kitching of University of Manchester Institute of Science and Technology, Mr G A Evans of HMFI and others predicted very high stresses near the mitres of the 20 inch pipe, on account of the bending moments indicated in Figure 6, and because of the axial stress in the pipe due to the reduction in diameter from the 28 inch bellows to the 20 inch pipe. These calculations were supported by the observations of appreciable pipe distortion in the SMRE tests. However, there was no way of predicting the buckling load of the pipe and tests were therefore arranged at Mining Research and Development Establishment, Bretby. Plate 13 shows the pipe at the end of the test. A further reason for the test was the possibility of progressive deterioration of the pipe under a few cycles of loading for which there was some evidence from the SMRE tests.

(ii) The increase of bellows volume, due to squirm, results in the vapour within the reactors doing work on the bellows. This mechanical work appears as kinetic energy of the pipe which therefore swings round clockwise (as seen in Fig. 6) with an increasing velocity as the bellows squirm.

SKETCH OF PIPE AND BELLOWS ASSEMBLY SHOWING SHEAR FORCES ON BELLOWS AND BENDING MOMENTS IN PIPE (DUE TO INTERNAL PRESSURE ONLY)

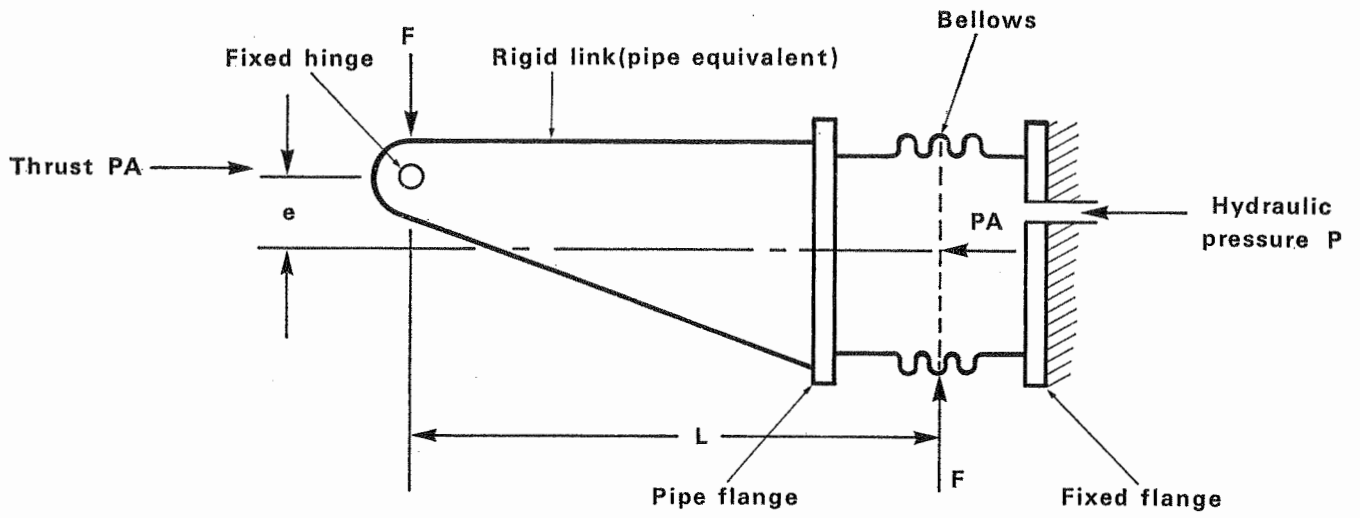
Fig. 7

(iii) With bellows pressurised, a downward shear force was applied by a jack pushing on the pipe flange, Figure 7. This produced an effective force at the bellows of 37 tonnes without tearing the bellows, thus demonstrating that a squirmed bellows is very resistant to failure in shear.

PRINCIPLE OF NOTTINGHAM TEST RIG

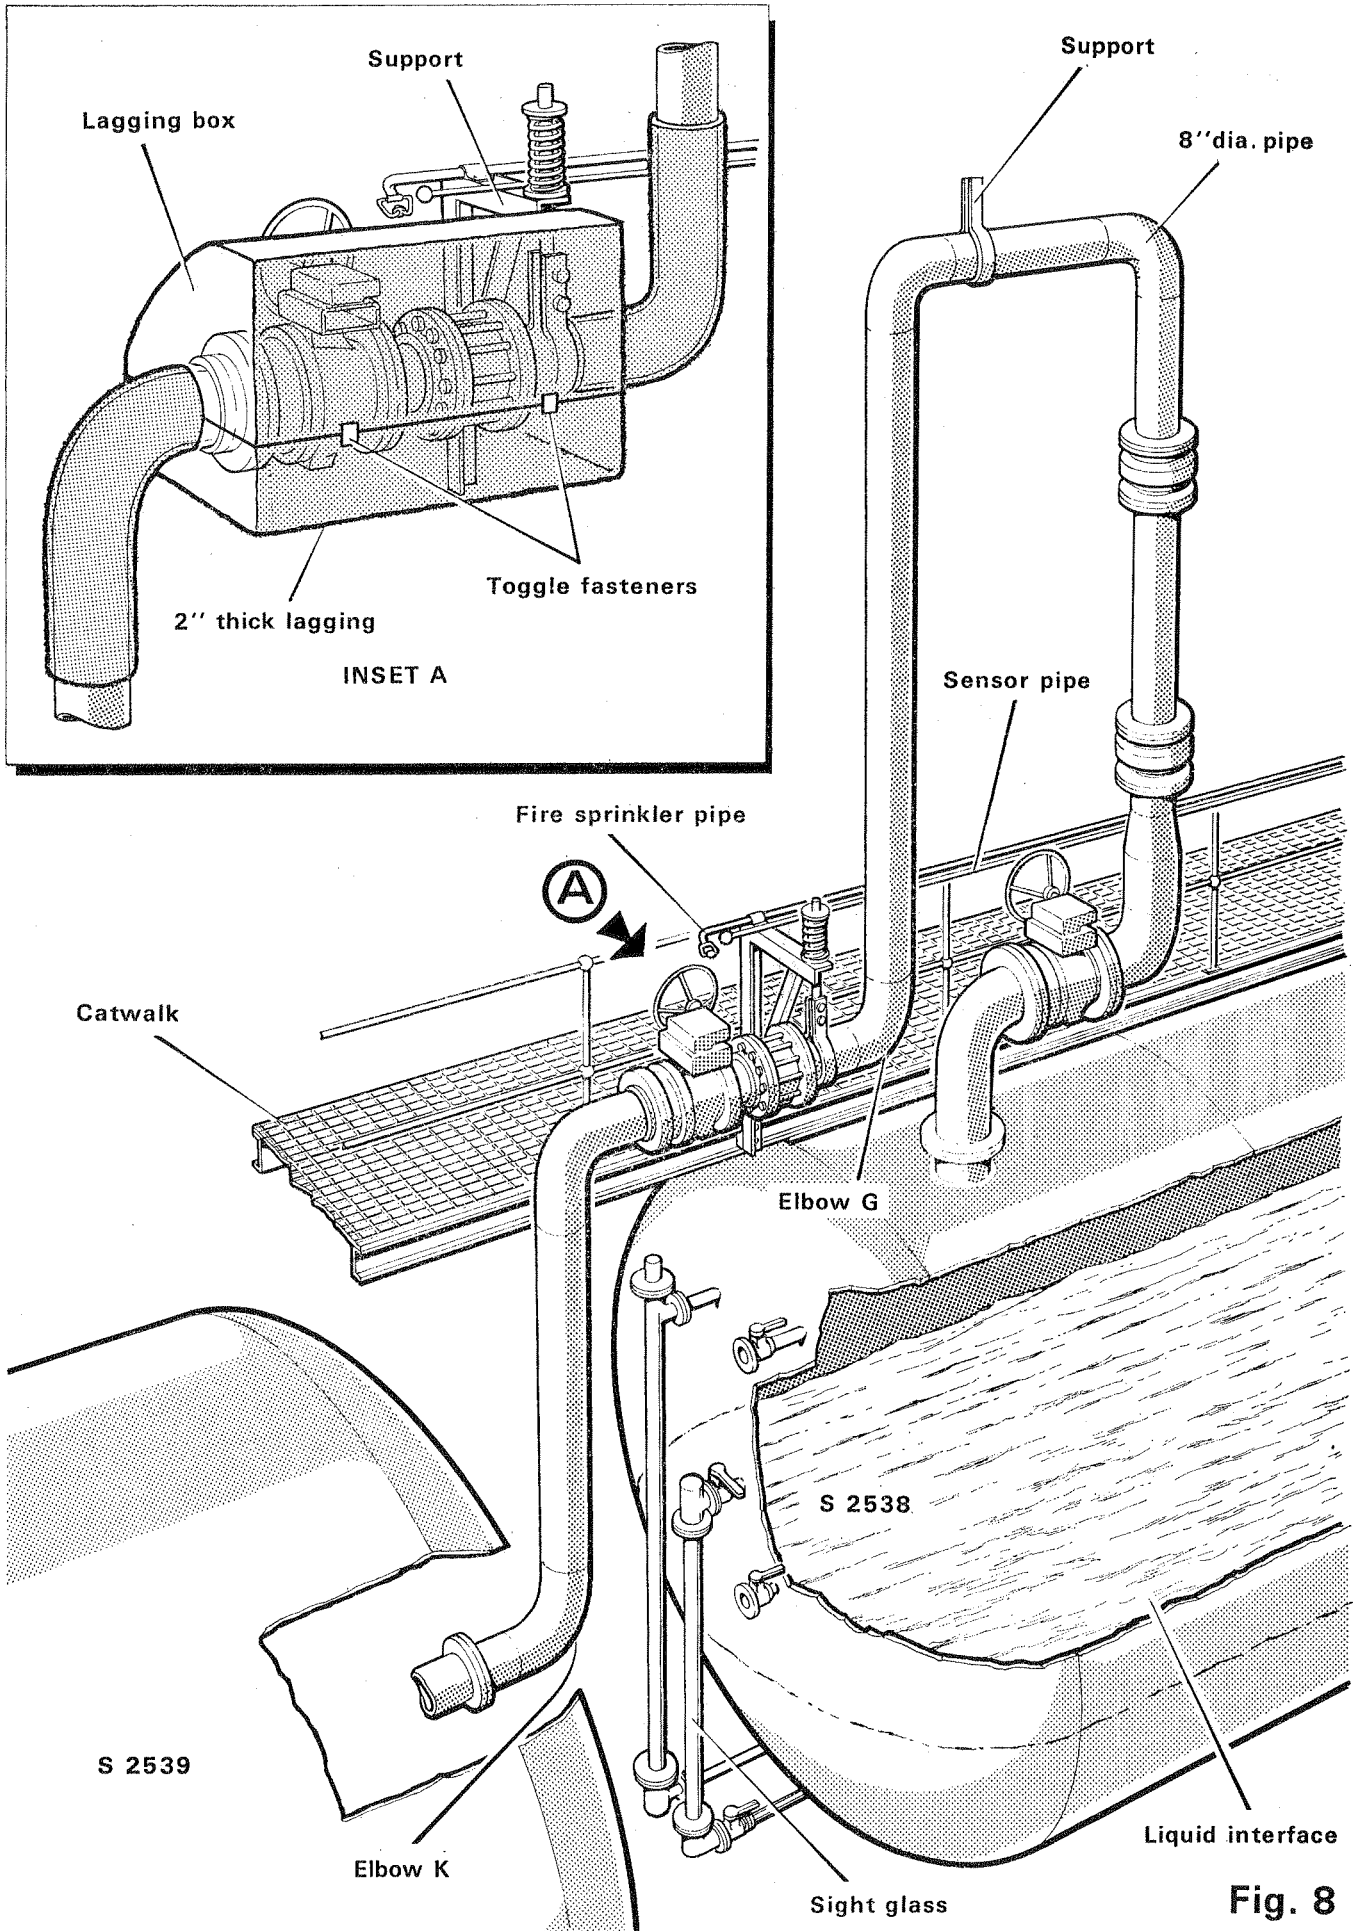
Fig. 8

2 We describe damage to the 8 inch pipe ("the pipe") connecting vessels S2538 and S2539 (Fig. 8) and related equipment. We also describe metallurgical investigations whose objective was to explain the observed damage.

SKETCH OF 8-INCH LINE AS VIEWED FROM THE NORTH WEST.
