The Flixborough disaster

Report of the Court of Inquiry

**Formal Investigation into Accident on 1st June
1974 at the Nypro Factory at Flixborough**

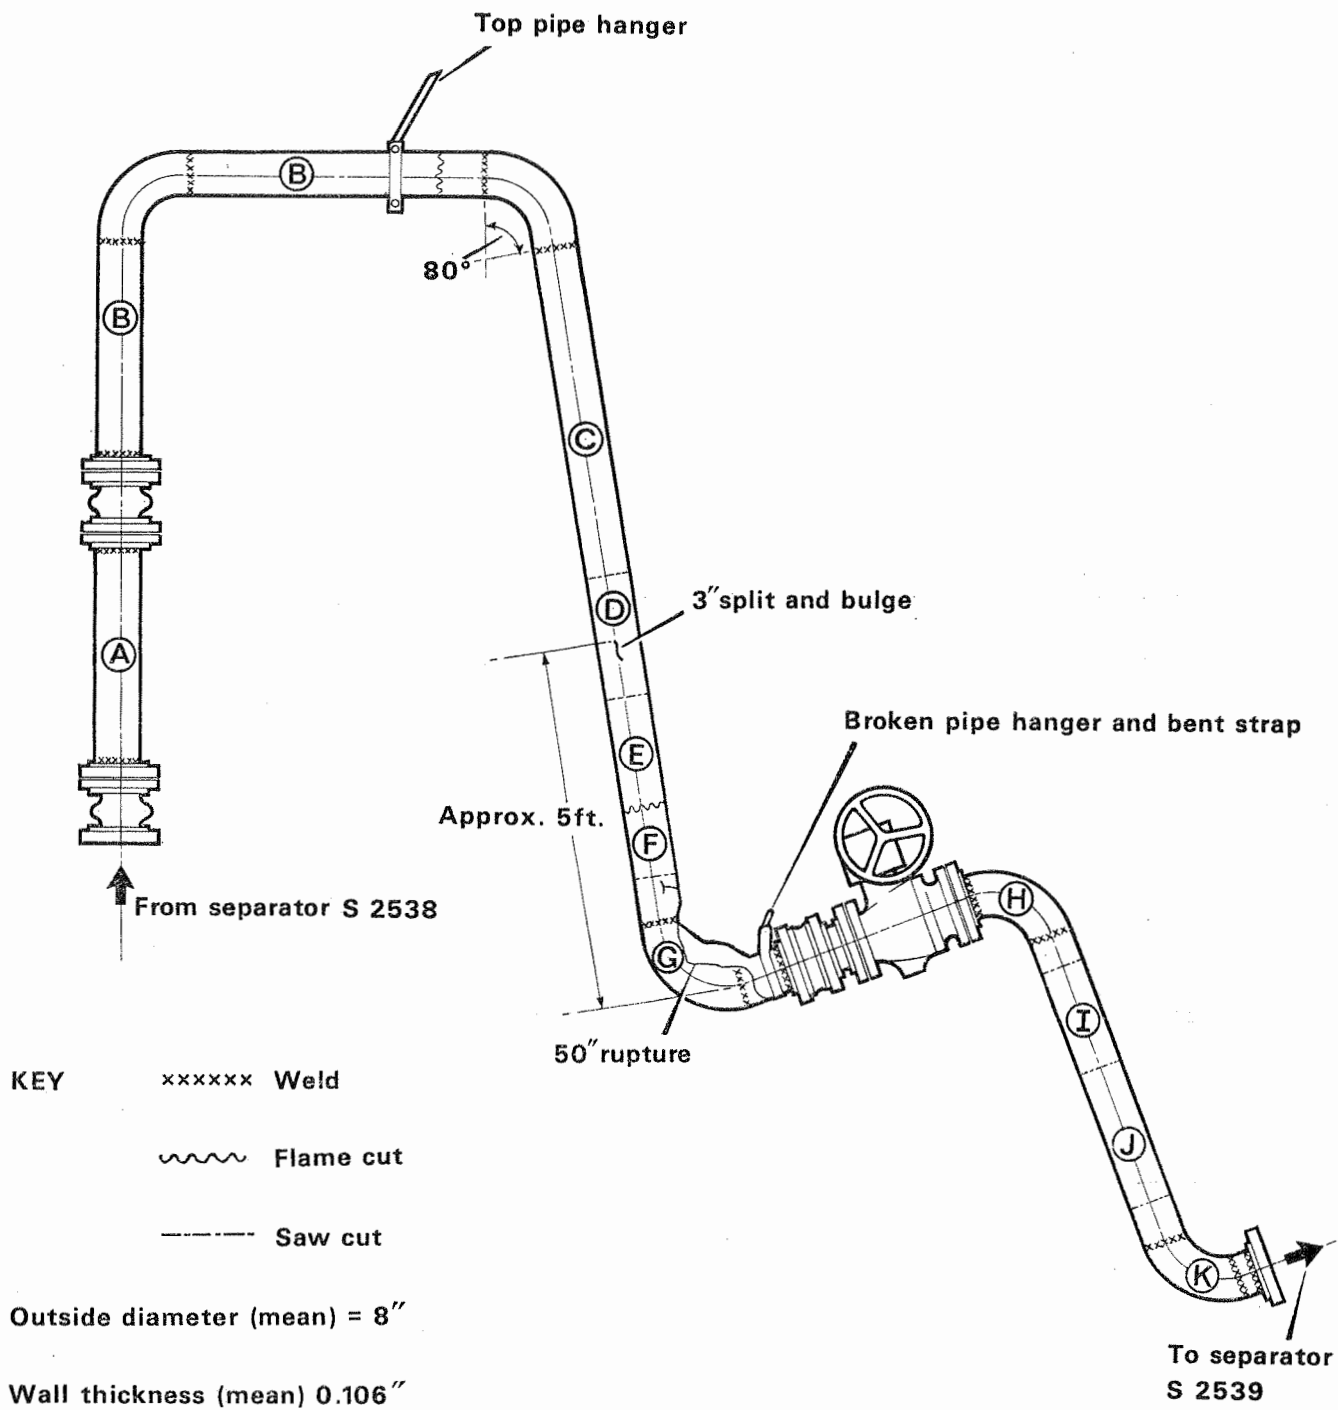
Fig. 10

4 There was a 3 inch axial split in the position D indicated in Figure 10. Around this split, the pipe wall had bulged out locally, opening up the split to a width of about 0.2 inch.

THE DAMAGED 8" PIPE
