Creeping Change: Liquid Accumulation in a Flare System at a Gas Terminal

Roger Berriman, Senior Process Safety Engineer, CSL, Woodland House, Woodland Park, Hessle, HU13 0FA, UK

Keywords: Flare, Condensate, Management of Change, Pre-startup safety review.

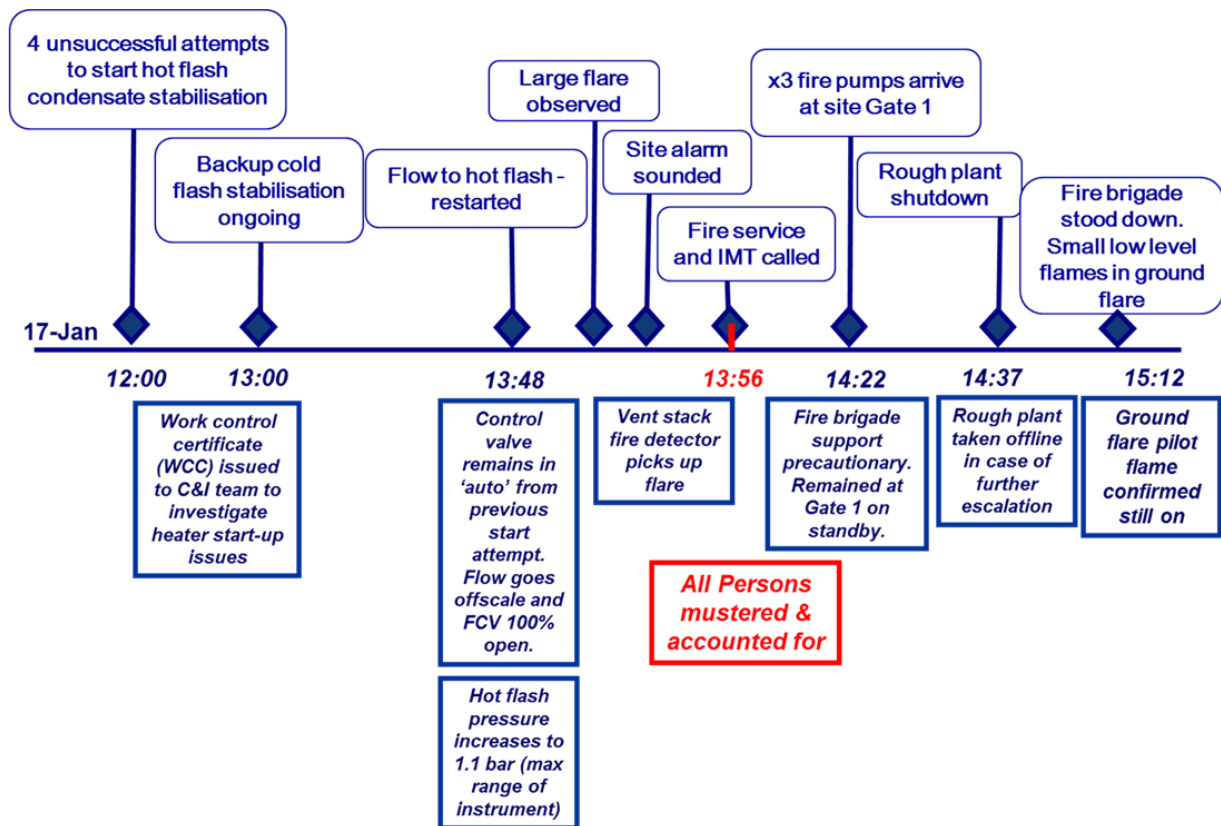
The timeline below was created from the distributed control system (DCS) trends, emergency response boards and witness statements taken as part of the event investigation.

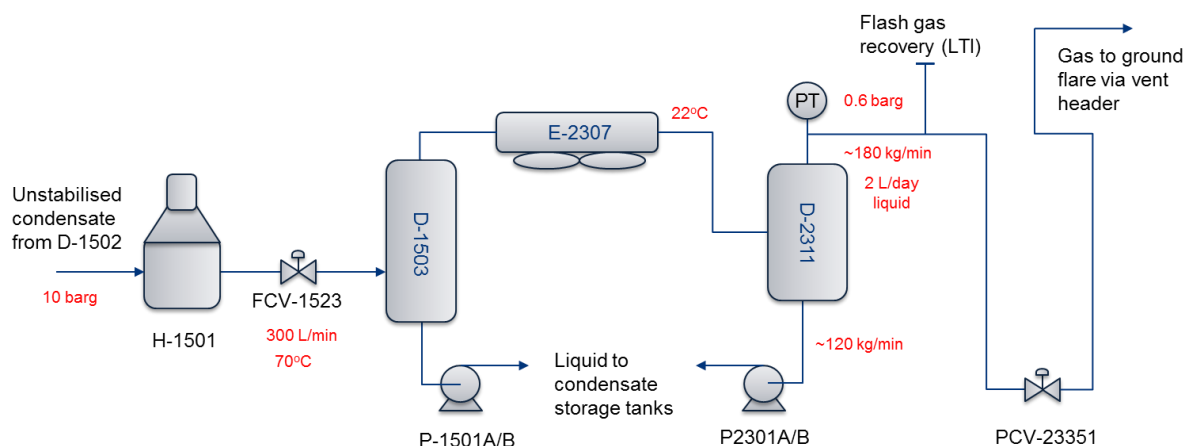
Figure 4: Simplified flow diagram for the 'hot flash' condensate stabilisation system.

The design intent of the 'hot flash' system is to heat unstabilised liquid condensate (hydrocarbon liquid with similar properties to gasoline) and liberate light end hydrocarbon gases as the pressure is reduced in flash drums. An air cooled dual fin fan heat exchanger (E-2307) partially condenses hydrocarbon vapours before the collected stabilised condensate (now with a reduced vapour pressure) is pumped to site bulk storage tanks. An overview of the hot flash system is shown in Figure 4. A small back pressure of 0.5 Barg (7 Psig) is maintained in the system by a pressure control valve (PCV-23351) with any excess of pressure relieved to the ground flare for safe gas disposal.

The hot flash system uses a dual fin fan cooler to condense vapour into a knock out drum (D-2311). One of the condensing fans on the hot flash system (E-2307/2) was found to be electrically isolated on investigation after the event. The fan motor had been isolated for maintenance activity within a shutdown that had finished three months prior to the event. Isolation of a single fan on the hot flash cooler reduced the effectiveness of E-2307 to cool and condense vapours into the collection knock out drum. During plant re-instatement activities following the shutdown, the isolation for the condensing fan motor had been marked as complete (i.e. removed) on the electronic control of work system whilst the field isolation lock remained in place. The action to check the fans were available was later included in the unit pre-start up safety review document (PSSR).

The hot flash condensate stabilisation system is currently operated in batch mode to process liquids produced from the gas production plant. The fin fan cooler (E-2307) used in the hot flash process was originally installed in 1983 as a pre-cooler for a flash gas compression recovery system. E-2307 was designed as a continuous partial condenser where any vapour condensing out en-route to the flash gas recovery system would separate out in the condenser knock out drum (D-2311). The flash gas compressor system has since been isolated and air gapped from the hot flash system (see Figure 4). The current operation of the system still uses the flash gas knock out drum (D-2311) but the vapours are now sent to ground flare when the system pressure rises and back pressure controller PCV-23351 opens. The change to operate the process under batch conditions and to remove the route to flash gas recovery did not account for E-2307 being a partial condenser which has resulted in vapour from the hot flash system condensing in the pipework downstream of the knock out drum i.e. in the vent header to ground flare.

The vent header to ground flare from the hot flash system is approximately 100 metres long in the approach to main process units and is unlagged 16" pipework which will act as a long heat sink causing vapours within the gas stream to condense out. The vent header was originally a 1983 first gas production pipeline from site and was converted to its current duty as part of a site enhancement project in 1995. The 'fall' of the converted vent header was therefore in the direction of the original gas flow, the change of duty of the line in 1995 therefore caused the vent line to fall back to the now installed hot flash stabilisation plant and not in the new direction of gas flow. Following the large flare event described, approximately 3.9m³ of liquid condensate was later drained from the header pipework downstream of the hot flash system (after PCV-23351).

- High pressure rise in the hot flash system. Ineffective pressure control by back pressure controller (PCV-23351) resulted in pressure spikes.
- Unreliability of the hot flash heater (H-1501). Failure to start (x4 times on day of event, x14 times on 16th January 2018) which led to further demand on control room operator (CRO).
