Incident

Lessons from Longford – 20 years on

Bob Weiss, Functional Safety Consultant, Australia

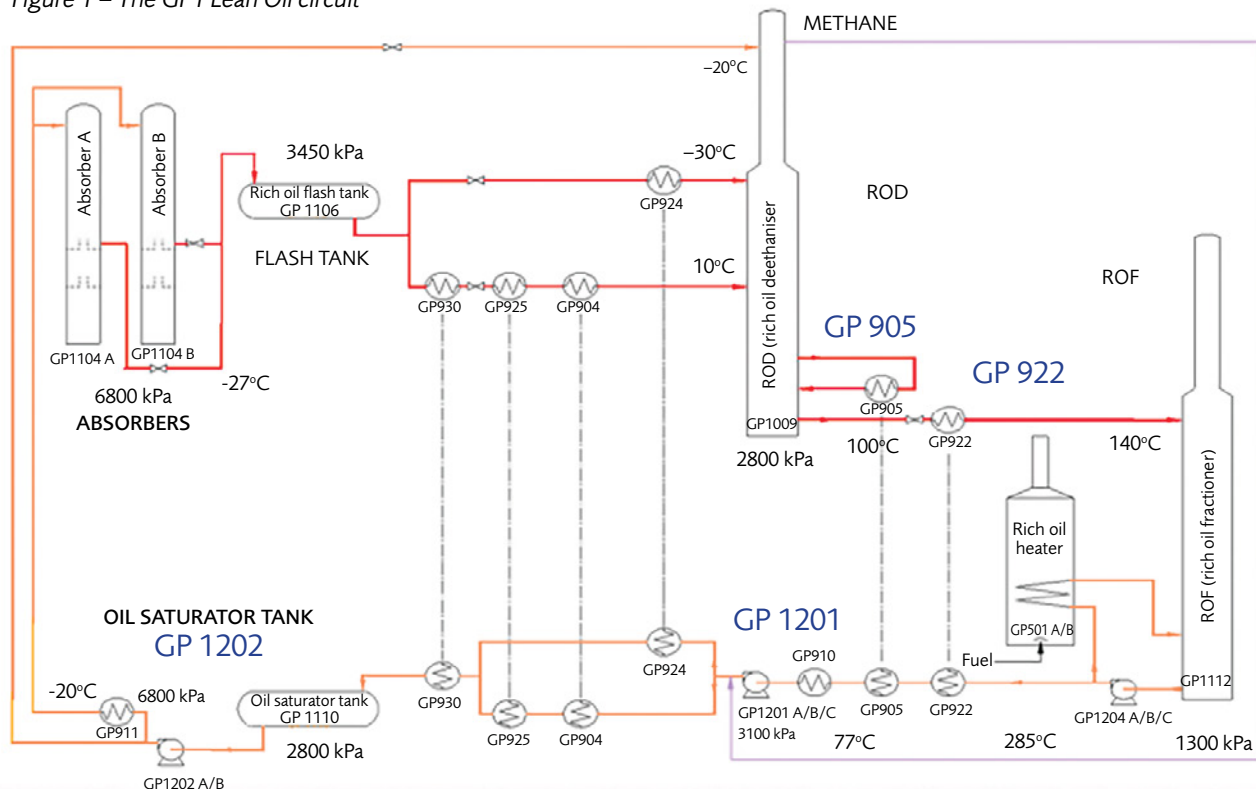
Figure 1 – The GP1 Lean Oil circuit

GP1 was a lean oil absorption plant (see Figure 1). Inlet gas from the slugcatchers, having had CO₂ and other impurities removed, was cooled to -25 °C and fed to the bottom of the two absorbers. A light oil, similar to aviation kerosene, absorbed most of the ethane and heavier hydrocarbons with the residue gas from the top of the absorbers being fed to the sales gas pipeline.

After being heated further by GP922, the rich oil was fed to the Rich Oil Fractionator (ROF). This distillation column recovered propane and heavier hydrocarbons, in the process regenerating the lean oil for recycle. The ROF reboiler, a gas-fired heater, heated the lean oil to about 285 °C. The hot lean oil was then pumped back to the absorbers through a series of heat exchangers by three sets of pumps (known as GP1204, GP1201, GP1202). At the discharge of GP1201, methane was injected to saturate the lean oil so as to minimise absorption of

methane from the sales gas. The heat exchangers progressively cooled the lean oil to 20°C by interchange with the colder rich oil. The cycle then repeated.
