Taming the Beast - Lessons Learned from 5 Decades of Aluminium Dust Explosions

This paper describes six aluminium dust explosion incidents which have occurred at AMG's site in Anglesey over the course of 5 decades. The incidents have revealed that the use of good explosion prevention and protection practices at the time was often insufficient and the use of measures over and above what would be expected is necessary. Owing to their very high reactivity and rapid flame propagation, protection from dust explosions with fine aluminium powder is often at the limit of what best available technology can deal with reliably. The site has found it is necessary to restrict access even to explosion protected plant as a result. The incident history has revealed gaps at each stage and enabled them to develop the explosion prevention and protection systems to the point where personnel now have a high level of protection. The paper also re-enforces the huge benefits gained from incident learning in advancing our process safety knowledge and the authors would like to thank AMG for being willing to share their experiences.

Incident 1 - Dust explosion in 1973

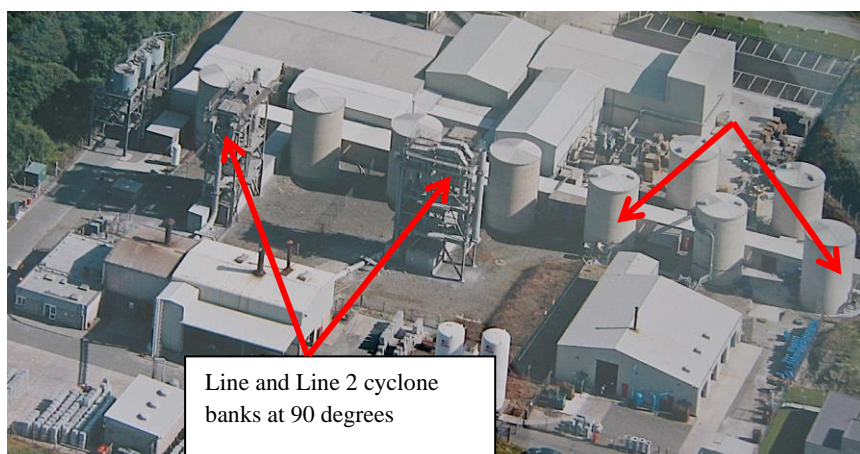
Screen and classifier towers (all cylindrical towers)

The classifiers were installed in identical rooms all of which could be accessed by a common corridor. The screen and classifier rooms were fitted with exchange key interlocks and the classifier rooms now have timed exchange key entry systems that prevent entry to the room until the classifier has stopped. The cylindrical screening and classifier towers are shown in Figure 3. The frequency of housekeeping was also increased and a centralised vacuum system installed to provide a better and safer way of cleaning. However, vacuuming aluminium powder is not without its process safety issues as the next incidents show.

Figure 3: Photo of site showing cyclone banks and screen / classifier towers

1. It was found that the close proximity and similar orientation of the two cyclone banks enhanced the level of damage. Therefore Line 1 and Line 2 cyclone structures were re-built at 90 degrees to each other and with a greater separation. This minimises domino effect potential, something which significantly impacted the level of damage in the 1983 explosion.
