Flixborough

50 YEARS ON

Lessons for Managers and Engineers Today

Robin Turney says the lessons learned from the disaster are still as relevant now as they were in 1974

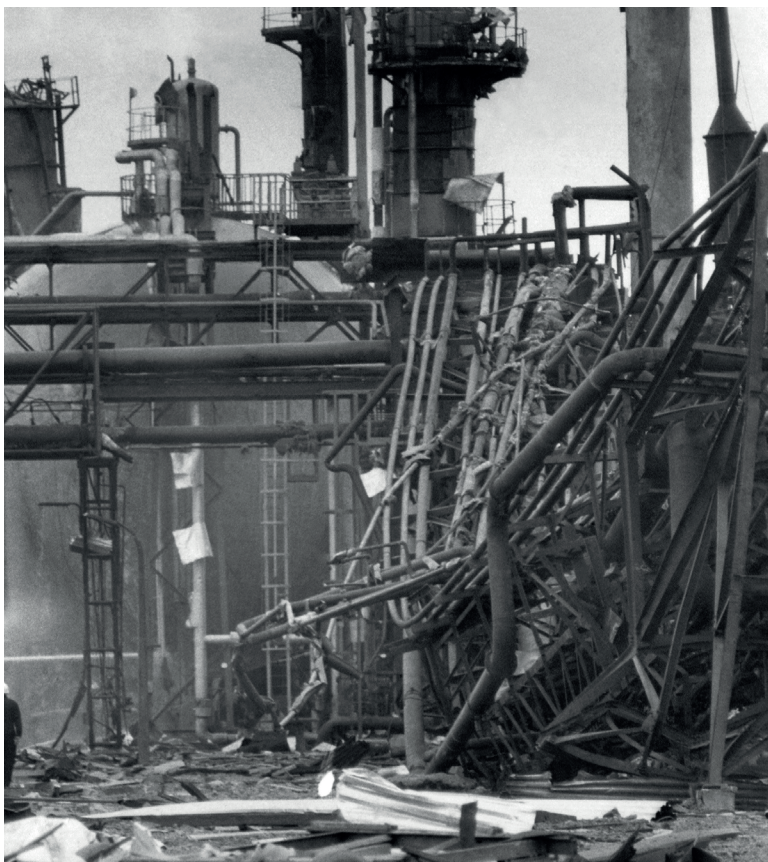
- At 16:35 the bellows and the connecting piece failed. This resulted in two 700 mm openings and the rapid release of 10–15 t of cyclohexane – 75°C degrees above its atmospheric boiling point – which vaporised immediately

temporary bypass. Calculations showed that, although the bypass could withstand normal operating conditions, it was highly likely that the bellows would “squirm” and fail at a pressure of 10.3–10.4 barg, below the relief valve setting of 11.0 barg. However, the plant had operated for almost two months without any obvious problems and a large part of the Inquiry was therefore devoted to examining alternative explanations. The Inquiry concluded that the most probable explanation was that “the disaster was caused by the introduction into a well-designed and constructed plant of a modification which destroyed its integrity”³
