EXPLOSION AT THE CONOCO HUMBER REFINERY – 16TH APRIL 2001

Jonathan Carter, Peter Dawson and Robert Nixon
Health and Safety Executive, Hazardous Installations Directorate

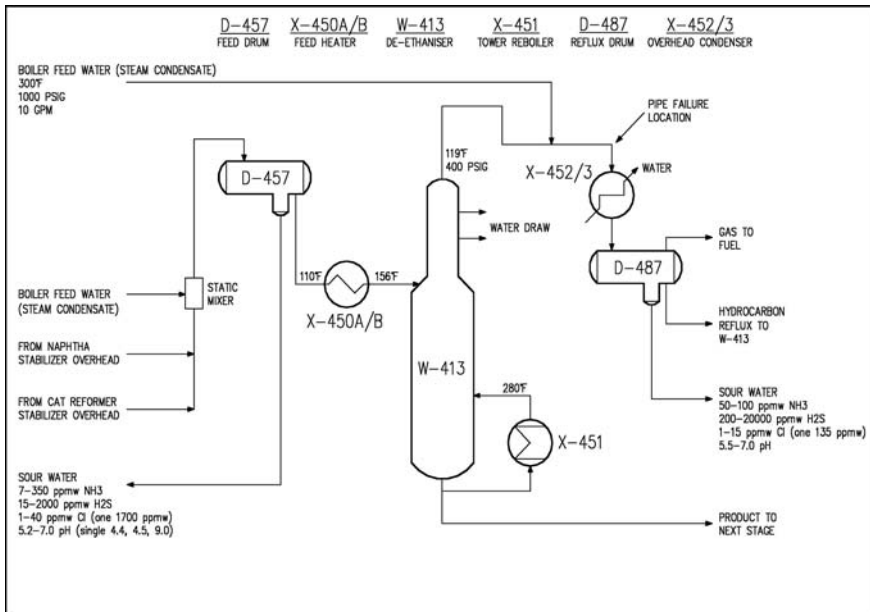
The SGP consisted of three distillation columns, W 413 (a de-ethaniser), W 414 (a stabiliser) and W 415 (a propane / butane splitter) (see Figure 1.) W 413 was fed from a feed drum (D457.) The overhead from W 413 passed through 6" pipe P 4363 to heat

Figure 1. Simplified process flow diagram – saturate gas plant de-ethaniser (w-413) (prior to 16th April 2001)
