HYDROGEN FABRICATION CRACKING: HSE's INDUSTRIAL EXPERIENCE, AND RESEARCH INTO DEFECT DETECTION WITH A NUMBER OF NDT TECHNIQUES

Harry Bainbridge¹ and Bernard McGrath²

¹HM Principal Specialist Inspector, Health and Safety Executive

²Inspection Validation Centre, Serco Assurance

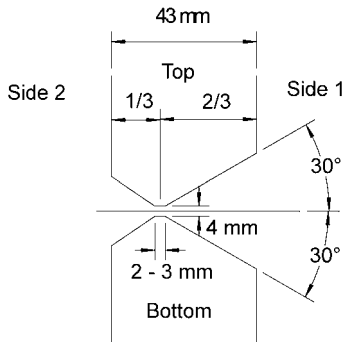
Figure 5. Geometry of the weld profile used in test samples

The weld profile was as shown in Figure 5. The welding procedure was the same as that used for the manufacture of LPG spheres with a modification to allow the insertion of weld beads from wet electrodes. Before laying down a wet bead, the weld was cooled back to ambient temperature, 10°C. Each sample contained 150 mm of weld. Two forms of restraint were used. In Sets 1 and 2 the weld was laid down in a letterbox slit as used in a modified Lehigh Restraint Test [5]. Initial tests with a large number of wet weld beads gave extensive cracking in the weld. The cracking was similar in appearance to solidification type cracking, and did not replicate the cracks found in the spheres. In Sets 3 and 4 two separate pieces of parent material were welded as a butt weld using strongbacks as restraint. The reduction in restraint, together with a reduced number of wet weld beads gave cracks identical to those found in the spheres. Two samples had only two wet weld beads, but this was sufficient to generate the HFC. The details of the different samples are given in Table 4.
