NON-DESTRUCTIVE TESTING – LEARNING FROM THE PAST, MAXIMISING FUTURE BENEFITS.

Harry Bainbridge, Health & Safety Executive, Bootle

Bernard McGrath, AEA Technology plc, Risley

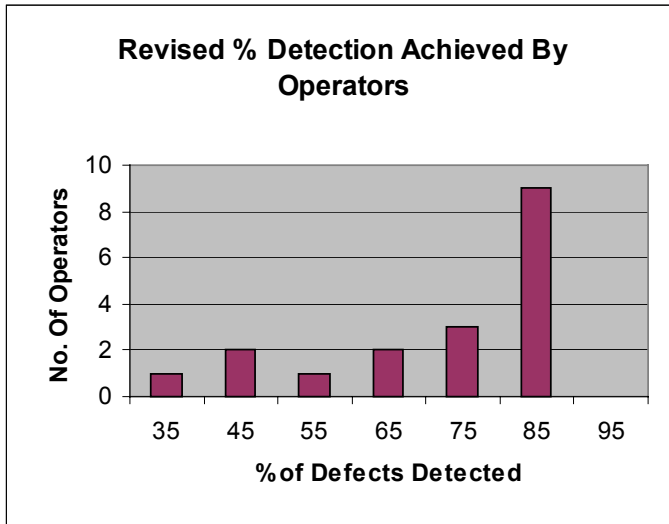
Figure 1 Operator Performance In Detecting Reduced Population of Defects With Ultrasonics In Manufactured Test Pieces

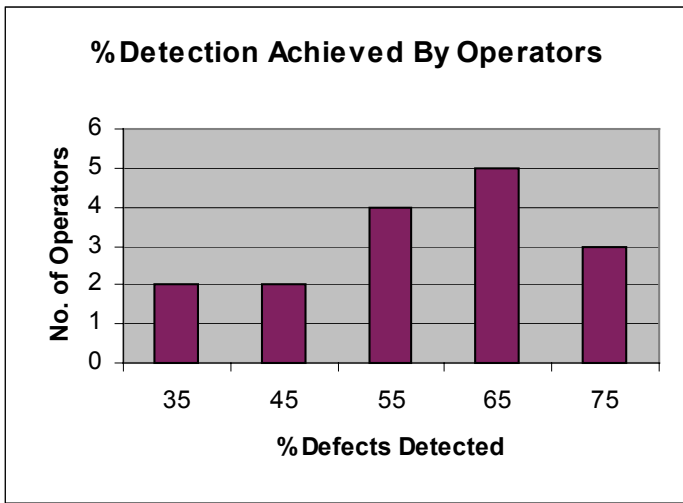
Figure 3 Operator Performance In Detecting All Defects With Ultrasonics In Manufactured Test Pieces

Looking at the total defect population of 20 defects, detectable by ultrasonics and not MPI, gives the ultrasonic operator detection rates listed in Table 4 and illustrated in Figure 3. The diagram gives data from 16 operators who were able to inspect most of the test pieces. One of the 16 did not inspect one test piece and his score is adjusted accordingly to give a percentage of the possible defects that he could have detected. The highest detection rate of 70% was achieved by three operators: this equates to the detection of 14 of the possible total of 20 defects. Conversely, the low detection rates of 30% and 35% equate to the detection of 6 and 7 of the 20 defects respectively.

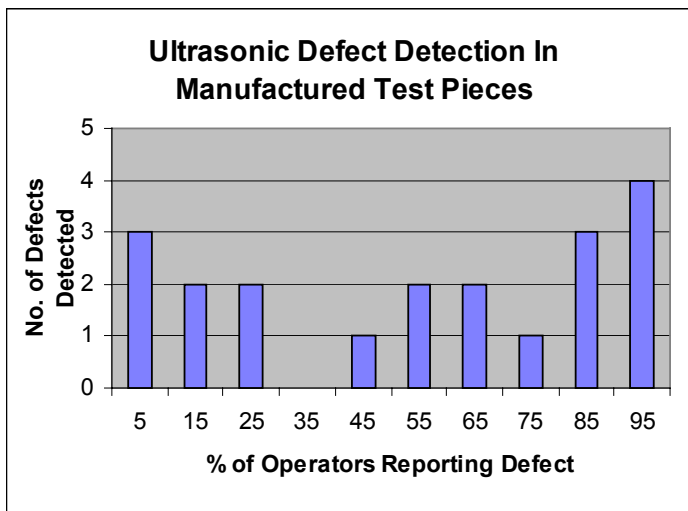
Figure 4 Detectability of All Individual Defects In Manufactured Test Pieces

The detectability of individual defects in the 20 defect population is illustrated in Figure 4. Two defects were detected by all operators whilst at the other end of the scale three defects were only detected by single operators. False calls were few and appeared random.

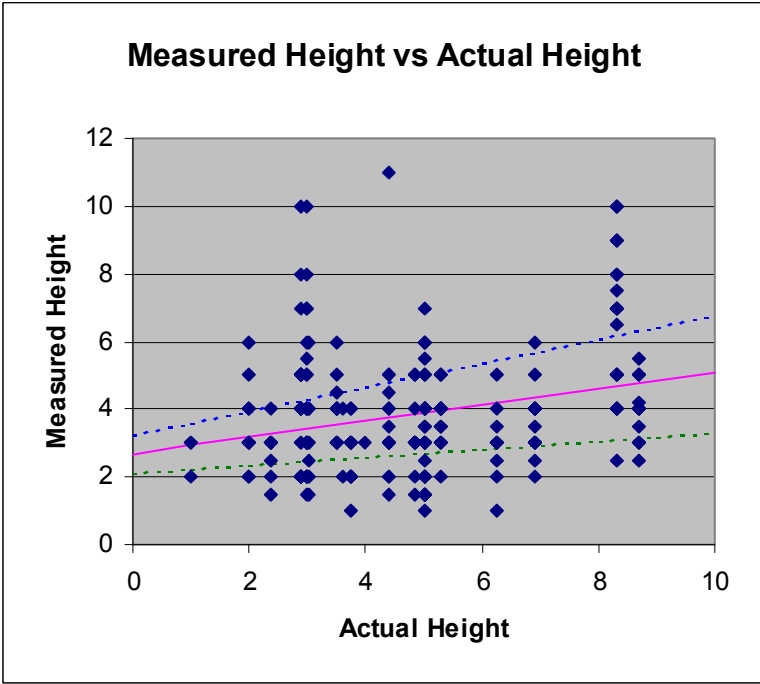
Figure 5 Plot of Measured Defect Height Against Actual Defect Height For The Manufactured Test Pieces

Apart from the occasional measurement, the positioning of the defects and the length and height measurements show a spread typical of most studies using a variety of operators. A plot of measured height against actual defect height is shown in Figure 5. Note that a number of points on the plot are positioned on top of each other. The solid line is the best fit line obtained through regression analysis. This has a slope of 0.24 and an intercept of 2.7. The dashed lines above and below show the 95% limits. The ideal line would have a slope of 1 and an intercept of 0.

Figure 5, the plot of measured defect height against actual defect height shows what other studies have shown, in that small defects are oversized and larger defects are undersized. However, the slope of 0.24 is far removed from the ideal of 1 and compares poorly to data obtained during the Sizewell B validation process which gave best fit lines of slope 0.85 for operators who achieved certification and of slope 0.42 for all operators. The Sizewell B data was obtained on thicker section material and with larger defects. It is likely that the PANI results were skewed by the geometric echoes interfering with the sizing process and the bias towards smaller defects.
