RECENT RAILWAY INDUSTRY ACCIDENTS : LEARNING POINTS FOR THE PROCESS INDUSTRIES

Christopher J. Beale, Ciba Specialty Chemicals, PO Box 38, Bradford, West Yorkshire. BD12 0JZ. UK.

Following a number of high profile accidents in the railway industry in recent years, there has been a large amount of public debate about rail safety. The lessons learnt from these accidents have raised issues which are applicable to the process industries, particularly regarding safety management, human factors, management of contractors and organisational structures. These issues contribute significantly to many process industry accidents. This paper reviews the press reports and published accident reports for some recent high profile accidents including the Channel Tunnel fire, the Kaprun fire, Southall, Paddington, Hatfield and Selby and identifies learning points which are relevant for preventing accidents in the process industry.

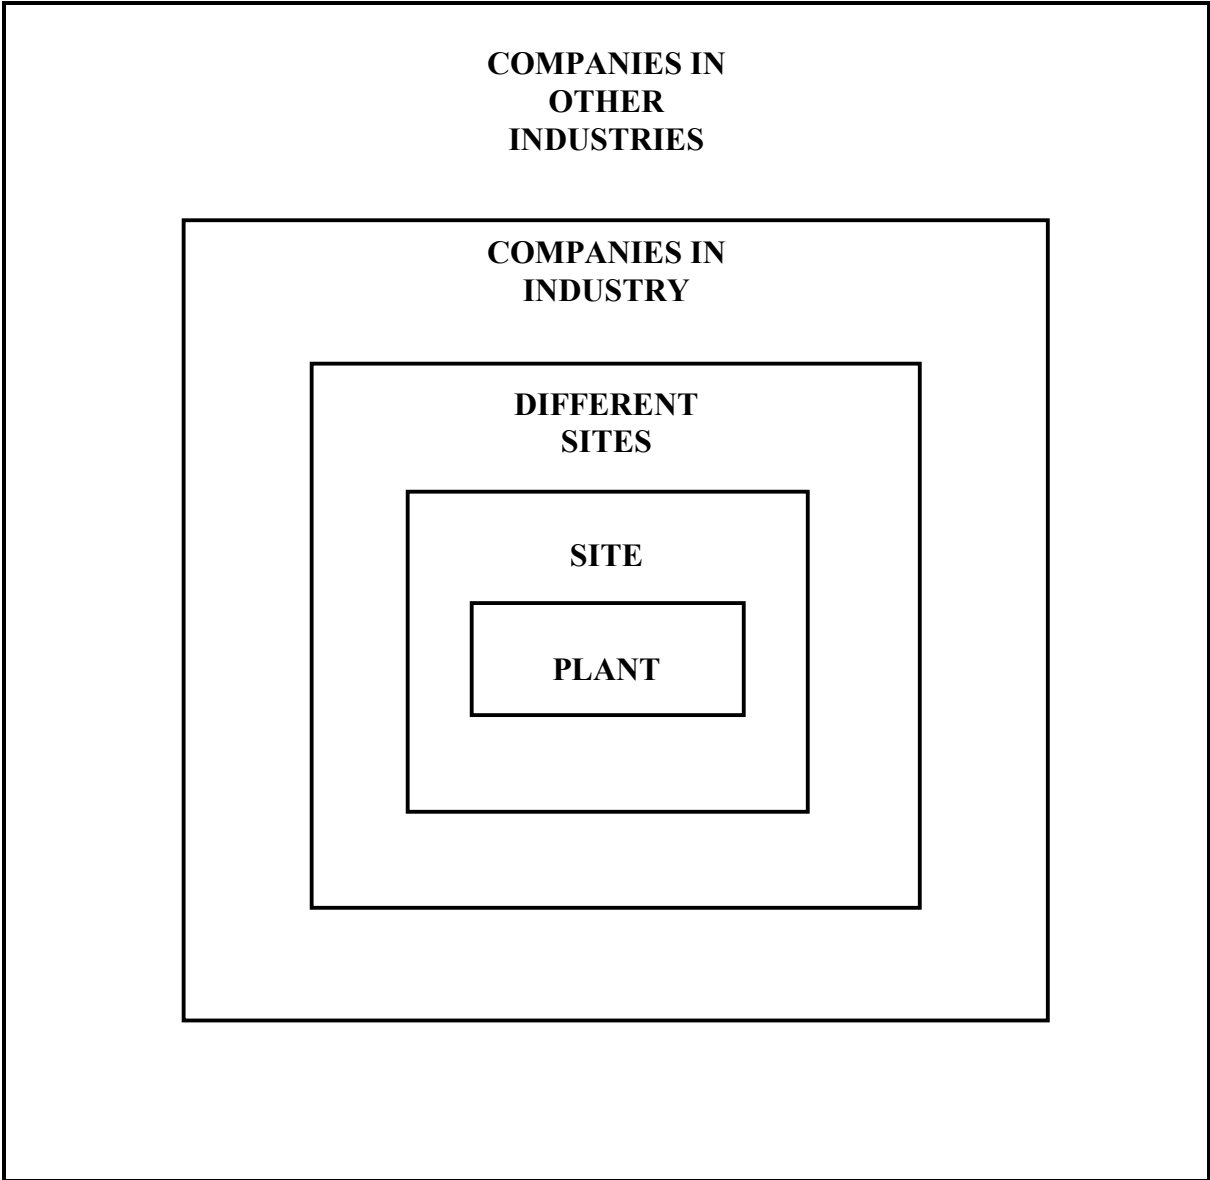
Figure 1 : Sources Of Historical Experience About Major Accidents For A Typical Multi-national Company.

This will allow the databank of experience about the causes of major accidents affecting the industry to be widened. **Figure 1** illustrates the sources of this information for a typical multi-national company.
