# BUNCEFIELD MAJOR INCIDENT INVESTIGATION

Initial Report to the Health and Safety Commission and the Environment Agency of the investigation into the explosions and fires at the Buncefield oil storage and transfer depot, Hemel Hempstead, on 11 December 2005

Buncefield Major Incident Investigation Board

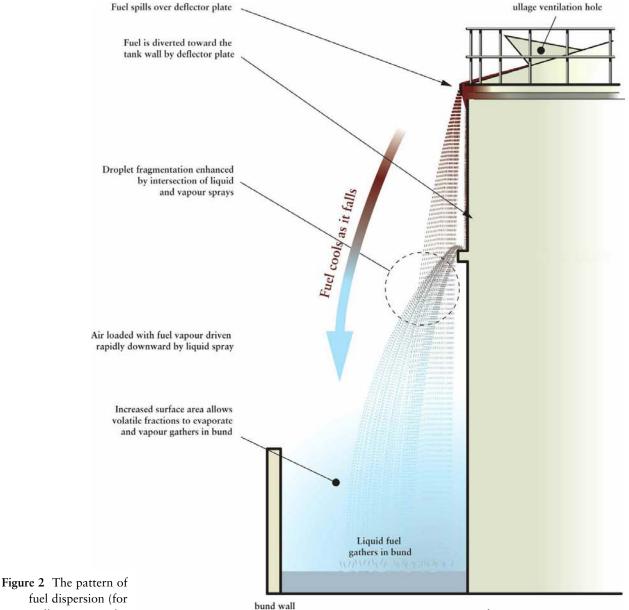
25 The Third Progress Report described extensive tests undertaken to model the behaviour of fuel escaping from Tank 912 during overfilling. Tank 912 was fitted with a deflector plate, installed to direct water from sprinklers on the tank's top to its sides to provide cooling in the event of fire. The tests demonstrated that the deflector plate channelled some of the escaped fuel onto the tank wall, but the rest ran over the top of the plate, fragmenting into droplets that cascaded through the air. Most of the fuel running down the wall hit a wind girder (a structural stiffening ring) and detached from the tank wall, creating a second cascade of droplets.

26 These conditions would promote the evaporation of the lighter components of petrol, eg butanes, pentanes and hexanes. The free-fall of droplets leads to entrainment of air and mixing between the air and fuel vapour, and the formation of a rich fuel/air mixture. Cooling of the surrounding air, already saturated with water vapour by the evaporation, would cause some of the water content to precipitate as an ice mist, which is consistent with the cloud of mist visible on

CCTV. The fuel/air mixture and its accompanying ice mist were heavier than air and so were initially contained within the bund. As the volume of the mixture grew from the continuing overfilling of the tank, it flowed out of the bund, dispersing and flowing off site. Further mixing with the air would have reduced the vapour concentration to the point where significant volumes of the mixture could support an explosion.<sup>12</sup>

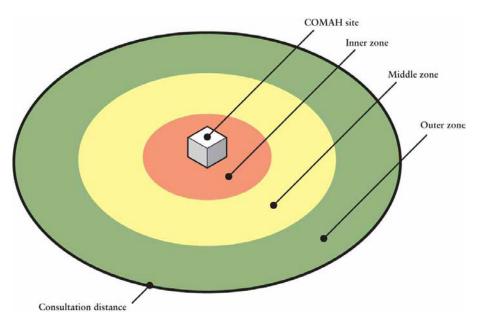
Figure 3 Consultation distance and zones

11 Within the consultation distance, HSE undertakes an assessment of the hazards and risks from the installation and produces a map with three contours representing defined levels of harm or risk which any individual at that contour would be subject to, based on information relating to the hazardous substances consent. The harm or risk to an individual is greater the closer to the installation. The contours form three zones, with the outer contour defining the consultation distance around major hazard sites. The local authority consults HSE on relevant proposed developments within this consultation distance.

12 When a planning application is received, HSE or the local planning authority first identifies in which of the three zones the proposed development is located. Secondly, the proposed development is classified into one of four 'sensitivity levels'. The main factors that determine these levels are the number of people at the development, their sensitivity (vulnerable populations such as children, old people) and the intensity of the development. With these two factors known, a simple decision matrix is used to give a clear 'Advise Against' or 'Do not Advise Against' response to the local planning authority, as shown below:

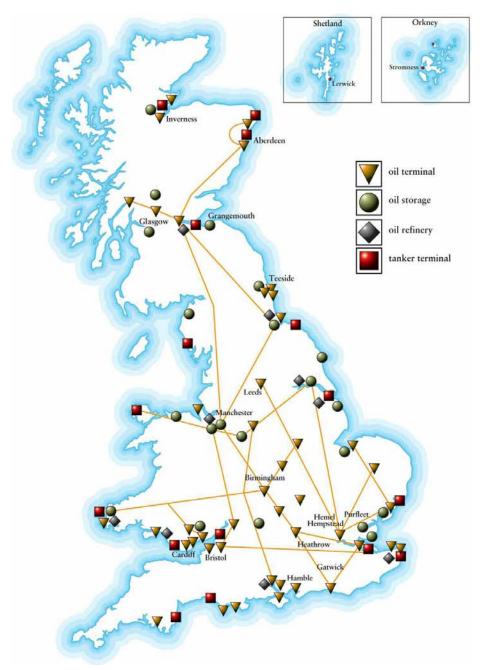
Figure 8 UK oil refinery and pipeline network

1 Petroleum products in the UK are predominantly supplied from nine refineries where crude oil is refined into liquified petroleum gas (LPG), petrol, diesel, aviation fuel, gas oil, heating oil and residual bitumen. From a typical barrel of North Sea crude oil, approximately 3% becomes LPG, 37% petrol, 25% diesel, 20% kerosene (aviation fuel/heating oil) and 12% fuel oil (for power generation). Figure 8 shows the location of the refineries. They are sited on the coast or on estuaries so that they can receive crude oil by ship.
