Ageing Plants – Corrosion is the Real Enemy but there are other problems

Eur. Ing. Robert Canaway B.Sc. C.Eng., F.I. Chem.E., M.I. Mar. E.
Managing Director, Suregrove Limited, 20 White Beam way Tadworth Surrey KT20 5DL

Abstract

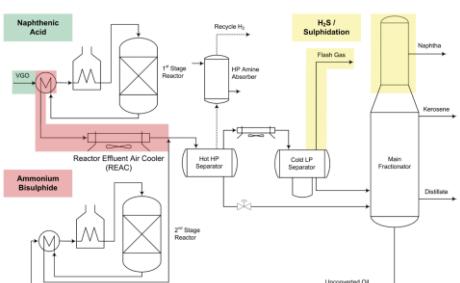
The use of material selection process/utility diagrams or Corrosion Identification PFDs/UFDs is highly recommended. In most mature plants the corrosion areas are known by the operator/owner.

Left is a typical flowsheet marked up to indicate expected high corrosion areas.

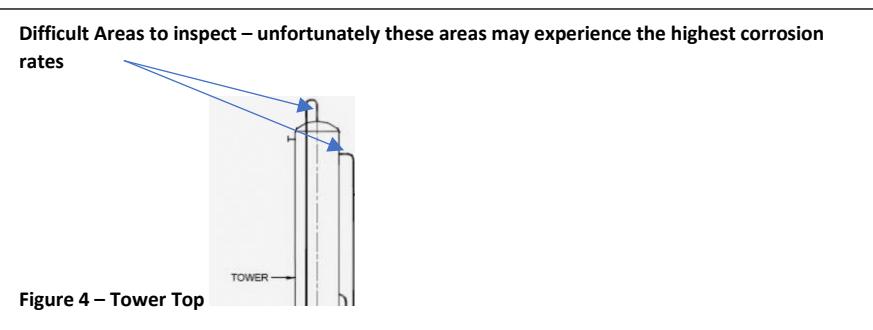
Figure 4 – Tower Top

Difficult plant areas e.g., vertical pipework for overhead lines which can corrode but cannot be easily inspected due to the elevation and compactness against the vessel top section.

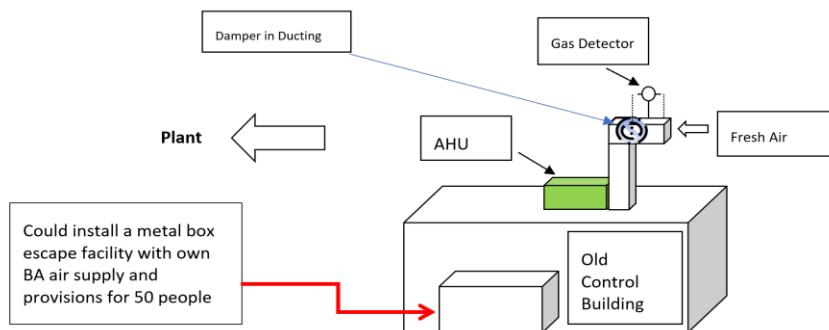
Figure 5 – Control Building Requirements

- 3) Poorly designed HVAC systems encourage gas ingress and do not remove heat generation from electrical devices causing them to overheat. Often the design did not cater for heat dissipation and the high ambient temperatures experienced at various locations in the world. Buildings should have clean air intakes facing away from the process and also dampers activated by in-line gas detectors. If the building is under closed air condition, then the heat rise should be calculated to find out whether the equipment can still function properly.

- 4) Use of polyurethane sealers for cable entries is to be avoided – this type of sealant is flammable and porous (with age).

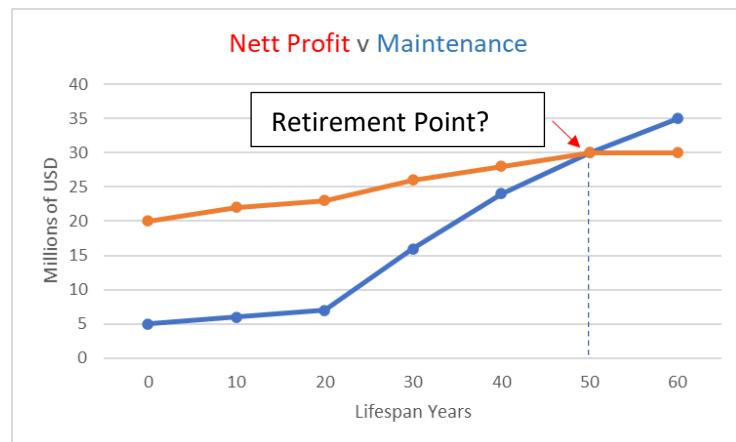
**Figure 6 – Retirement Point**

Once the maintenance costs including any ongoing repairs approaches the net profit it is usually time to retire the plant. Any reduction in profit (for example a declining oil reservoir with higher water production) may lower the net profit but unfortunately maintenance costs do not go down with age.

Retirement is usually based on:

- Declining demand for the products from the plant
- The costs to continue and the net profit

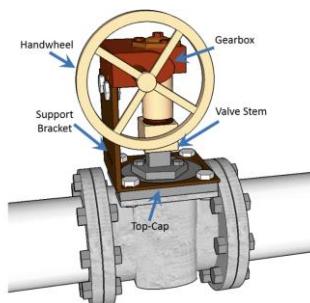
Event	Detail	Remark
Case Study No.1 On November 22, 2016, an isobutane release and fire seriously injured four workers in the sulphuric acid alkylation unit at a refinery in Baton Rouge, Louisiana. During removal of an inoperable gearbox on a plug valve, the operator performing this activity removed critical bolts securing the pressure-retaining component of the valve known as the top-cap. When the operator then attempted to open the plug valve with a pipe wrench, the valve came apart and released isobutane into the unit, forming a flammable vapour cloud. The isobutane reached an ignition source within 30 seconds of the release, causing a fire and severely burning four workers.

This type of valve should have been replaced or clear working instructions should have been given to the maintenance crew. Warning Signs are useful to indicate direct connections to the internal process for this type of configuration, but the best risk reduction measure is replacement.

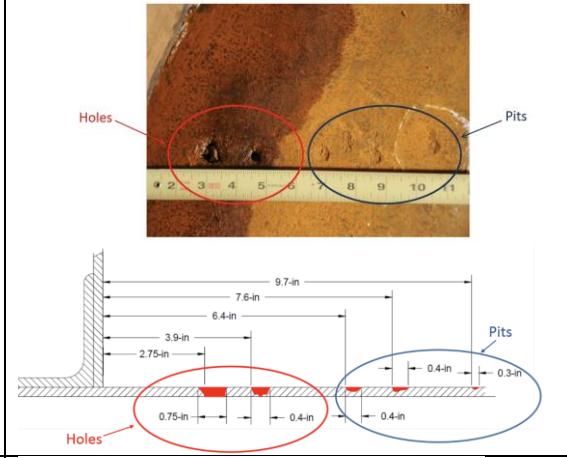
<p>Case Study No.2</p> <p>A chemical storage terminal tank leaked in Charleston, West Virginia on 05/11/2017 and contaminated the local water supply leaving thousands of residents without clean drinking water. The 20-foot-diameter tanks were most likely constructed in the late 1930s. The cylindrical shell and cone roof were of an obsolete, single lap-riveted construction. The tanks contained a 0.25-inch lap-welded bottom that inspectors estimated to be a replacement for the original lap-riveted bottom. The bottom interior of tank 396 was found to have deep, isolated pits or crevices near the shell (side) of the tank in addition to two holes on the tank floor, approximately 0.75 inches and 0.4 inches in diameter, which were the source of the leak</p>

<p>The photograph shows a close-up of a brown, rusted metal plate with two circular red outlines. The top outline, labeled 'Holes', encloses two small circular holes. The bottom outline, labeled 'Pits', encloses several deeper, irregular depressions. Below the photograph is a technical cross-sectional diagram of the tank bottom. It shows a vertical wall on the left and a horizontal plate on the right. Two red outlines on the plate are labeled 'Holes' and 'Pits'. Dimensions are indicated: 9.7-in, 7.6-in, 6.4-in, 3.9-in, 2.75-in, 0.75-in, 0.4-in, 0.4-in, 0.4-in, and 0.3-in.</p>	<p>Tank Inspection was inadequate for ageing tanks and the advanced pit corrosion was not identified. This eventually made two holes in the bottom plate allowing a toxic chemical to be released into the environment.</p>

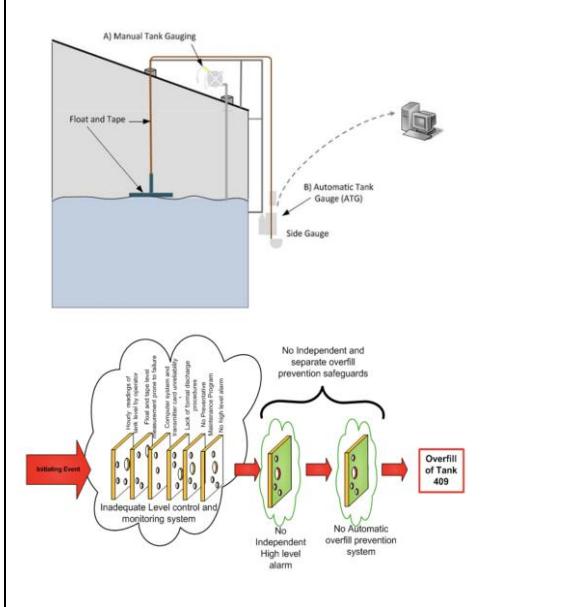
<p>Case Study No.3</p> <p>On October 23, 2009, a large explosion occurred at the CAPECO facility in Bayamón, Puerto Rico, during offloading of gasoline from a ship. A 5-million-gallon aboveground storage tank overflowed into a secondary containment dike. The gasoline spray aerosolized, forming a large vapour cloud, which ignited after reaching an ignition source in the wastewater treatment area of the facility. The blast and fire from multiple secondary explosions resulted in significant damage to 17 of the 48 petroleum storage tanks and other equipment onsite and in neighborhoods and businesses offsite. The fires burned for almost 60 hours. Petroleum products leaked into the soil, nearby wetlands and navigable waterways in the surrounding area.</p>

<p>The diagram illustrates two methods of tank gauging: A) Manual Tank Gauging, which uses a float and tape to measure the liquid level, and B) Automatic Tank Gauge (ATG), which uses a side gauge. Below these, a flowchart shows the sequence of events leading to the overfill of Tank 409. It starts with 'Refilling Event' leading to 'Inadequate Level control and monitoring system' (which includes 'No independent and separate overfill prevention safeguards'). This leads to 'Independent High level alarm' (which includes 'No automatic overfill prevention system'), and finally to 'Overfill of Tank 409'.</p>	<p>Multiple physical causes contributed to Tank 409 overfill: Malfunctioning of the tank side gauge or the float and tape apparatus during filling operations led to recording of inaccurate tank levels Normal variations in the gasoline flow rate and pressure from the ship without the facility's ability to identify and incorporate the flow rate change in real time into tank fill time calculations may have contributed to the overfill. Potential failure of the tank's internal floating roof due to turbulence and other factors may have contributed to the overfill.</p>
