## Buncefield response

# Buncefield – Reflections from a regulator

Wayne Vernon, Strategic ALARP, Australia

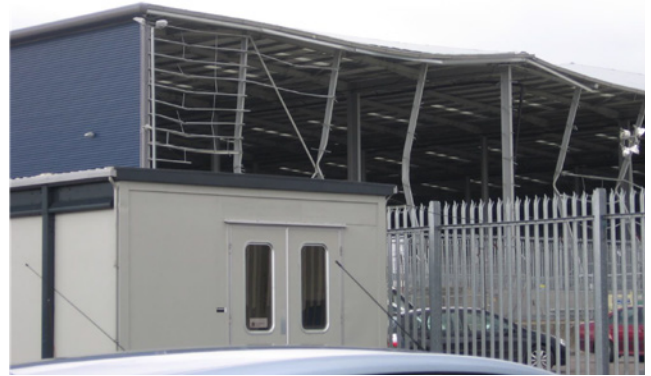
When I first arrived at the site, months after the explosion, the extent of the damage to the site and its surrounds was shocking. Nearby trees were stripped of branches, adjacent buildings had their external facades ripped away to reveal crumpled support structures. The devastation resembled a war zone.

Figure 2 – Damaged building near the Buncefield storage depot

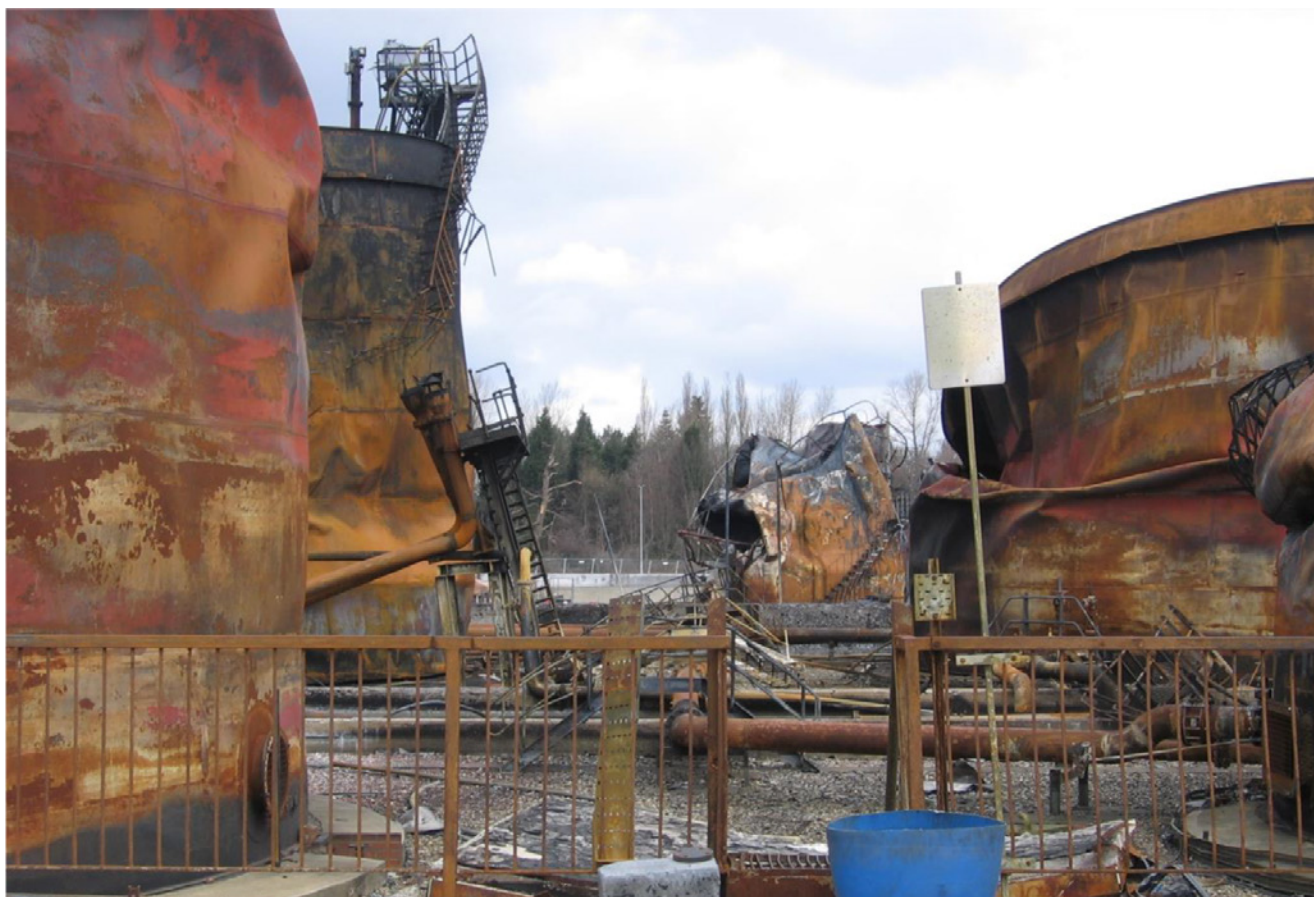
Figure 3 – The post-apocalyptic landscape we were trying to obtain evidence in
